August 6, 2024

Mr. Steve Wiesner, PE
Mr. Tim Bailey, PE
Santa Cruz County
701 Ocean Street, 4th Floor,
Santa Cruz County, California 95060

SUBJECT: GEOTECHNICAL REPORT
Mountain Charlie Road Storm Damage PM 1.63
Santa Cruz County, California

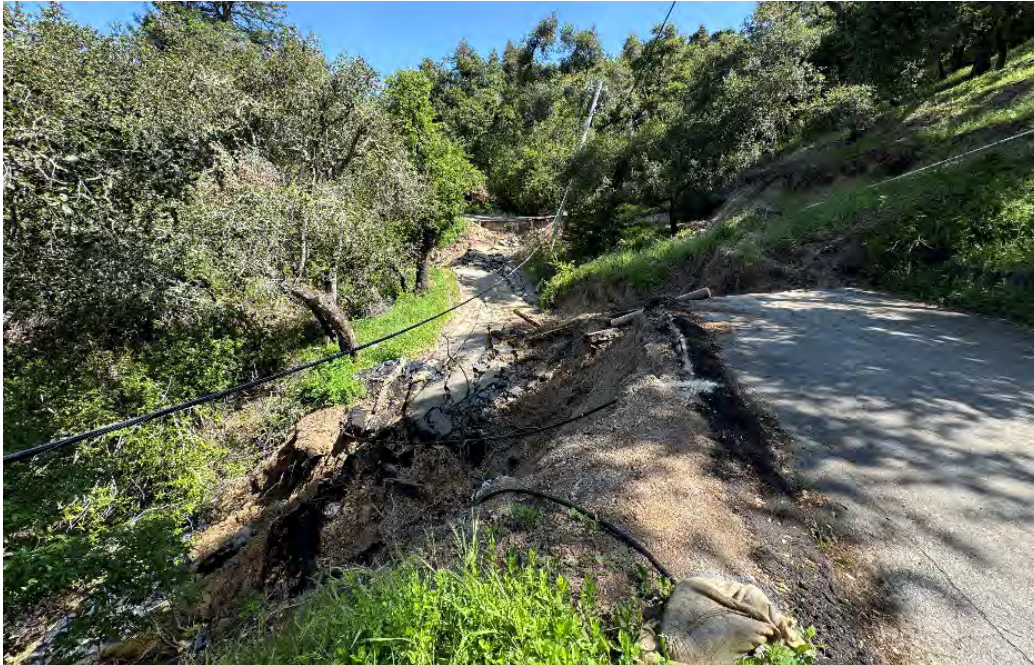
Exhibit 1 Scarp on Mountain Charlie Road, Looking North at PM 1.63

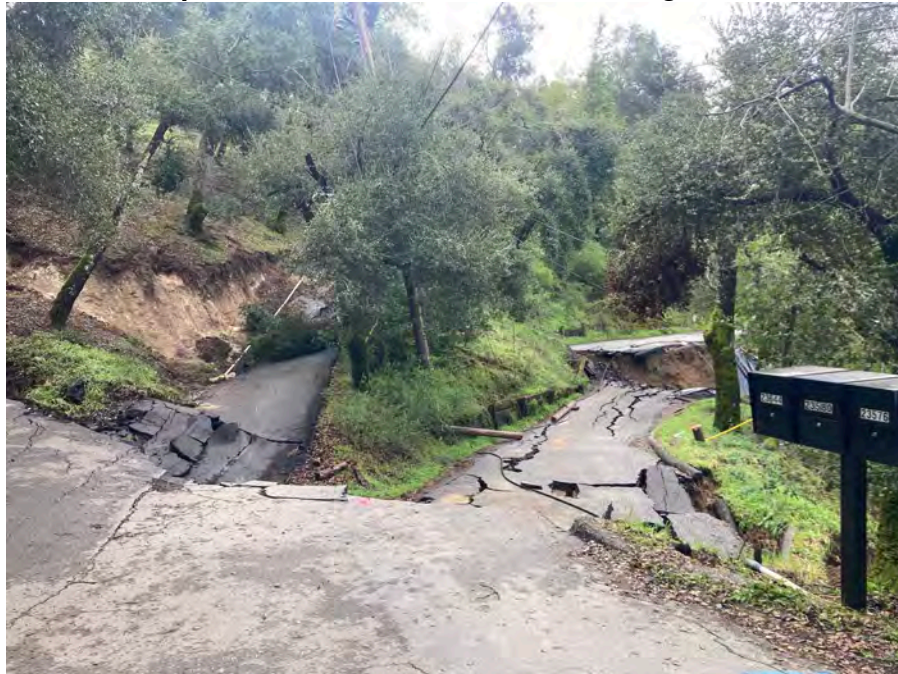
Exhibit 2 Scarp and Damage on Mountain Charlie Road, Looking South at PM 1.63

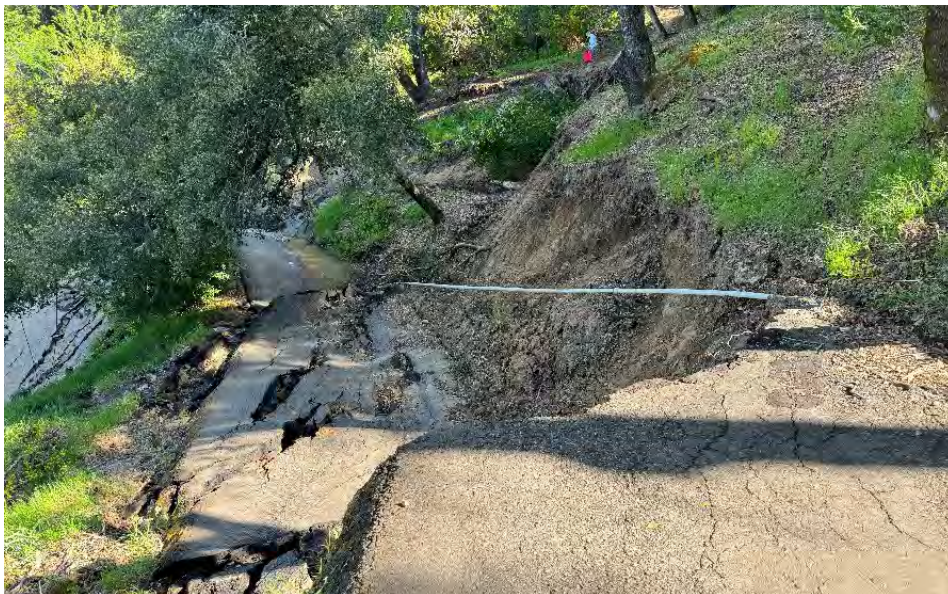
Observations of the driveway reveal that the top of the scarp is generally aligned with the inboard edge of the driveway and follows the edge of the driveway drainage path. See Exhibit 2. The scarp geometry encompasses a 100-foot segment of Mt Charlie Road and extends 80 feet east towards the driveway from the edge of pavement. The scarp extends about 100 feet from the Mt. Charlie Road pavement edge downslope to the west. The toe of the slipout was characterized as an area with saturated soils that exhibited seepage and showed moderate relief compared to the surroundings, see Figure 3 Site map.

Exhibit 3 Scarp on Driveway, Looking North at PM 1.63

Mt. Charlie Road has multiple longitudinal tension cracks that vary in width up to approximately 1 foot wide that generally extend to the boundary of the slipout extents. See Exhibit 3.

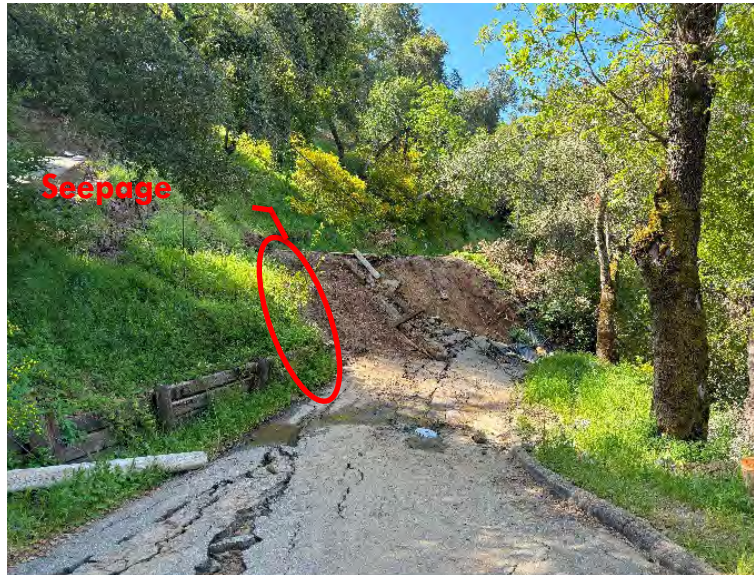
Exhibit 4 PM 1.63 Looking South, Seepage Area Shown Above Road

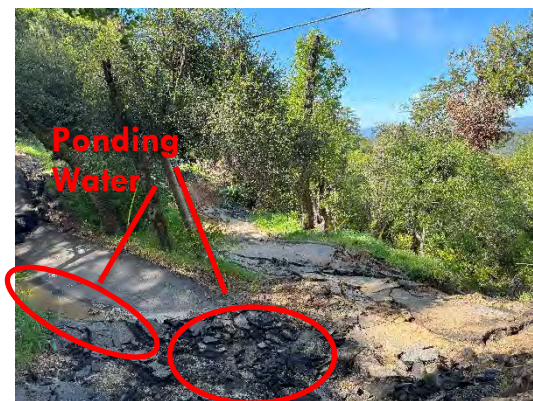
Exhibit 5 Northside of Scarp, Looking Southwest

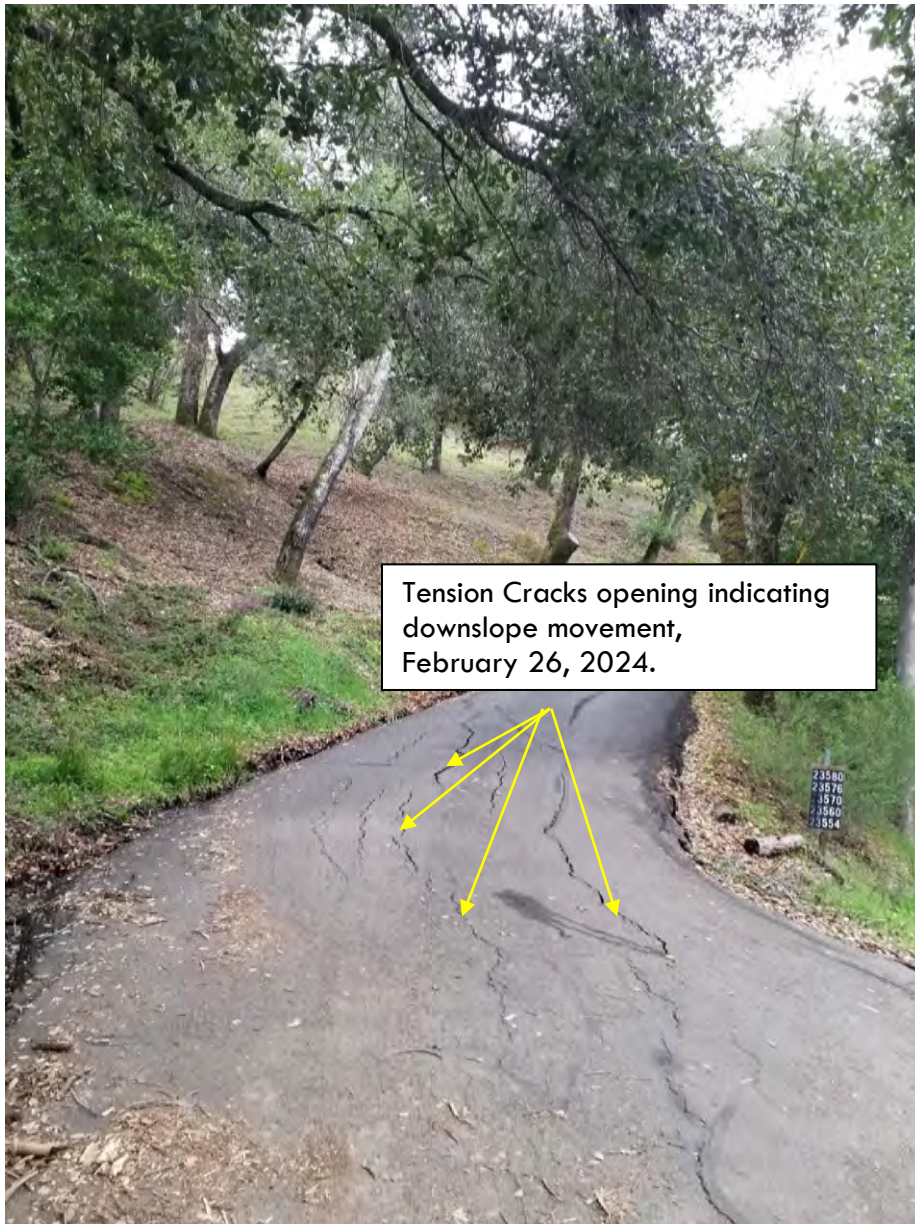
Prior to the catastrophic collapse on February 29, 2024, photographs showed how the slope was gradually moving and tension cracks were opening in the driveway and slope above the road due to the groundwater water infiltration and groundwater rise from the storm.

Exhibit 7 February 26, 2024, Tension Cracks

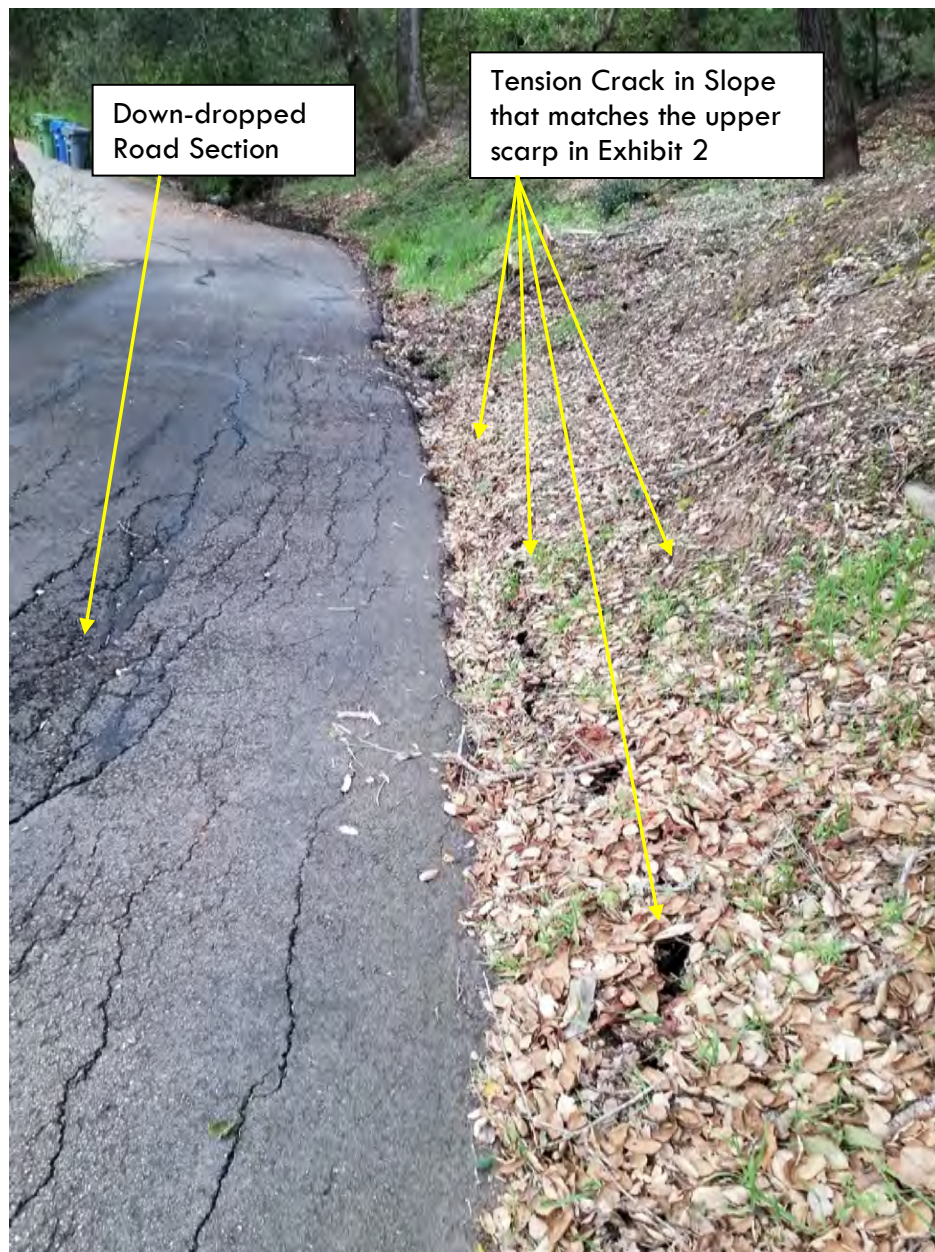
Exhibit 8 Tension cracks, down-dropped road, tension crack in slope, February 26, 2024

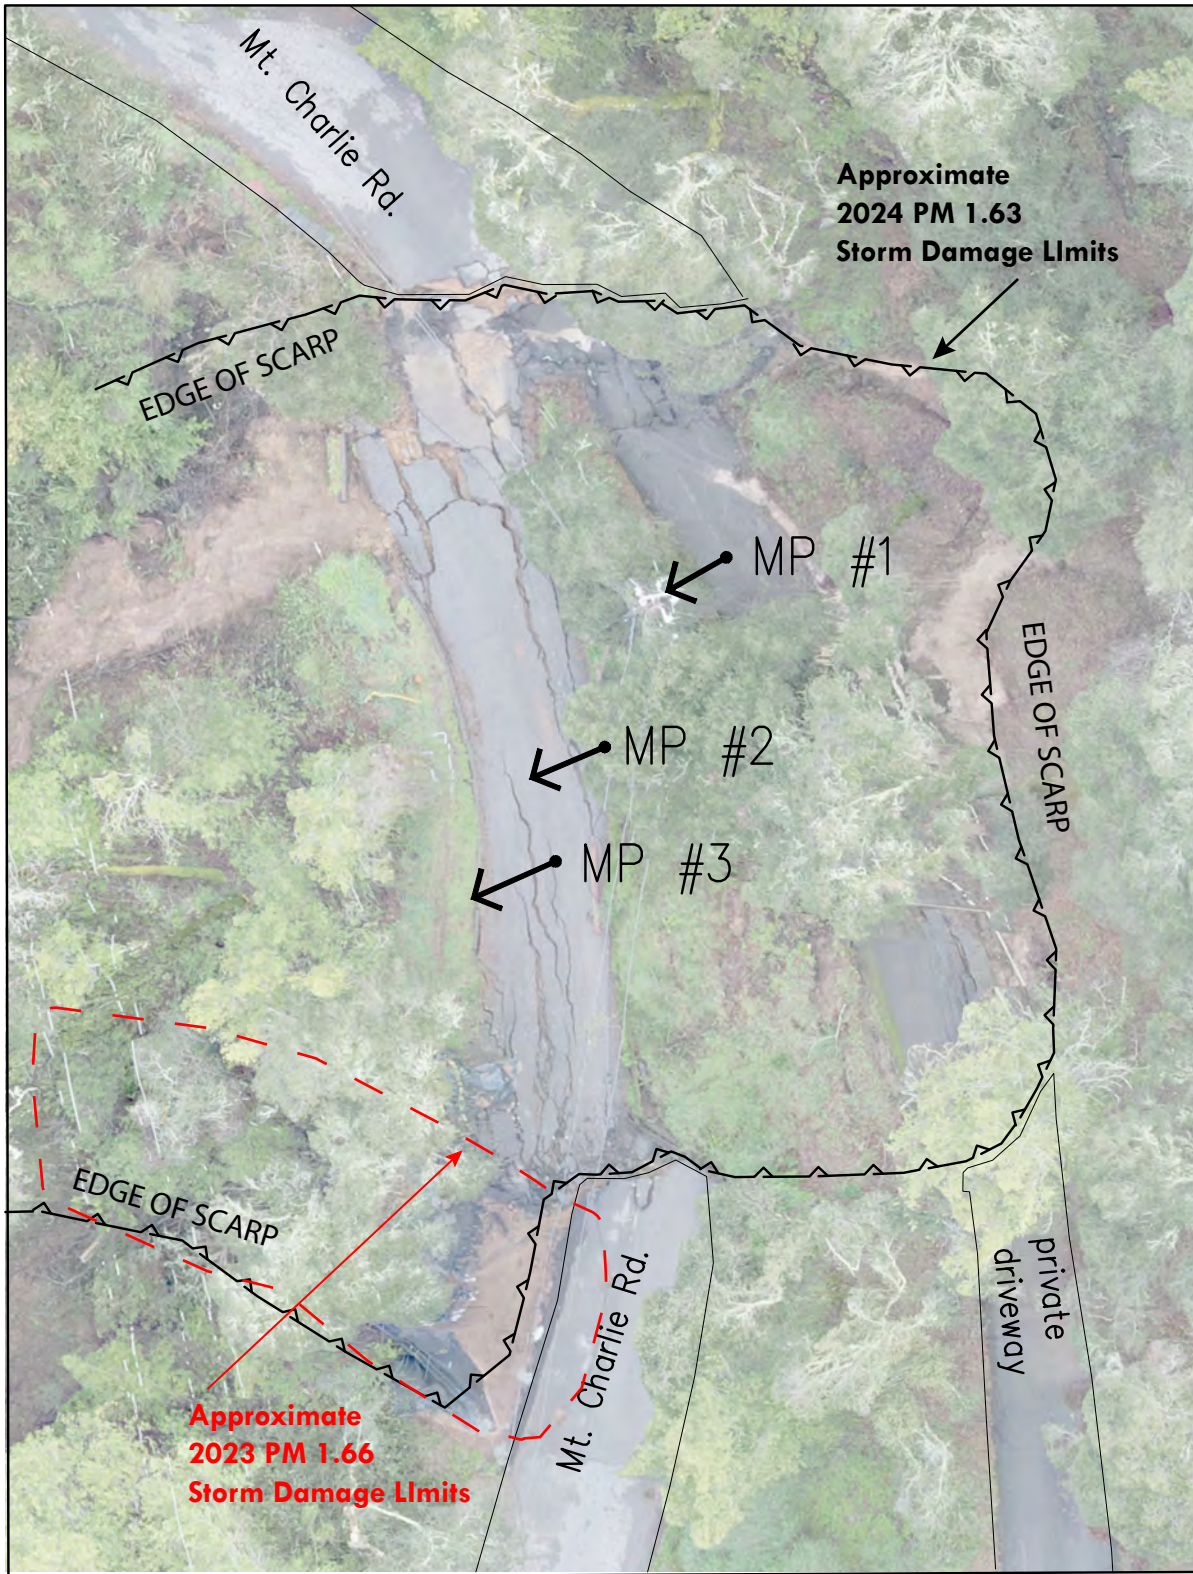
FIG 1

PRIOR TO SETTING MONITORING STATIONS MP#1, MP#2 & MP#3, THE SITE HAD ALREADY MOVED:

HORIZONTALLY 10.85'
VERTICALLY 6.86'

AFTER SETTING MONITORING ON 3/7/24, STATIONS MP#1, MP#2 & MP#3 HAVE MOVED AS FOLLOWS:

MP#1 HORIZONTALLY 7.28'
VERTICALLY 5.61'

MP#1 HORIZONTALLY 8.56'
VERTICALLY 4.72'

MP#1 HORIZONTALLY 9.71'
VERTICALLY 4.66'

TOTAL AVERAGE MOVEMENT
HORIZONTALLY 19.4'
VERTICALLY 11.6'

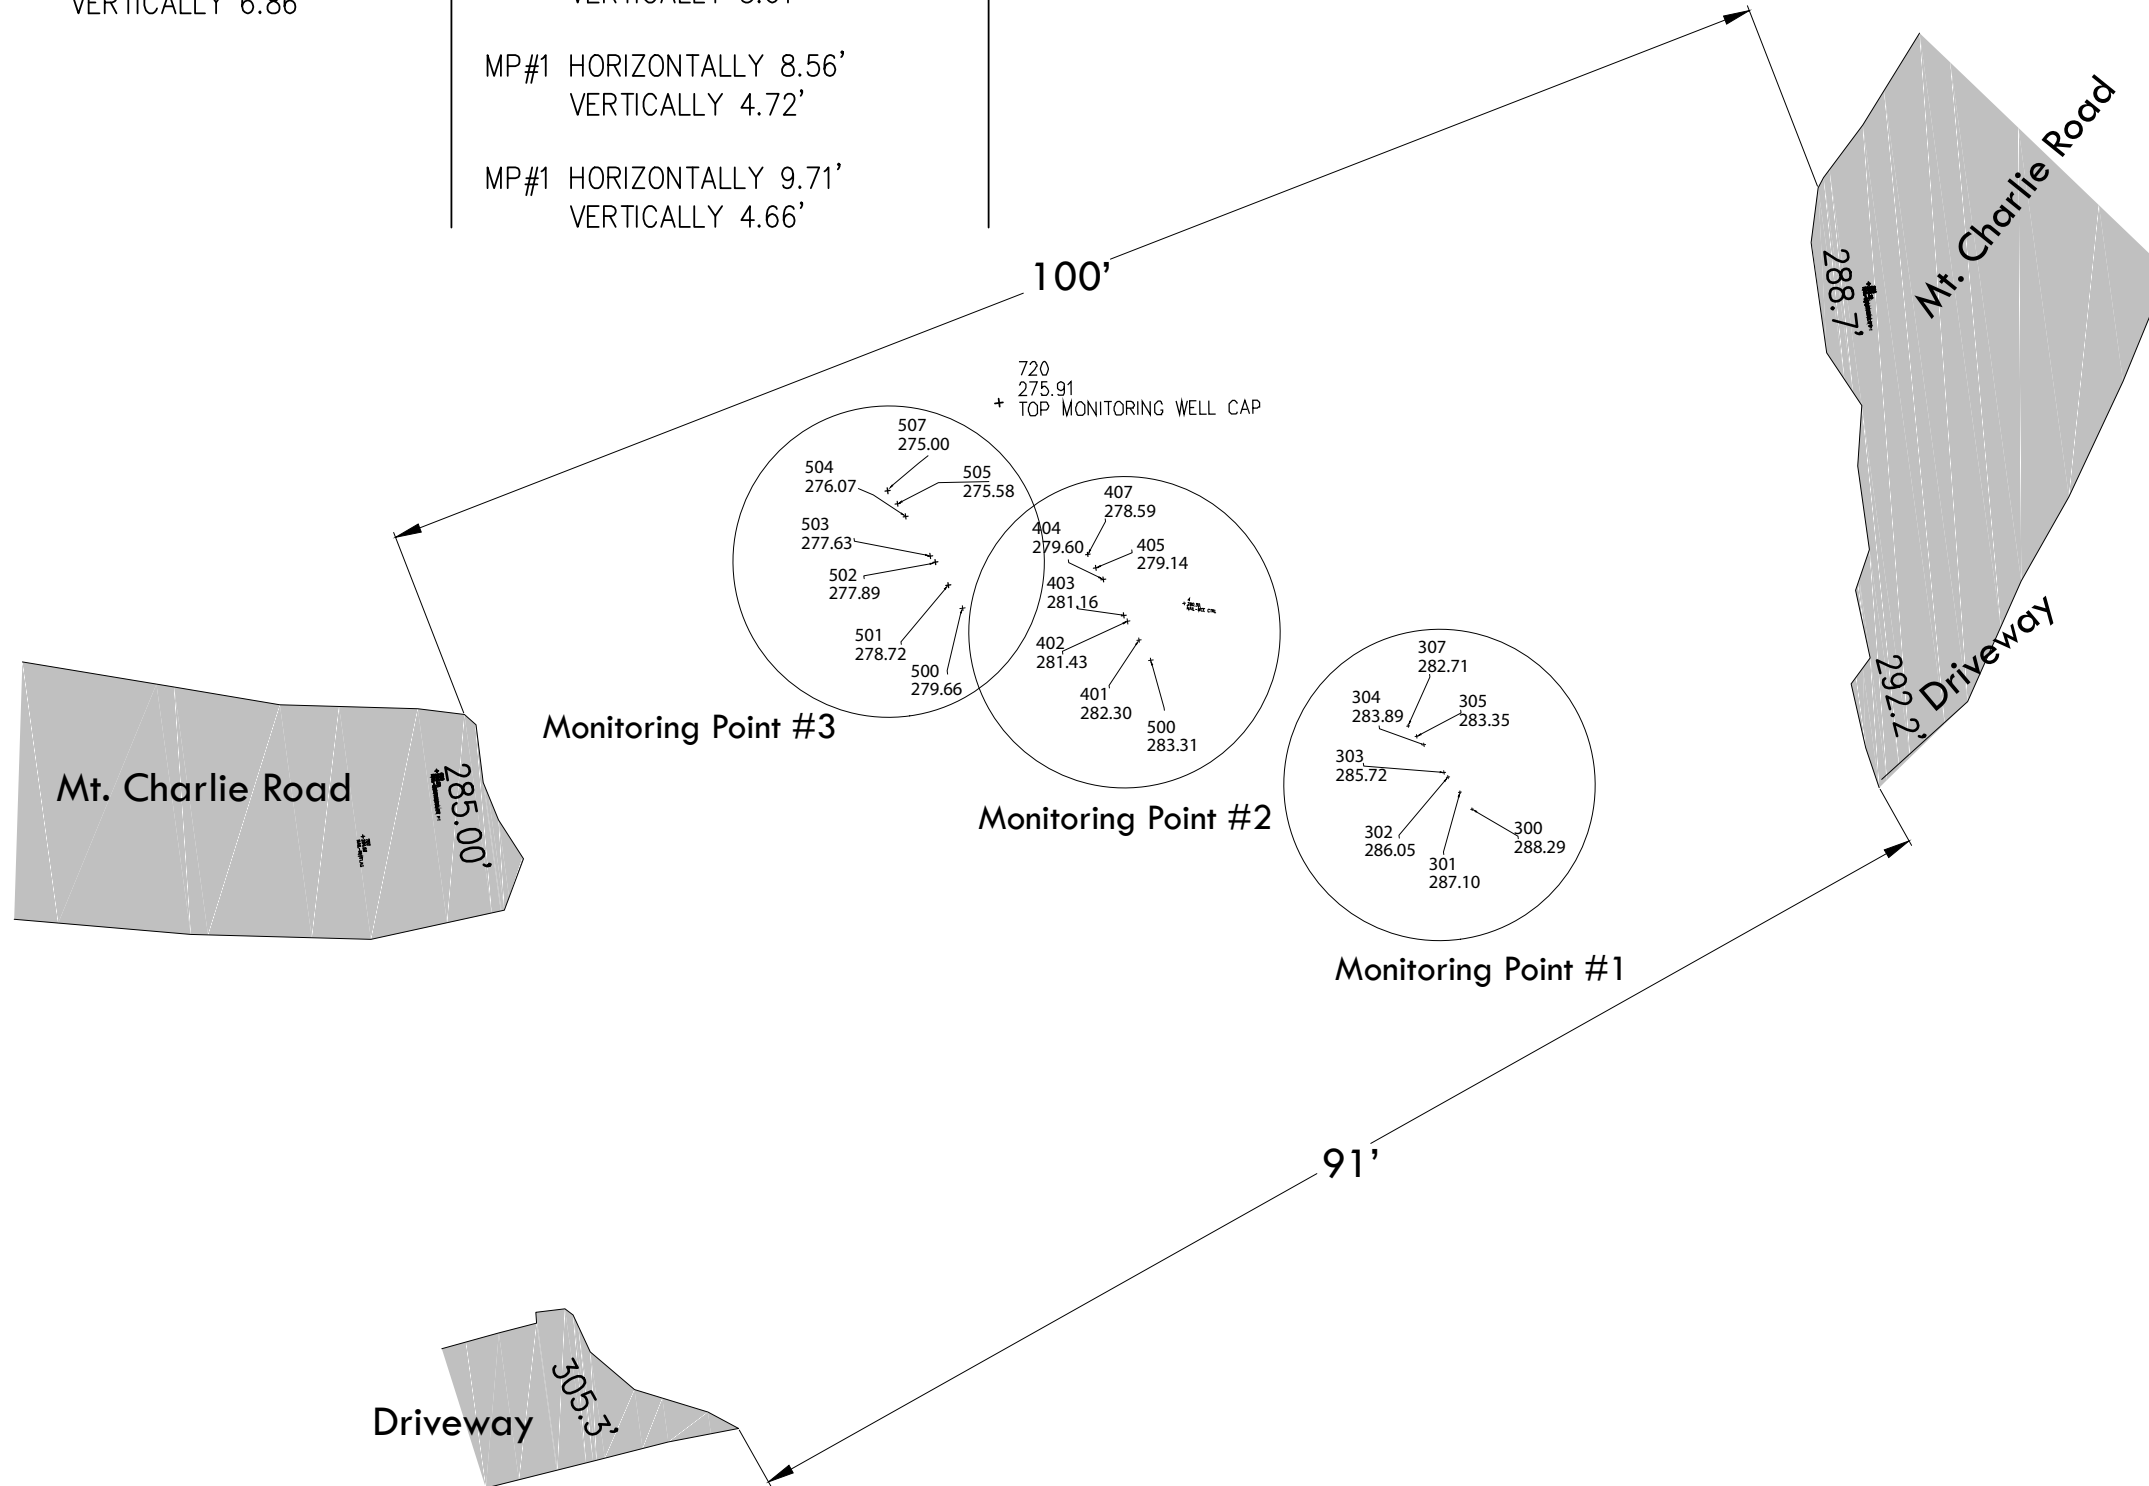
Mt. Charlie Road PM 1.63 Storm Damage Santa Cruz County, California	
Survey Monitoring	
May 2024	Project No. 730
MGE Engineering, Inc. <small>Civil, Structural, and Geotechnical Engineers</small>	FIG 2

Monitoring Point No. 1	7.28 feet horizontal,	5.61-feet vertical;
Monitoring Point No. 2	8.56 feet horizontal,	4.72-feet vertical;
Monitoring Point No. 3	9.71 feet horizontal,	4.66-feet vertical.

Using the average of the monitoring point data for horizontal and vertical movement, and the recorded movement prior to setting the monitoring points, gives a total movement of 19.4 feet horizontally and 11.6 feet vertically.

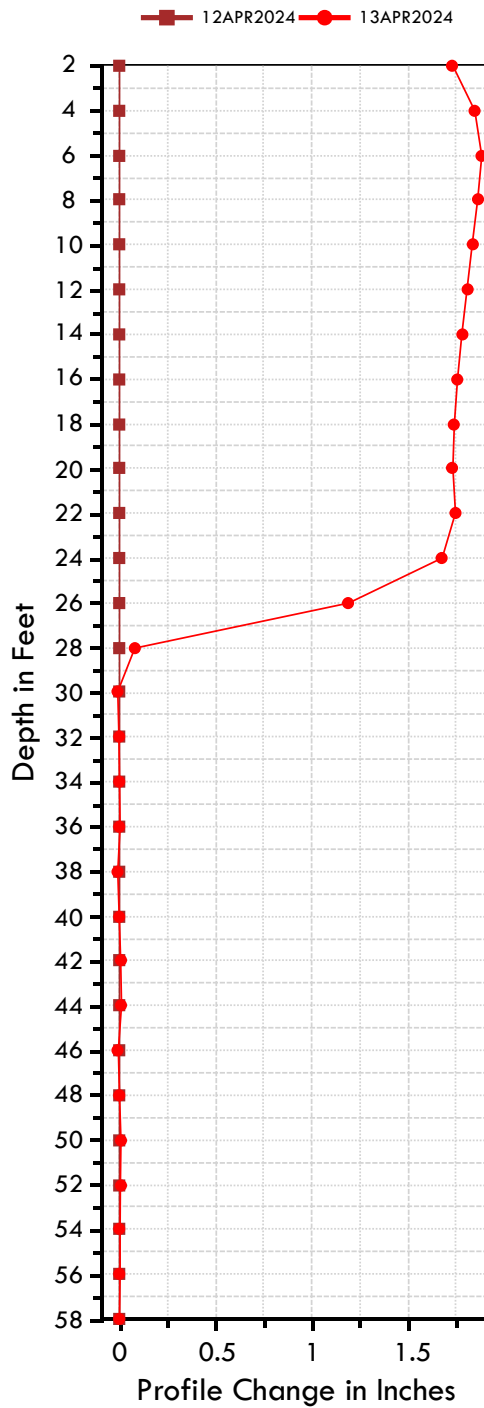
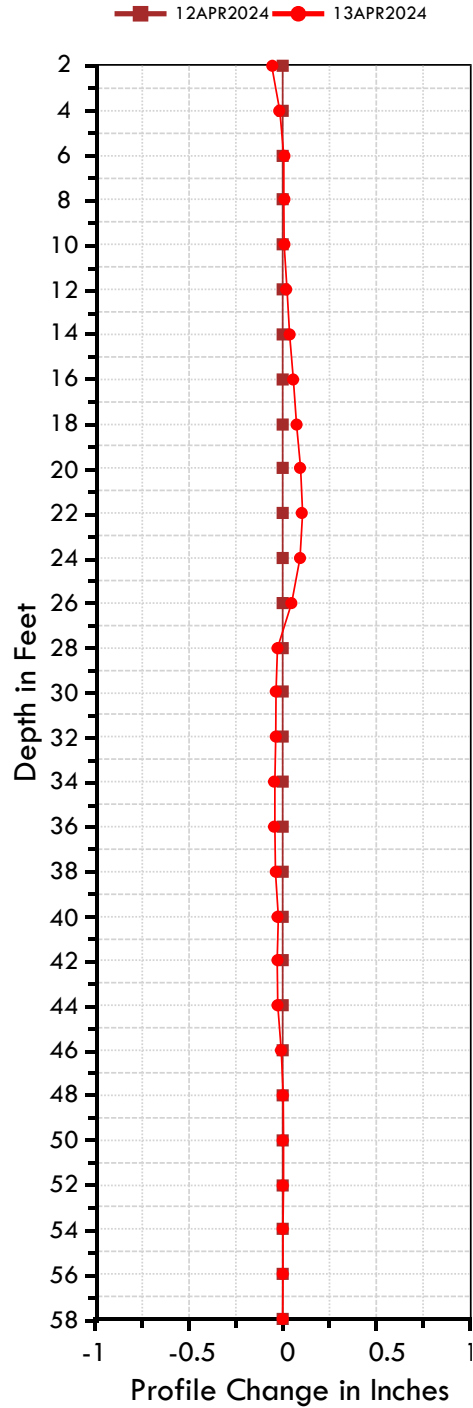
Inclinometer Data in Boring B4 shows the depth of the failure plane at the B4 location is 28-feet deep. The scarp limits are defined by the obvious back scarp on the hillside and the toe of the storm damaged debris was observed and identified during walking traverse on the slope. These limits are shown on Figure 3 Site Map. In our opinion, the slipout failure plane is within the soil unit and not within the rock unit below 30-feet depth. MGE did not observe tension cracks upslope from the existing scarp limits. However, soft soil was observed above the scarp near the walking trail used by residents to access their property. This trail is within 20-feet of the upper scarp limits.

Mt. Charlie PM 1.63
A-axis

Mt. Charlie PM 1.63
B-axis

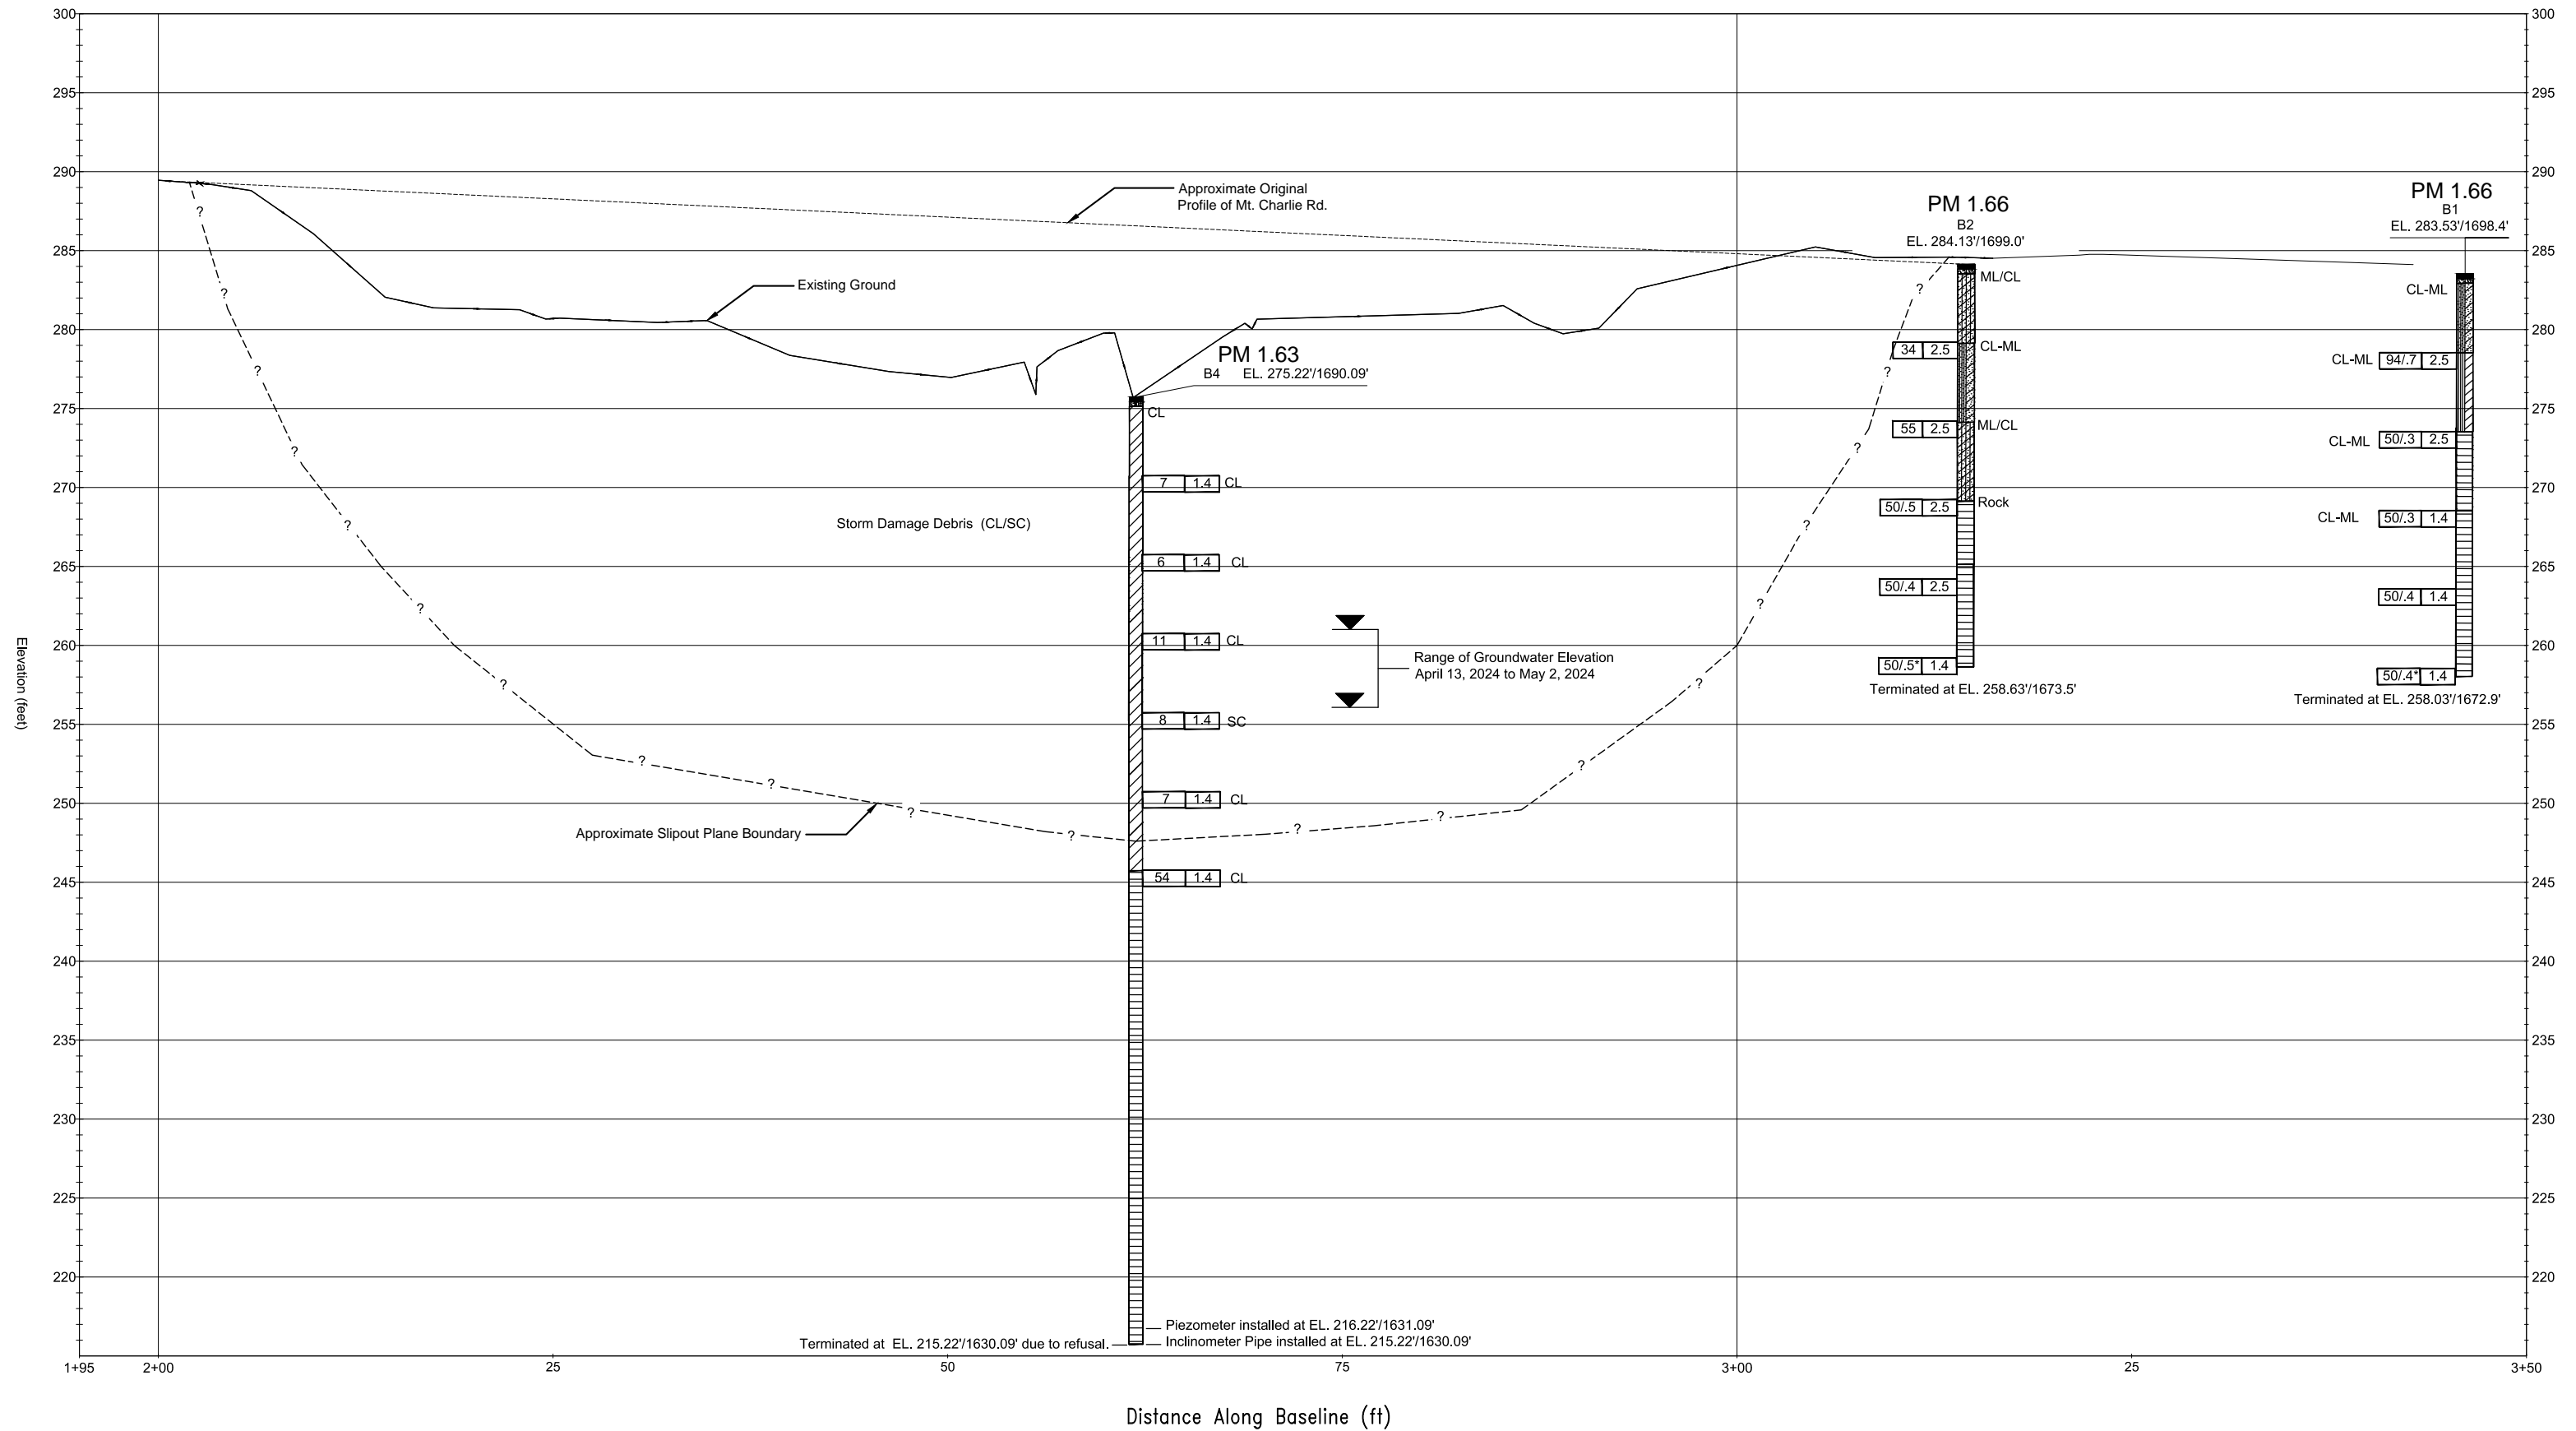
Cross Section Identification		Cross Section A		
DIST. 5	COUNTY Santa Cruz	ROUTE	POSTMILE 1.63	PROJECT NUMBER 730
PROJECT OR BRIDGE NAME Santa Cruz Storm Damage				
FIGURE 6		PREPARED BY Edward Muro	DATE May 2024	SHEET 2 of 3

Saturation of the local native soil appears to be the cause of the slipout damage. The failure of the embankment is a deep-seated circular failure. The failure plane is not within the underlying rock unit. This failure mechanism is different from the 2023 adjacent storm damage that was shallow on the outside of the road embankment. During the major storm disaster experienced by Santa Cruz County between January 31st and February 9, 2024, this location experienced approximately 8 inches of rainfall based on the rainfall gauge located nearest to the site. The groundwater elevation response to precipitation that we noted during our piezometer readings suggest the precipitation during the major storm disaster saturated the soil at the site. This led to the failure observed at PM 1.63 during the 2024 atmospheric river storms. The scarp limits noted along Mt. Charlie Road during the 2024 site visit coincided with the tension cracking observed in the photographs take on February 26, 2024. Isolated seepage appears above the original Mt. Charlie Road elevation and above the culvert inlet elevation at the road. In our opinion, the culvert is not the source of seepage in the slope, nor the cause of the existing soil saturation based on our observations of seepage and ponded water about the site.

The scarp limits and failure plane depth would indicate that a soldier pile wall would be an effective repair for restoring Mt. Charlie Road given the right-of-way constraints and the anticipated height of a suitable repair. In our opinion, a wall height of 25 feet at the former roadway edge is likely. Given the wall height, tie-backs anchors may be required unless lightweight fill is used to reduce lateral earth pressures. Given that a portion of the slipout debris will require removal to restore the site, there is an opportunity to import lightweight fill and reduce the amount of or need for tie-back anchors.

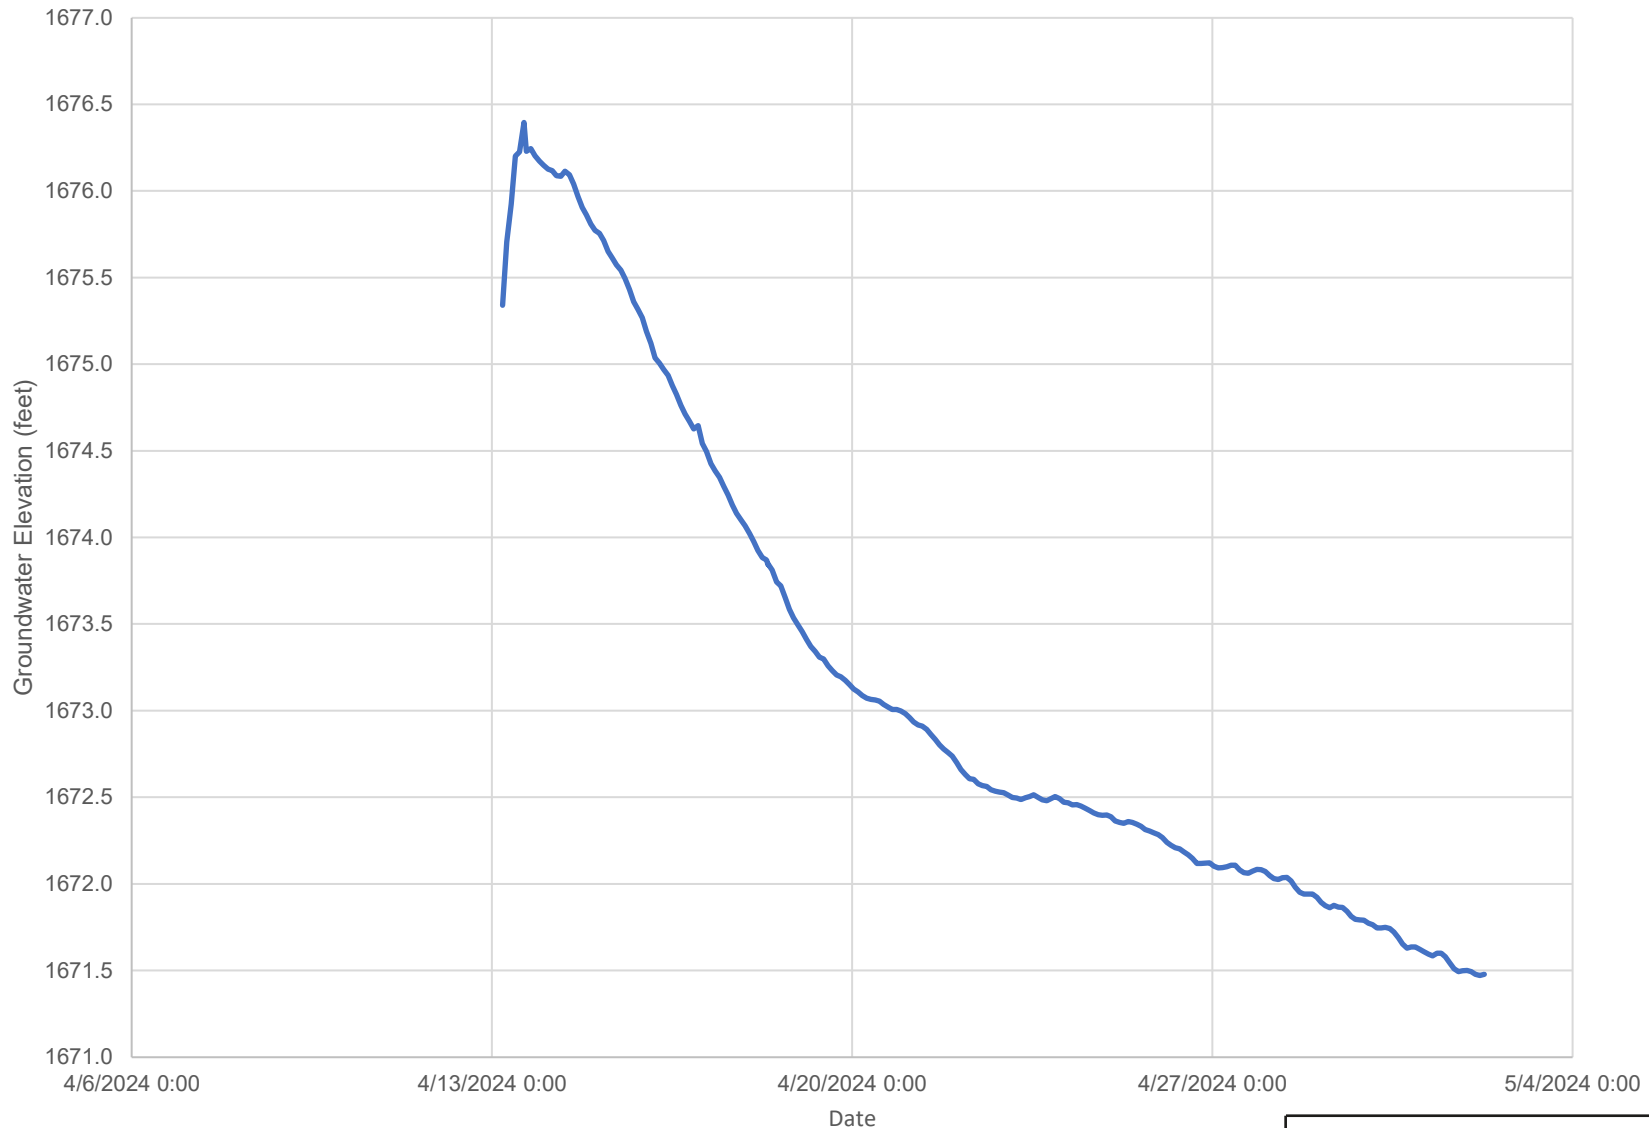
Based on the locations of ponded water, seepage, and the groundwater level data from the piezometer, groundwater elevations are not confined to the soils:rock interface and are elevated above this level. Seepage areas may be present within the slipout debris mass near the back scarp and are likely contributing to the saturation in the slope.
