HATCH LEGEND

ALUMINUM		CONTINUOUS LUMBER
	STEEL		PLYWOOD
	BATT INSULATION		GRANULAR MATERIAL
	RIGID INSULATION		EARTH
	CMU		CONCRETE
	BRICK		CMU GROUTED SOLID
	EIFS		GYPSUM BOARD

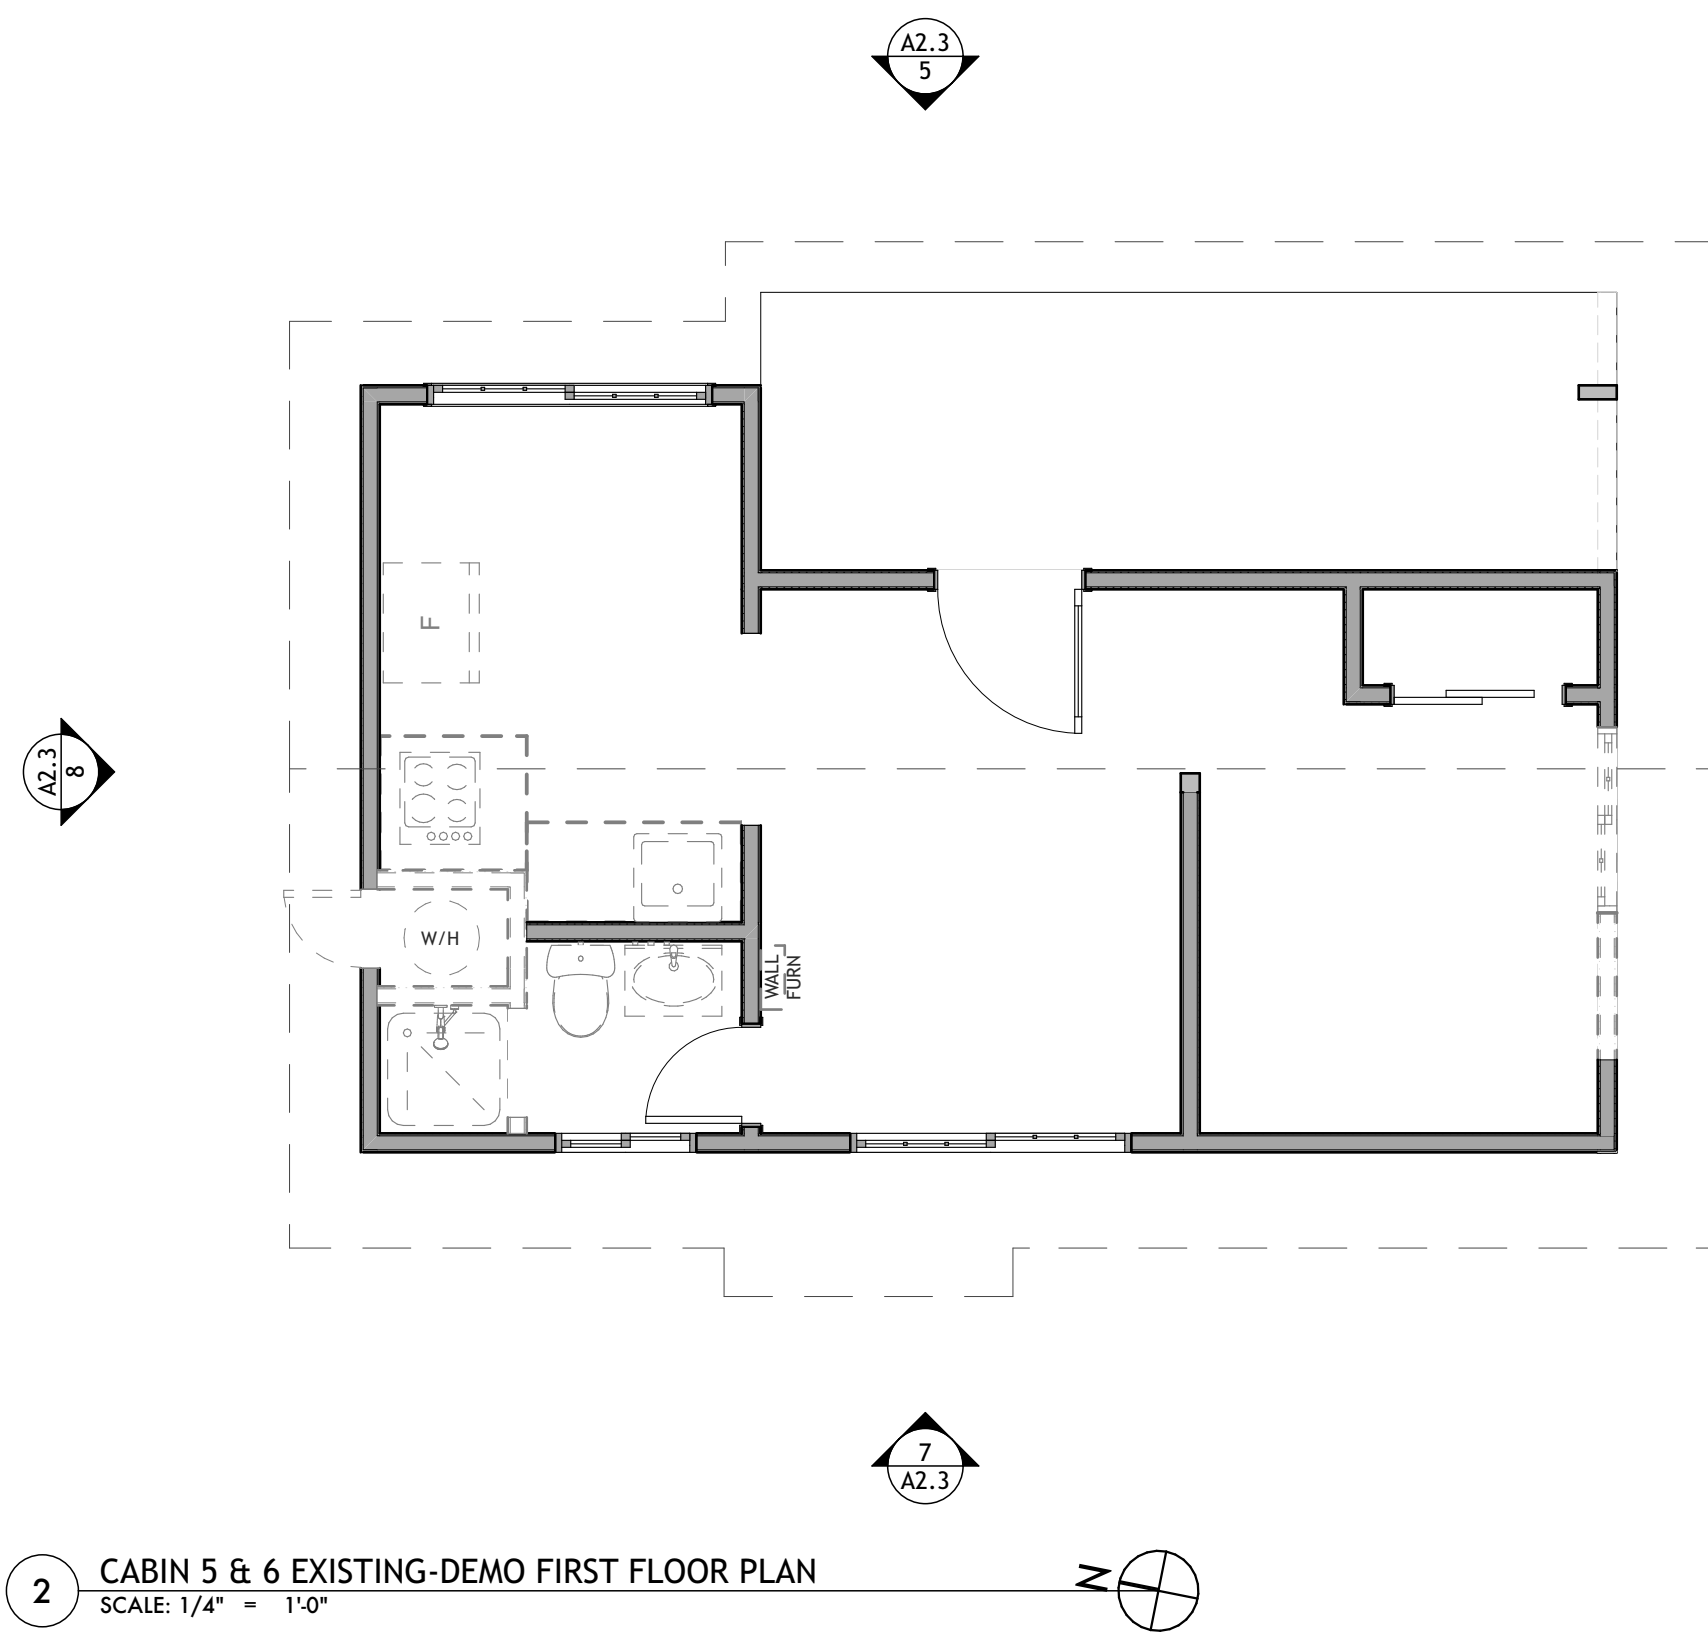
2 CABIN 5 & 6 EXISTING-DEMO FIRST FLOOR PLAN
SCALE: 1/4" = 1'-0"

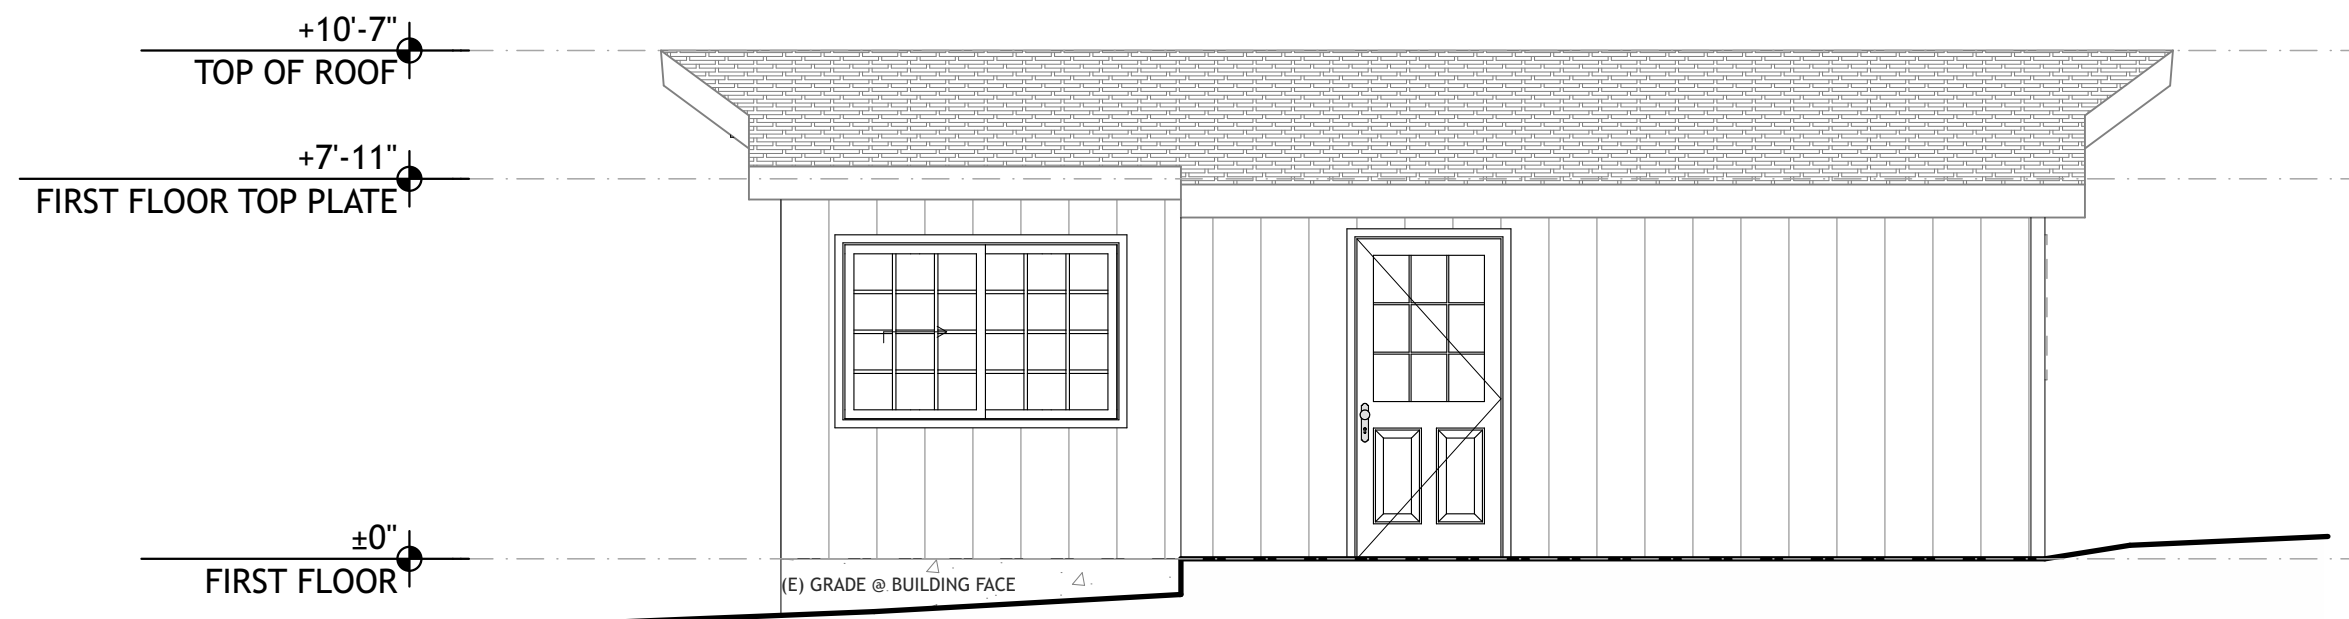
5 CABIN 2&4 EXISTING-DEMO SOUTH ELEVATION
SCALE: 1/4" = 1'-0"

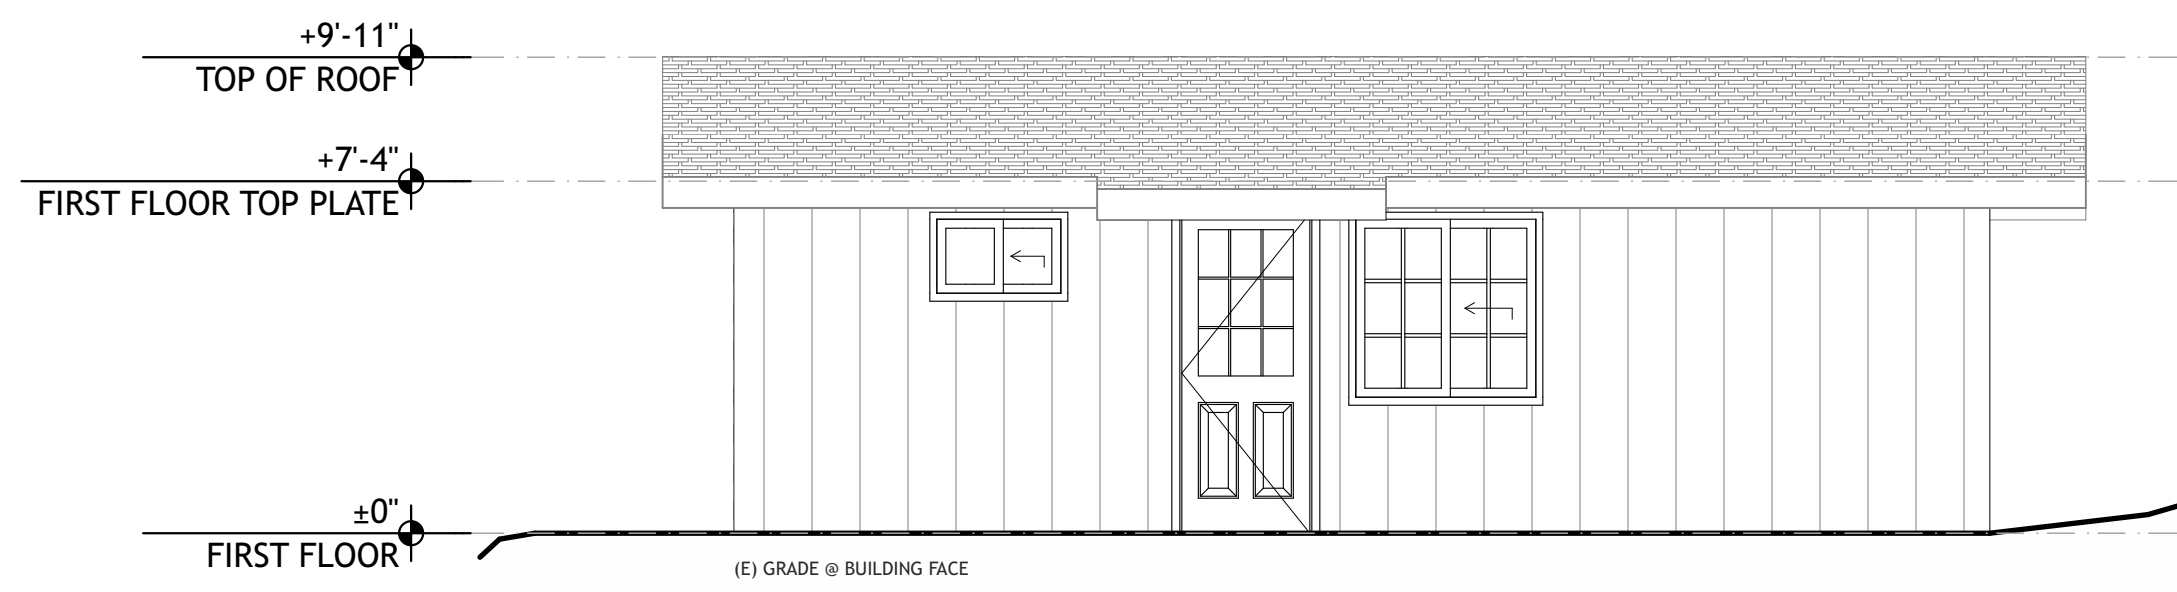
5 CABIN 8 EXISTING-DEMO SOUTH ELEVATION
SCALE: 1/4" = 1'-0"

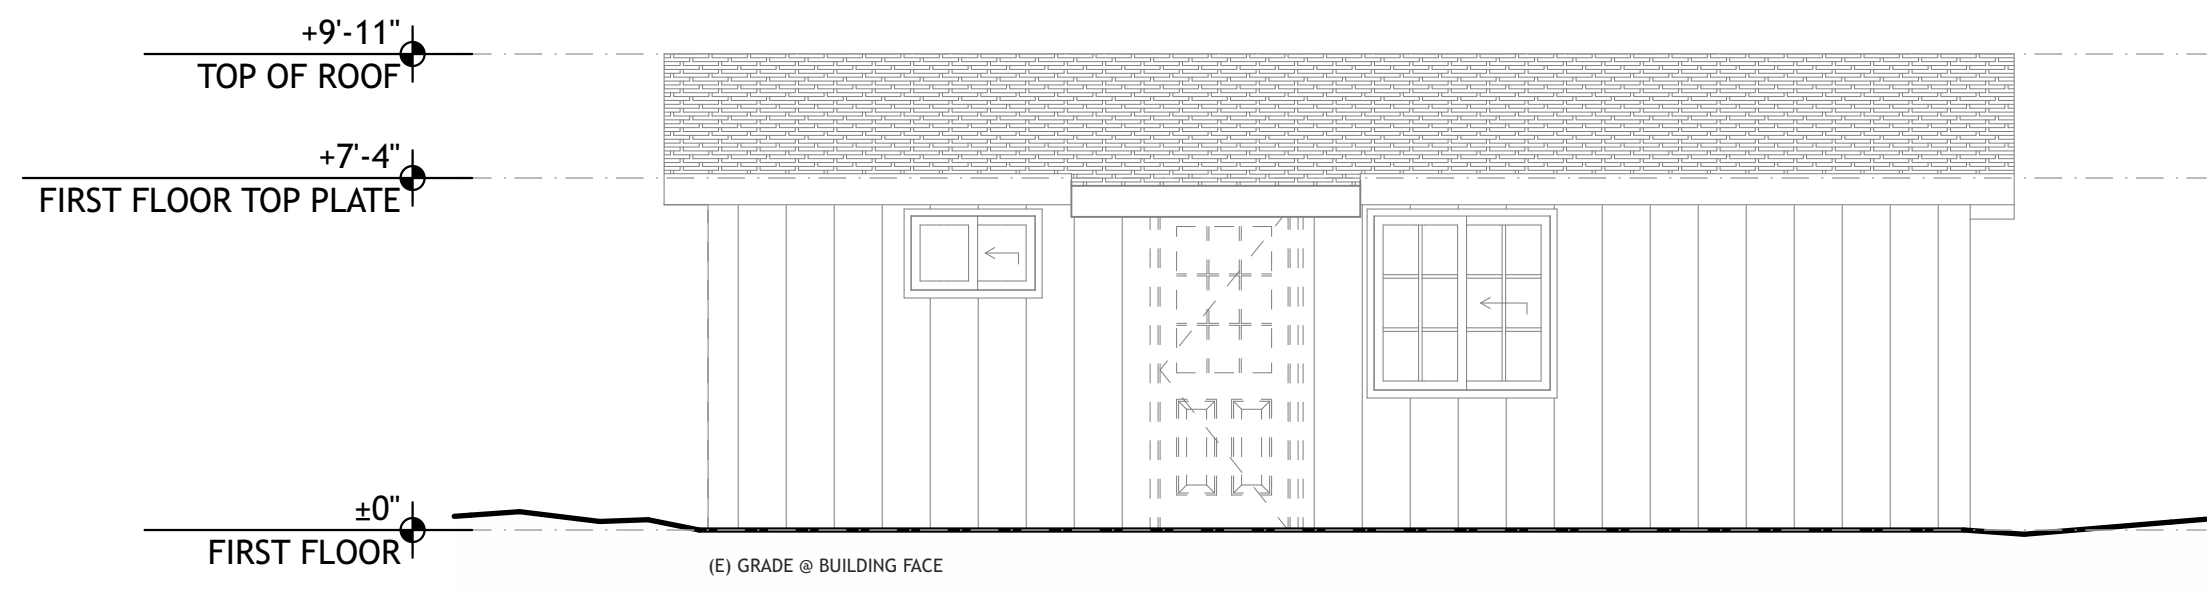
5 CABIN 9 EXISTING-DEMO SOUTH ELEVATION
SCALE: 1/4" = 1'-0"

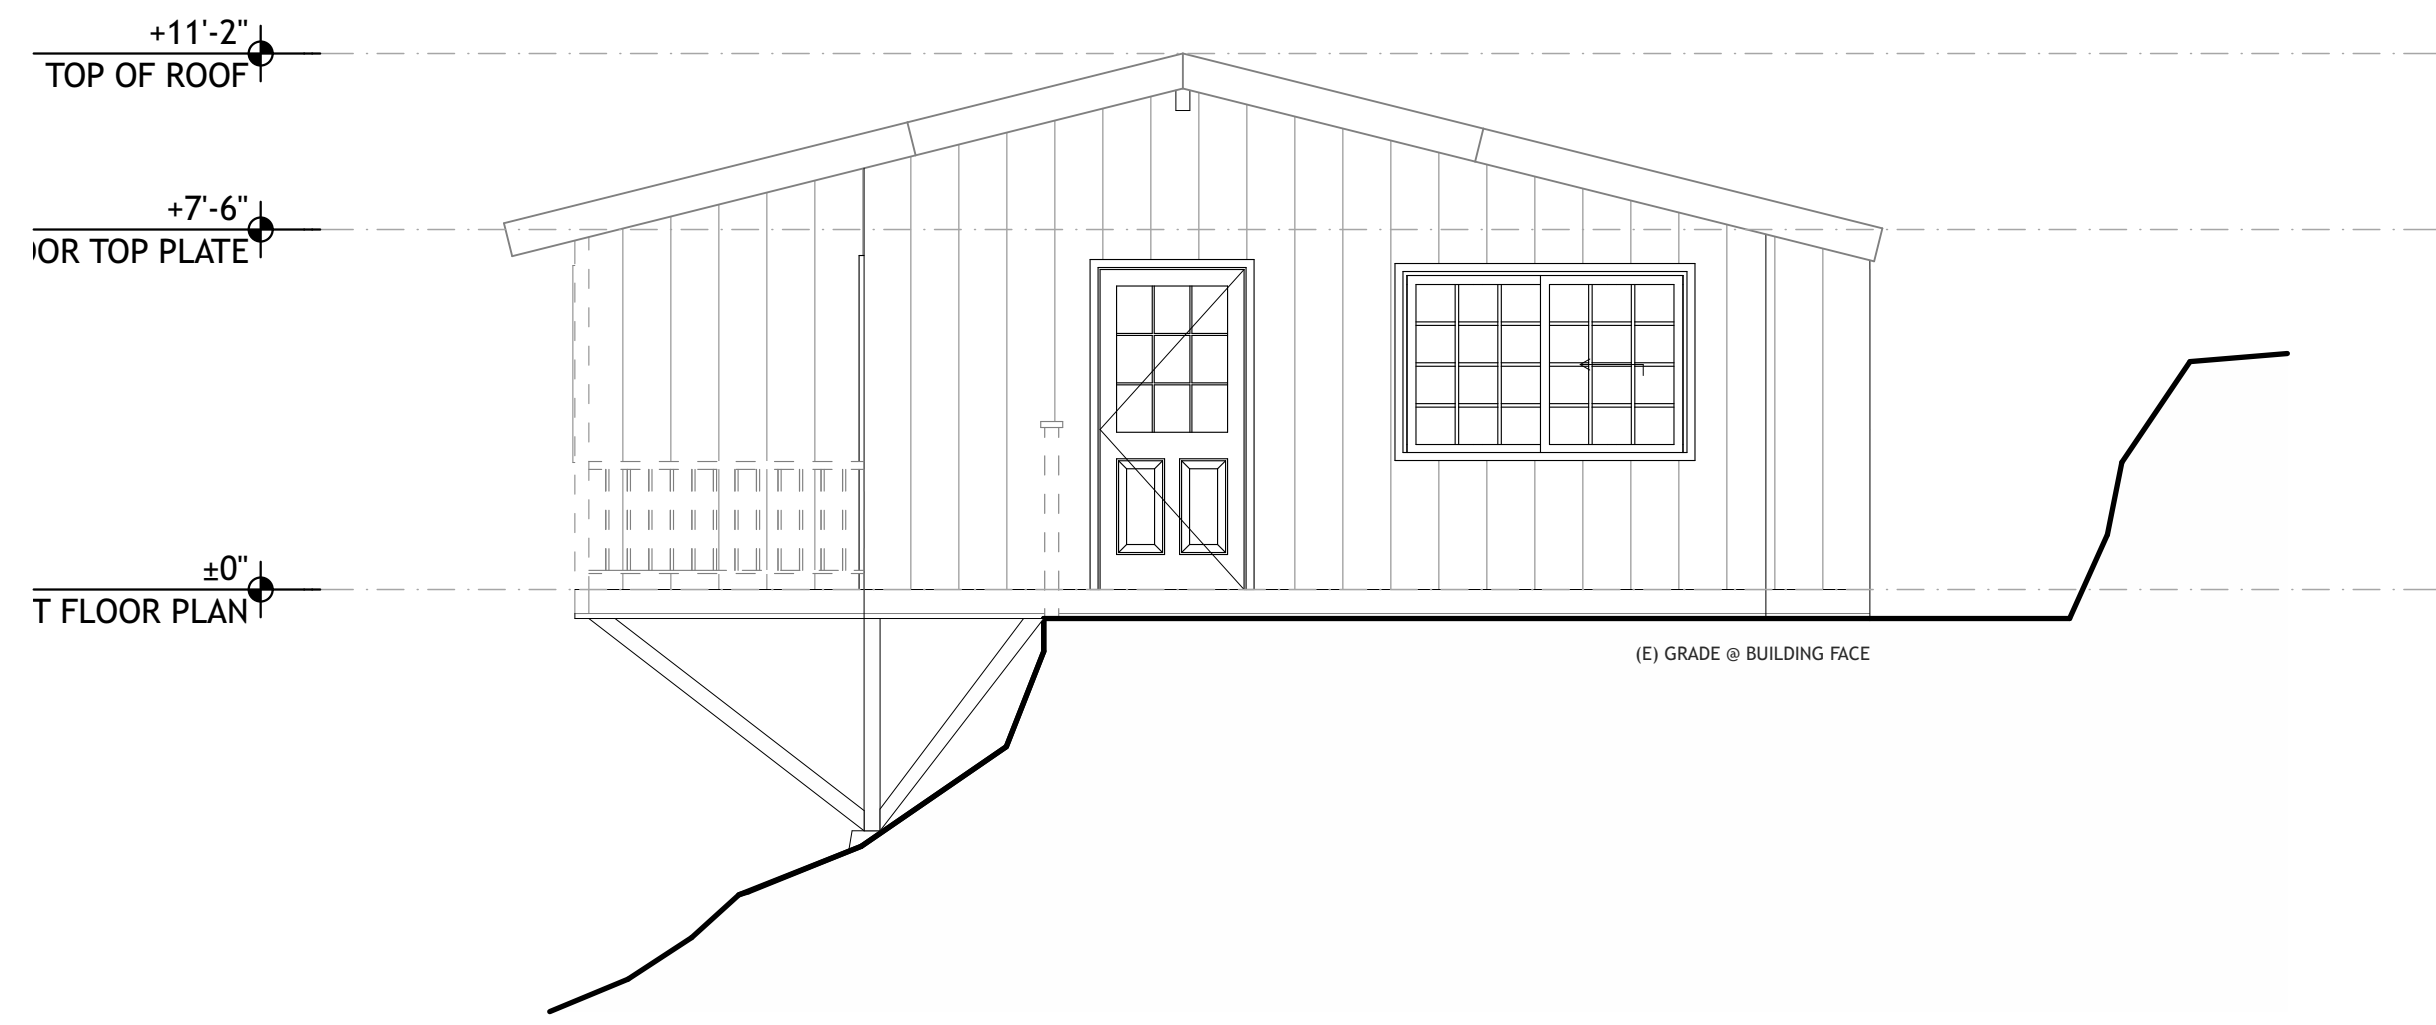
5 CABIN 10 EXISTING-DEMO EAST ELEVATION
SCALE: 1/4" = 1'-0"

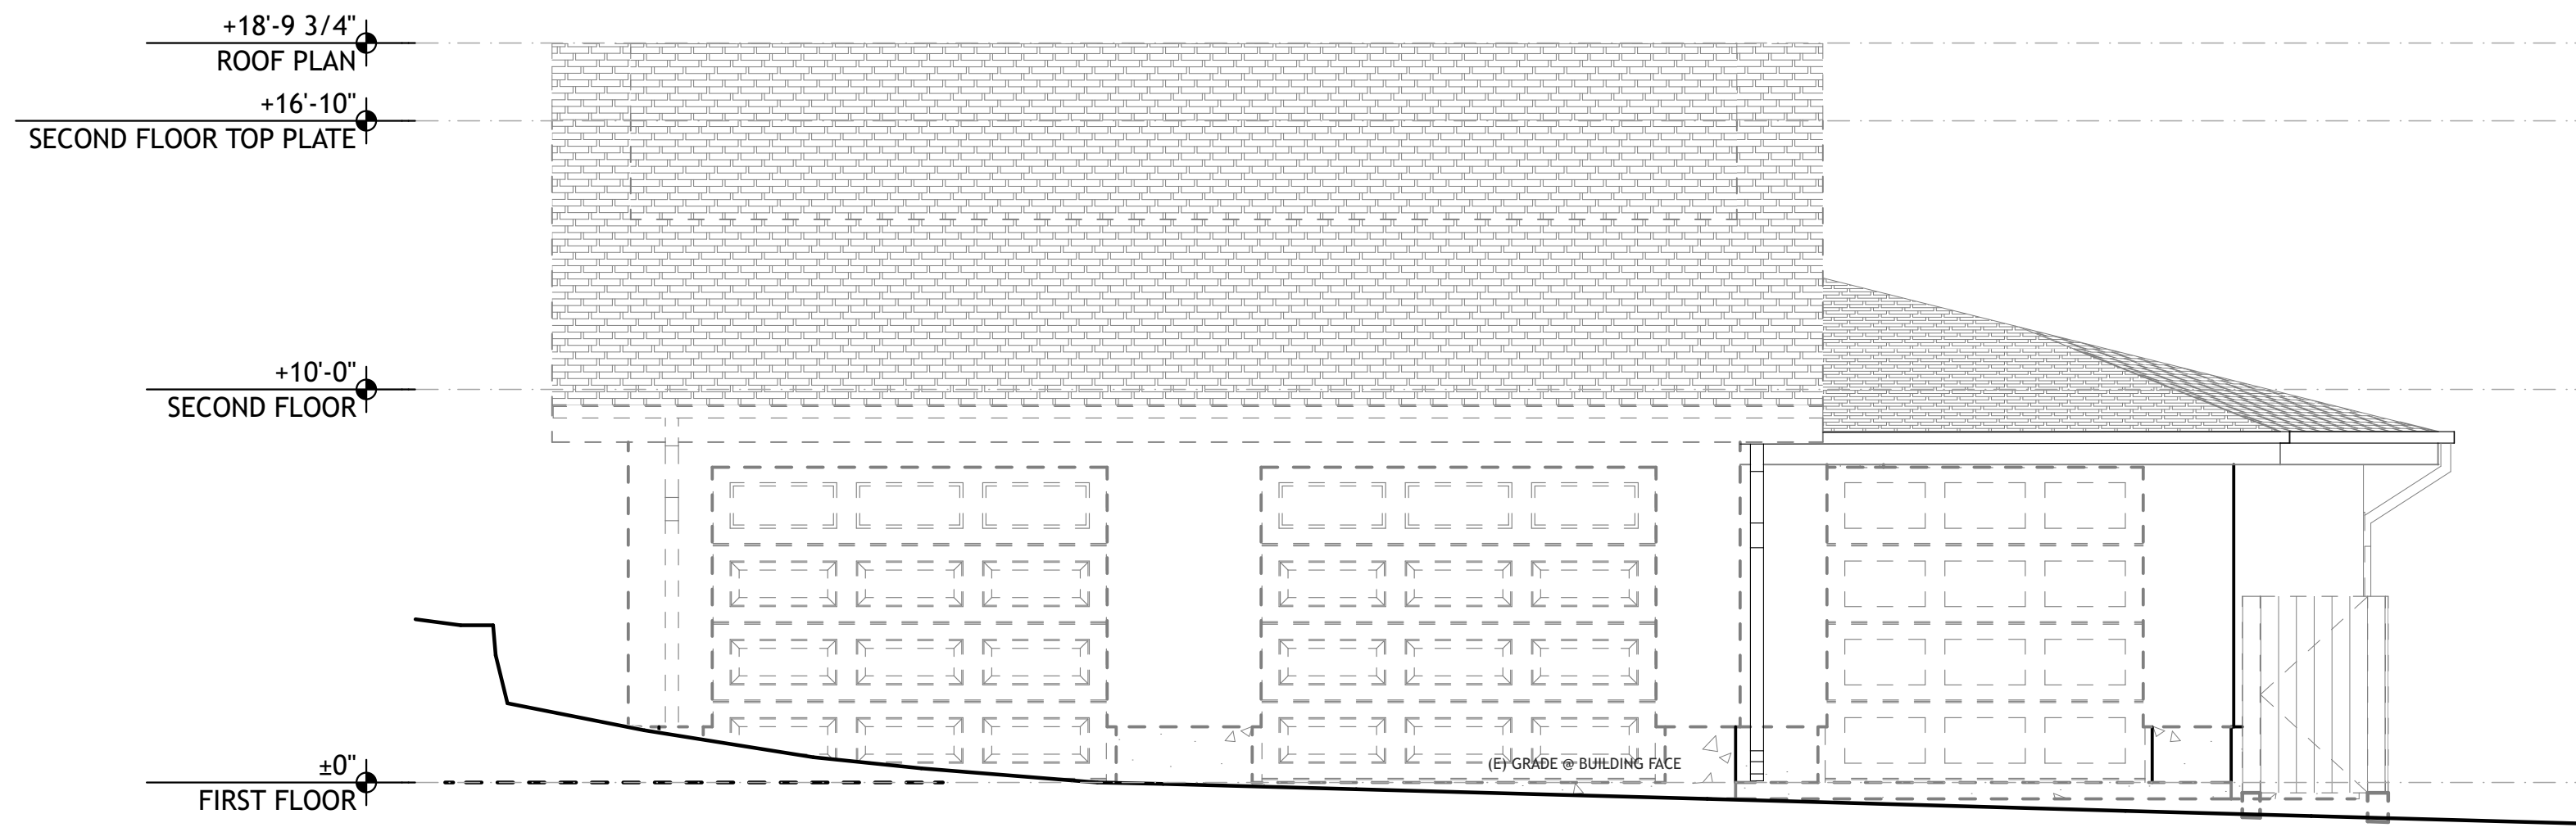
1 GARAGE EXISTING-DEMO SOUTH ELEVATION
SCALE: 1/4" = 1'-0"

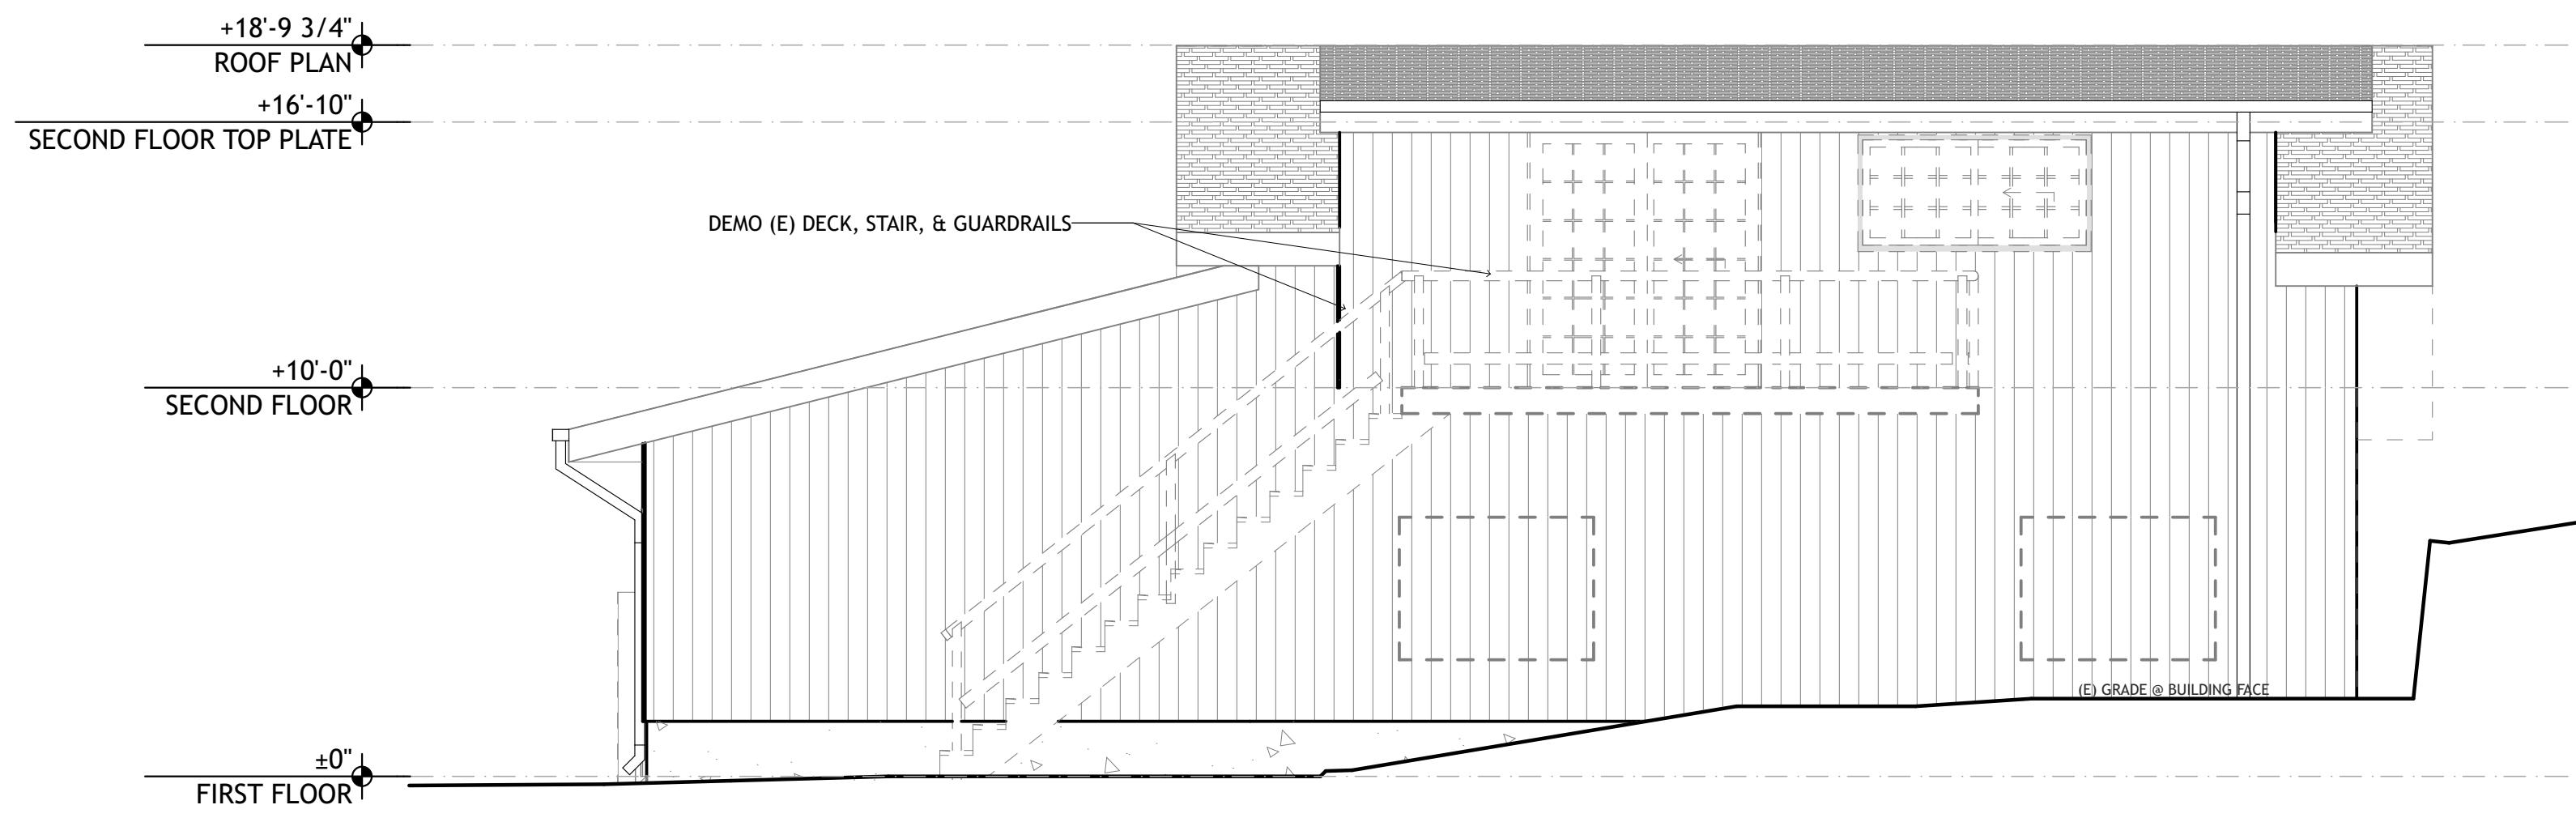
1 GARAGE EXISTING-DEMO NORTH ELEVATION
SCALE: 1/4" = 1'-0"

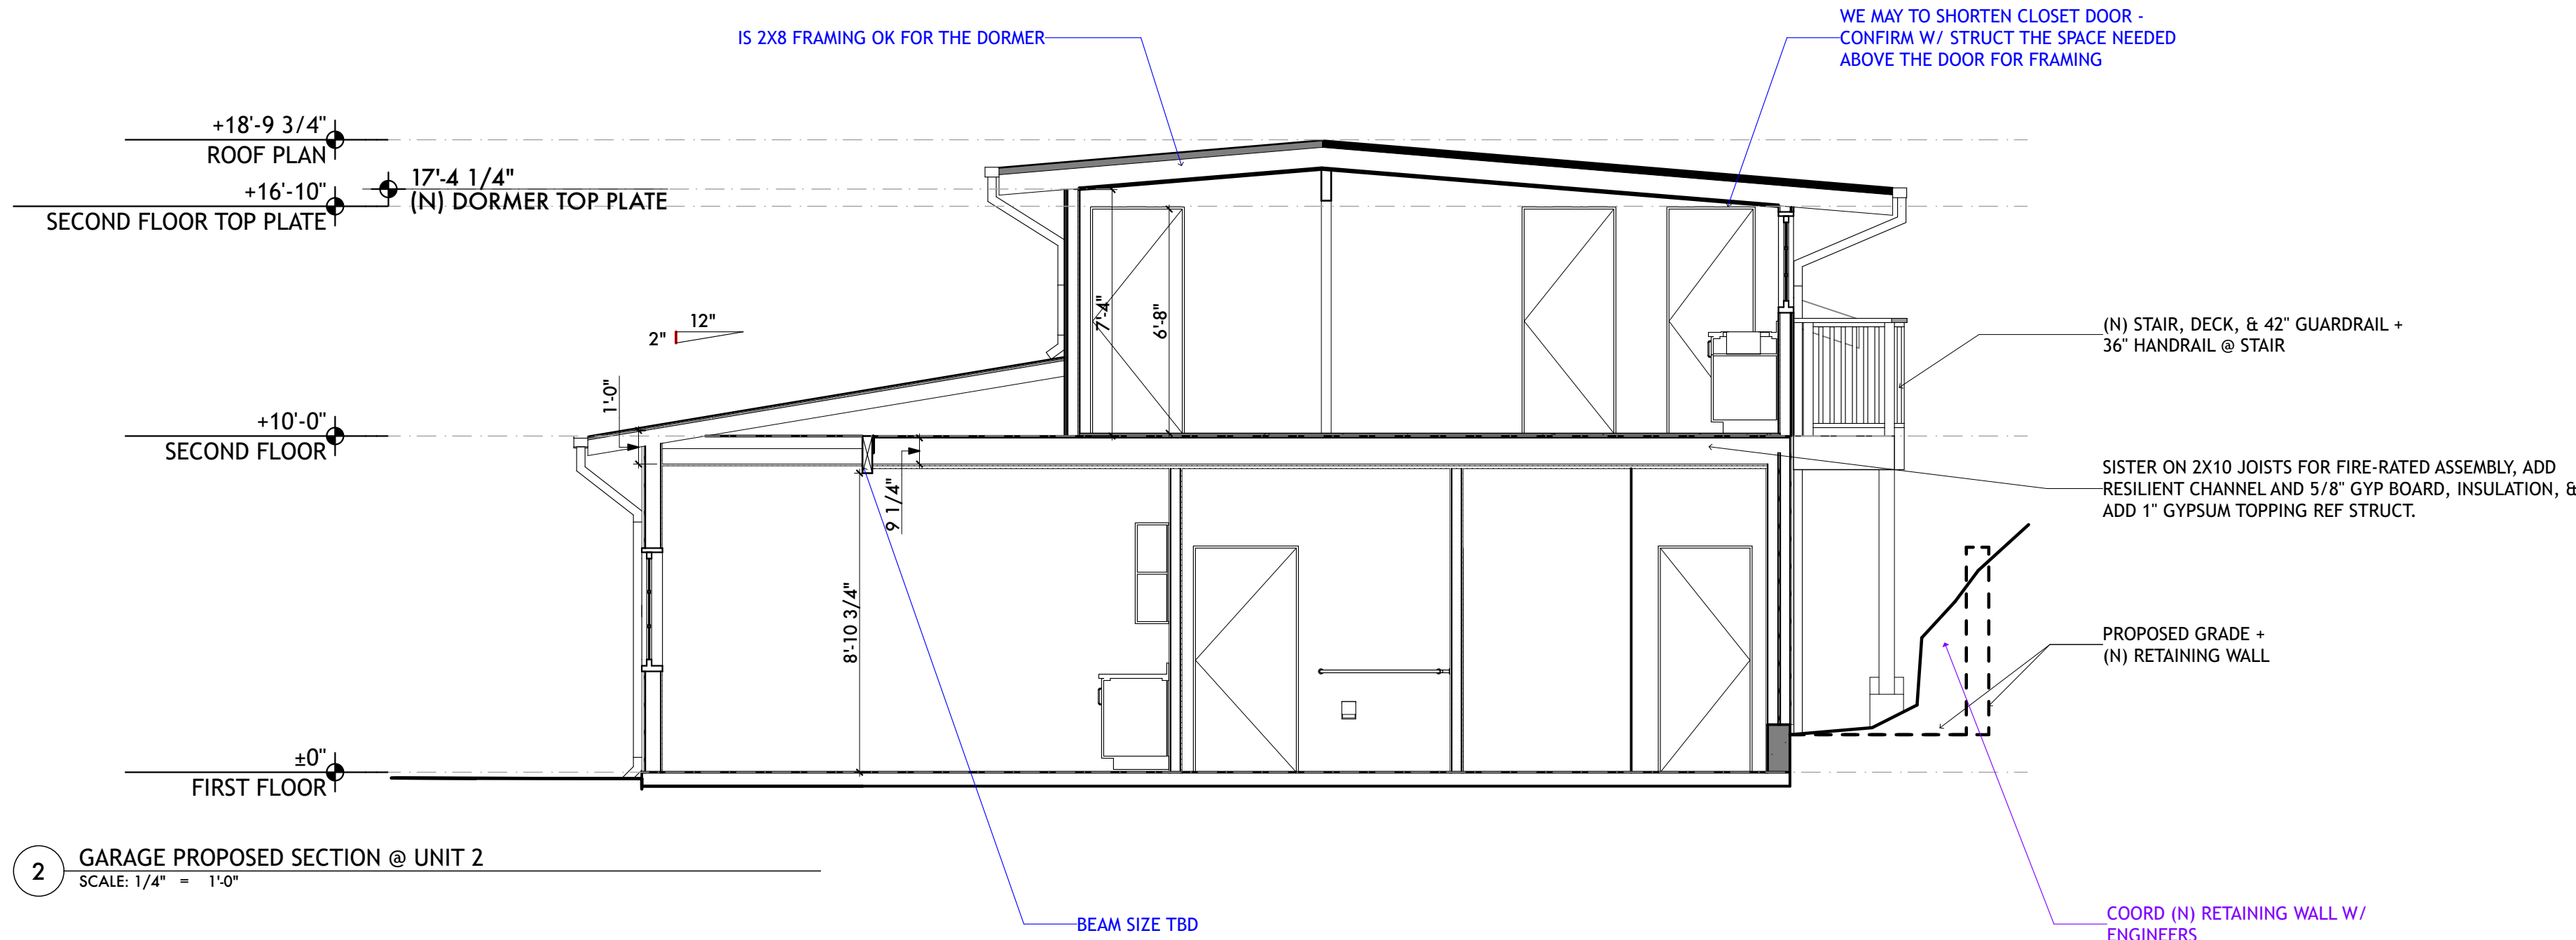
2 GARAGE PROPOSED SECTION @ UNIT 2
 SCALE: 1/4" = 1'-0"

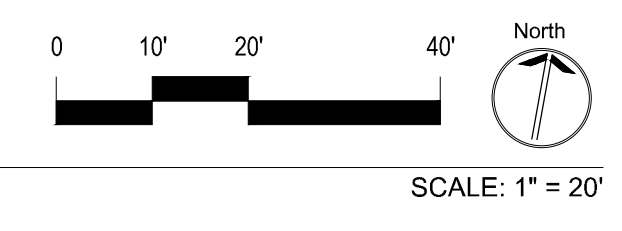
17	MODULAR 5	SWIMMING POOL AREA	NEW MODULAR ONE BEDROOM UNIT
18	MODULAR 6	SWIMMING POOL AREA	NEW MODULAR ONE BEDROOM UNIT
19	WASTE RECEPTACLES	UNDEVELOPED	GARBAGE AND RECYCLING DISPOSAL COLLECTION AREA
20	POOL BUILDING	POOL BUILDING	TO BE DEMOLISHED

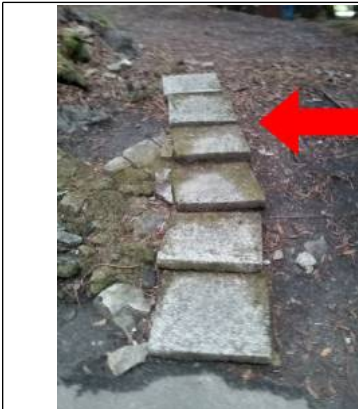
Uneven risers create a tripping hazard.

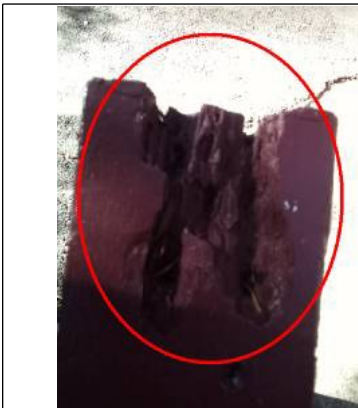
Dry rot fungus damage.

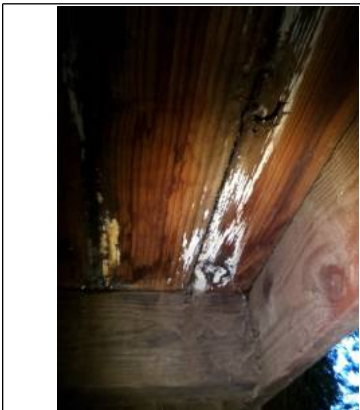
Fungus damage attack on cabin 9.

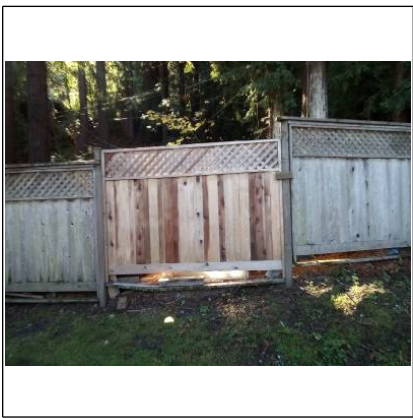
Landscaping affecting foundation

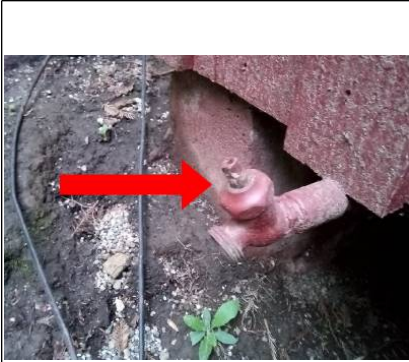
Hose bib missing handle.

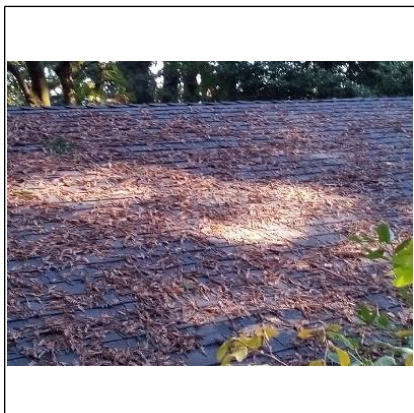
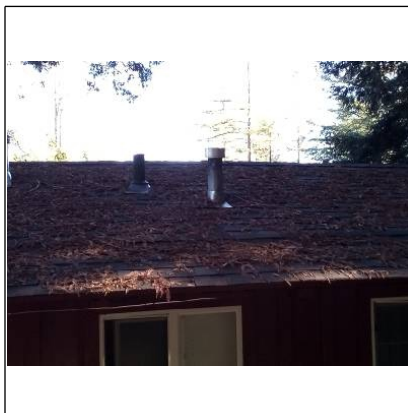
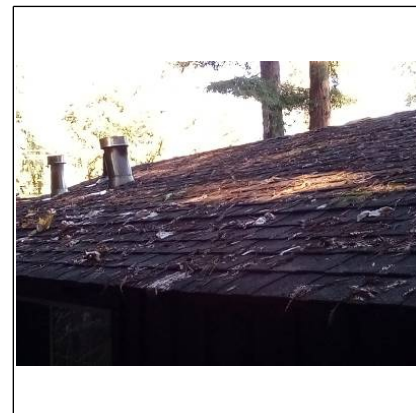
Condition of Roof Coverings

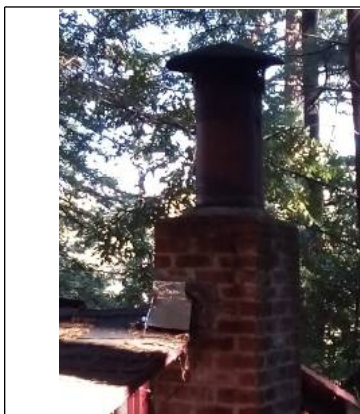
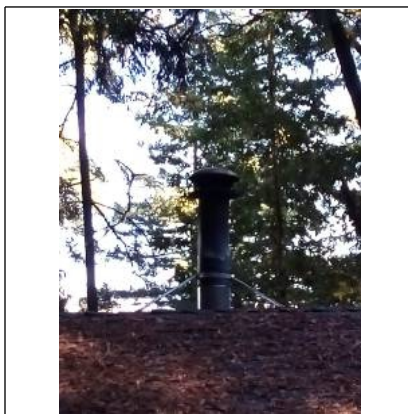
Gutters/Scuppers/Eavestrough

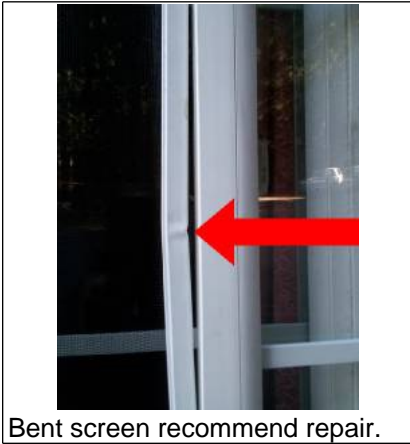
Bent screen recommend repair.

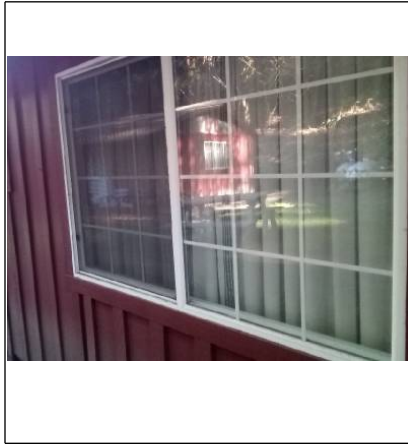
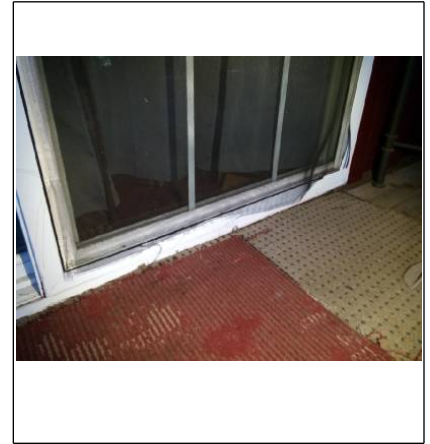
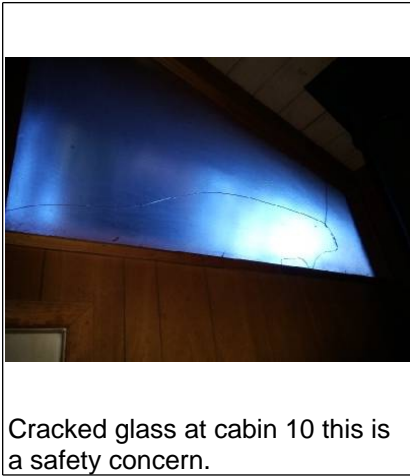
Cracked glass at cabin 10 this is a safety concern.

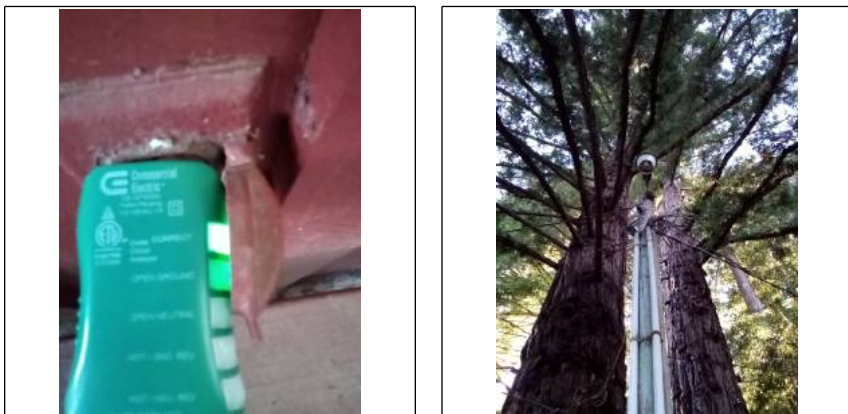
Building(s) Exterior Wall Construction

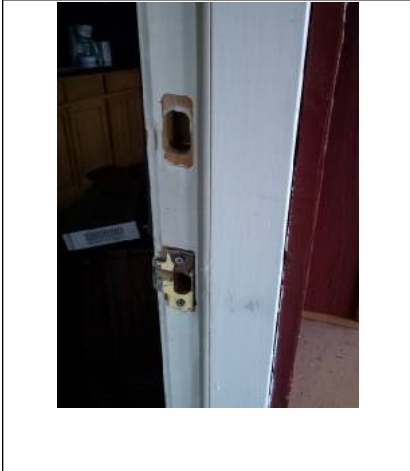
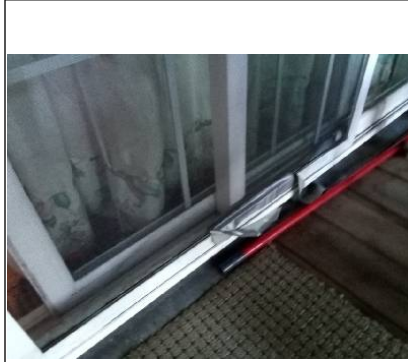
Damage sliding screen door at cabin 9.

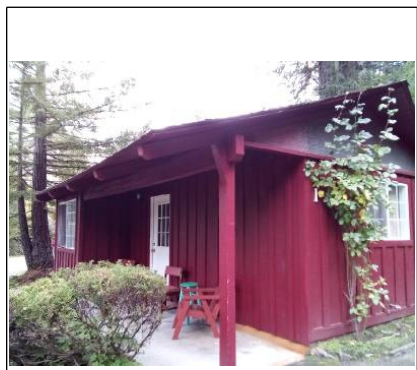
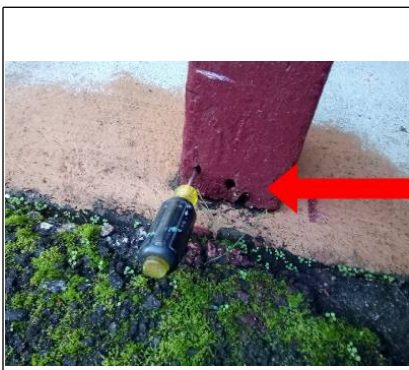
Fungus damage and dry rot at entry post recommend contacting appropriate trades for repair or replacement.

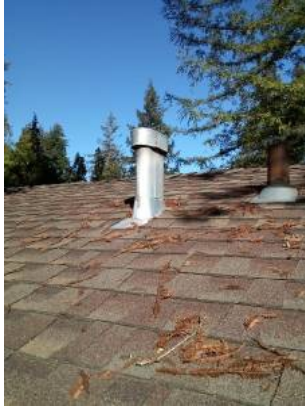
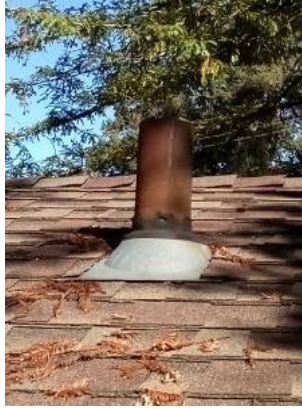
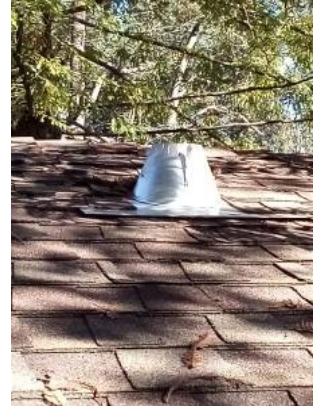
Missing cap at roof jack.

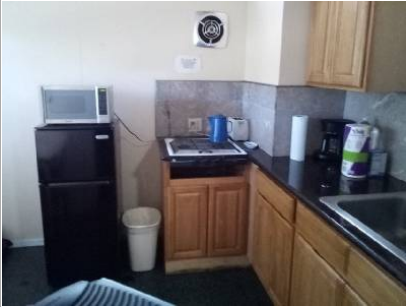
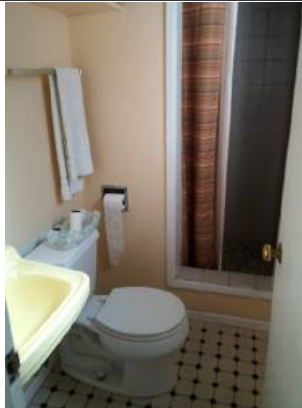
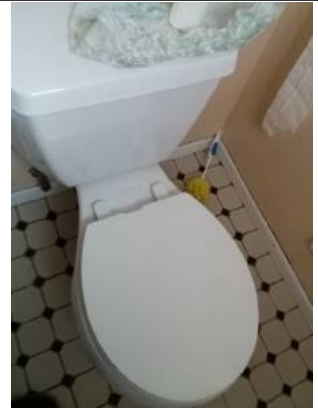
Low flow toilet noted.

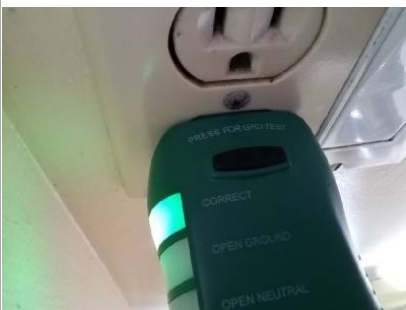
Recommend GFCI receptacles being installed in all bathrooms and kitchens this is a safety concern.

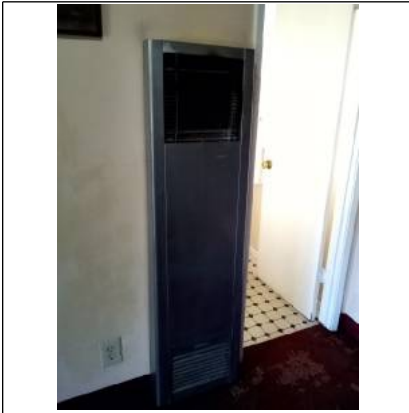
Well furnace was tested and found being satisfactory condition at time of inspection.

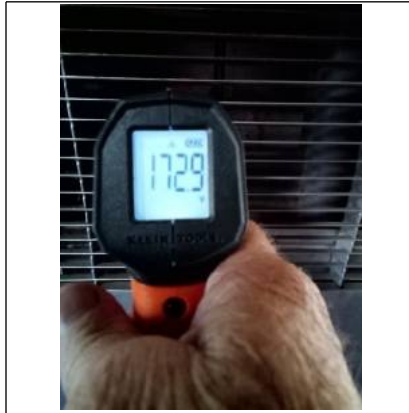
Temperature at wall furnace.

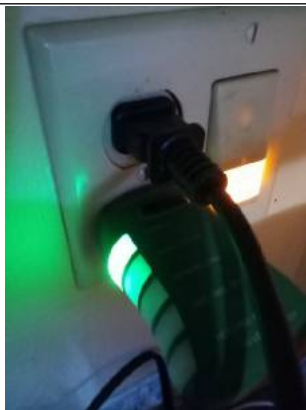
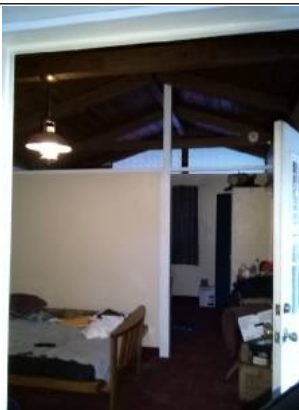
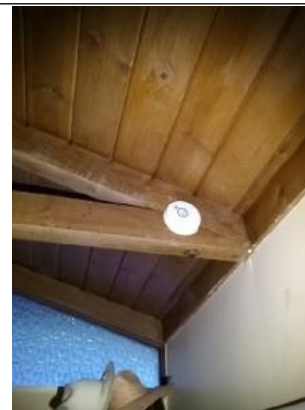
Smoke detectors were tested and found in satisfactory condition at time of inspection.

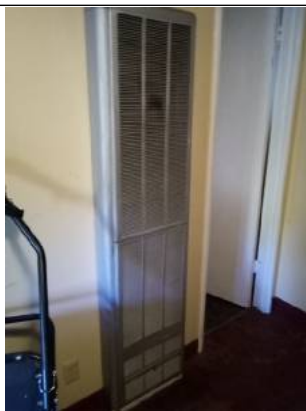
Wall furnace was tested and found to be in satisfactory condition at time of inspection.

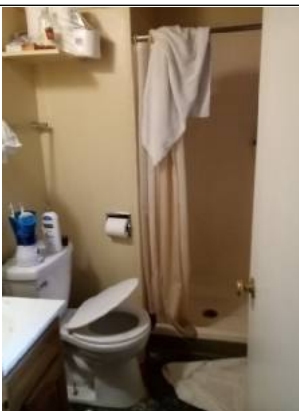
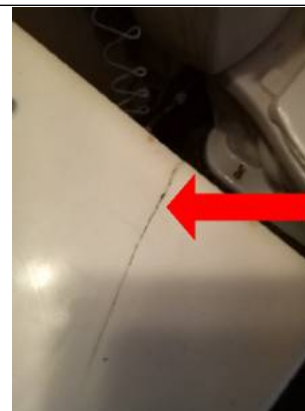
Crack and vanity top that bathroom.

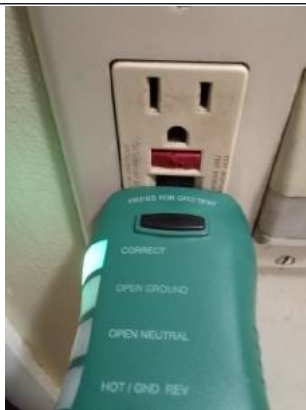
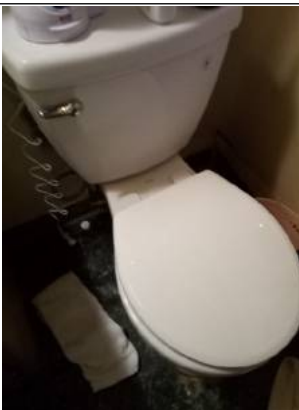
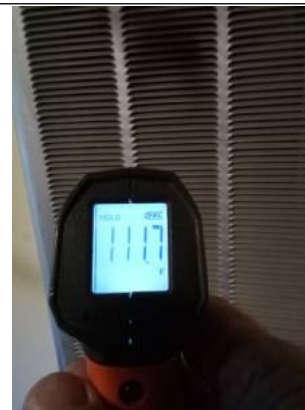
Temperature at wall heater.

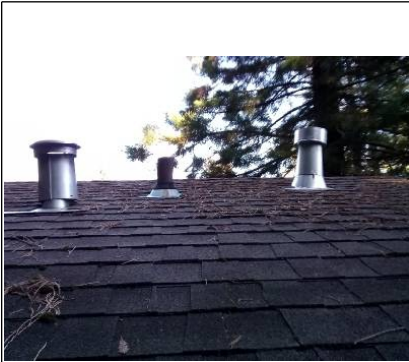
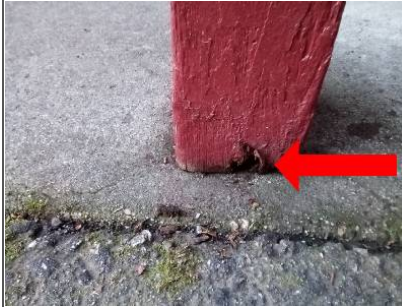
Fungus and dry rot damage on post at entry recommend contacting appropriate trays to evaluate and repair.

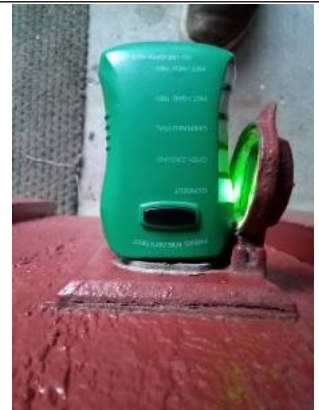
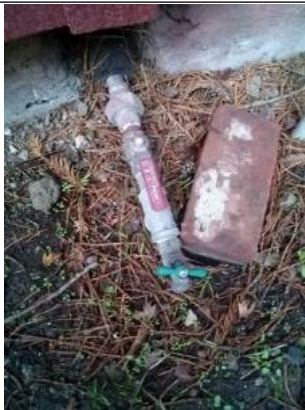
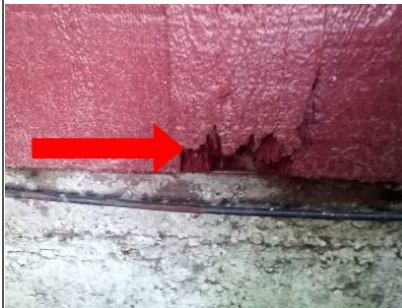
Try rot fungus damage at trim
