HATCH LEGEND

ALUMINUM		CONTINUOUS LUMBER
	STEEL		PLYWOOD
	BATT INSULATION		GRANULAR MATERIAL
	RIGID INSULATION		EARTH
	CMU		CONCRETE
	BRICK		CMU GROUTED SOLID
	EIFS		GYPSUM BOARD

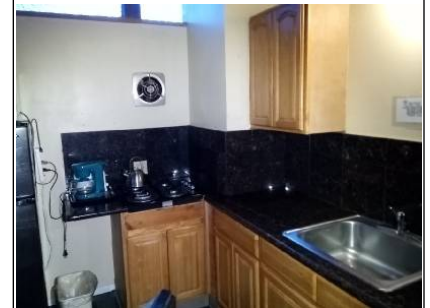
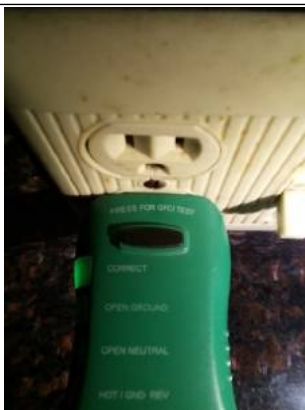
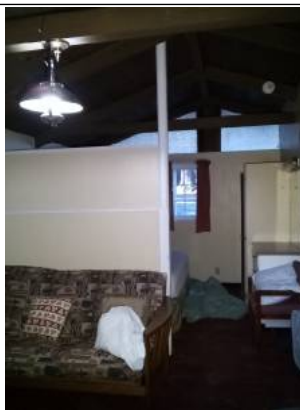
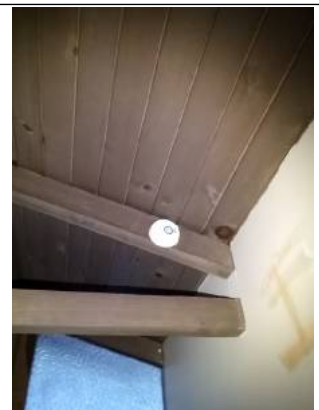
Try rot fungus damage at trim

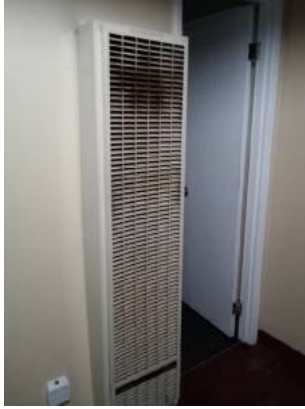
Well finish was tested and found being satisfactory condition at time of inspection.

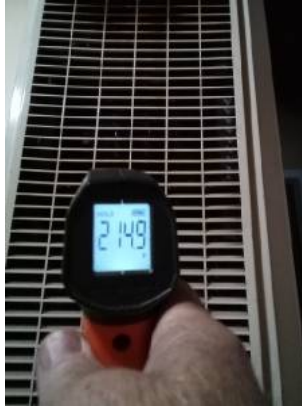
Temperature at wall furnace.

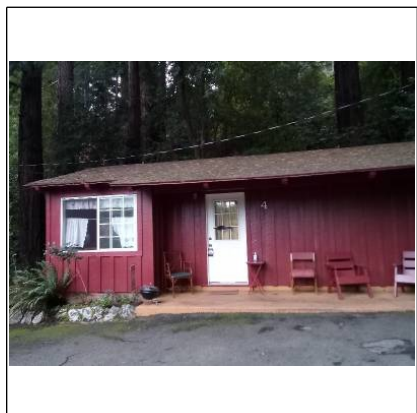
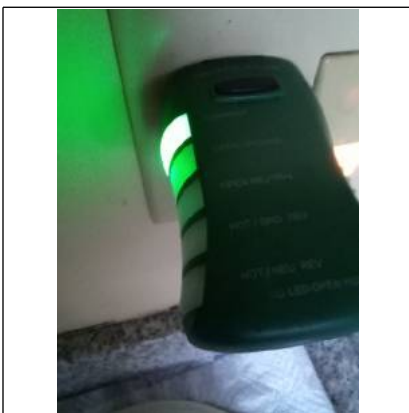
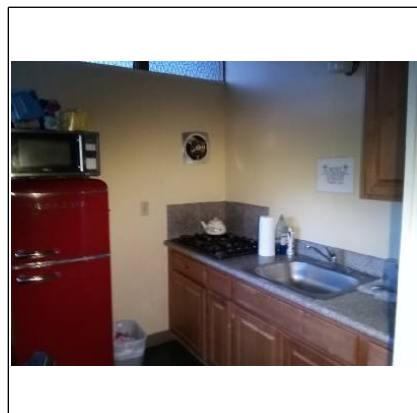
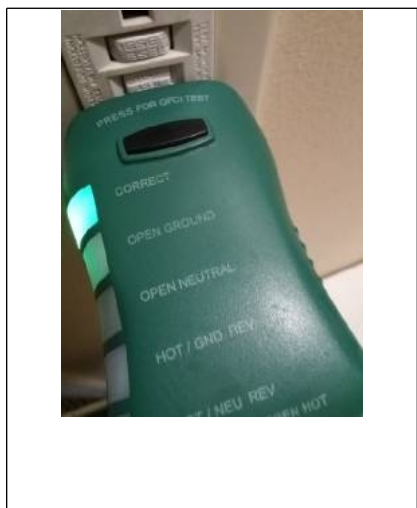
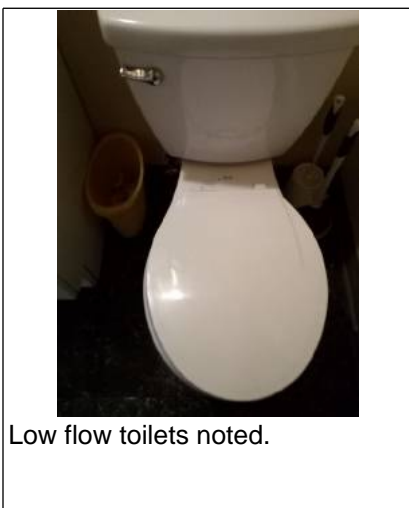
Low flow toilets noted.

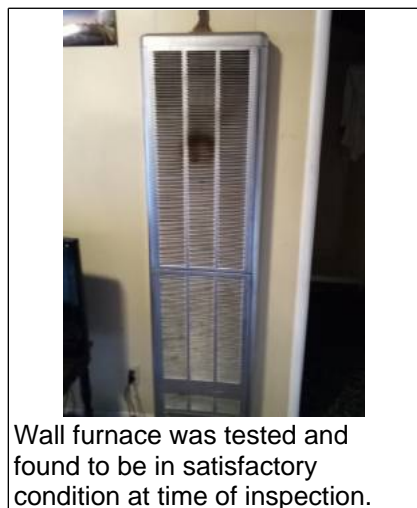
Wall furnace was tested and found to be in satisfactory condition at time of inspection.

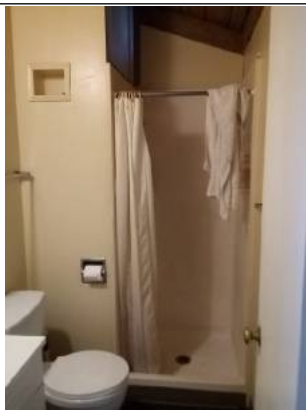
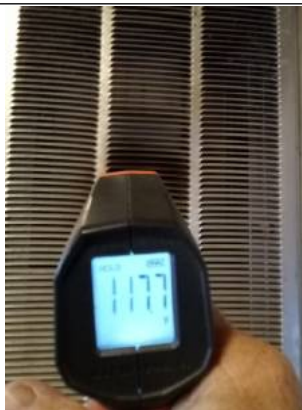
Temperature at wall furnace.

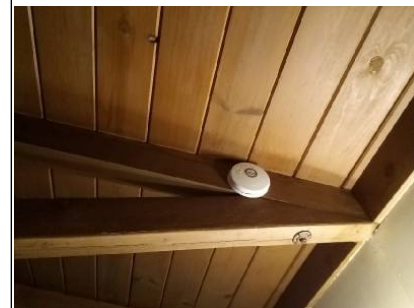
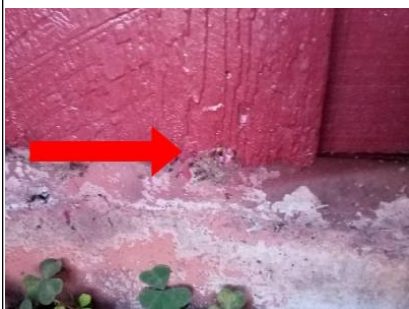
Dry rot damage it's trim.

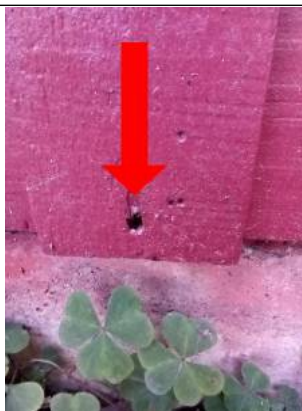
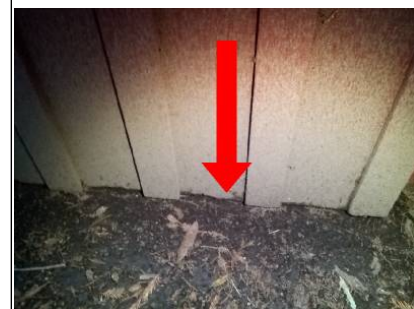
Siding and contact with the ground.

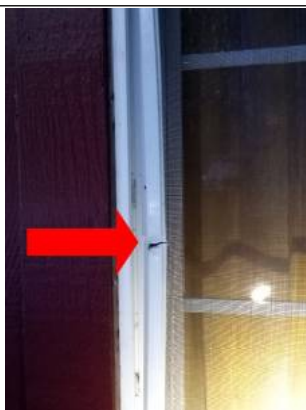
Bent and damage screen.

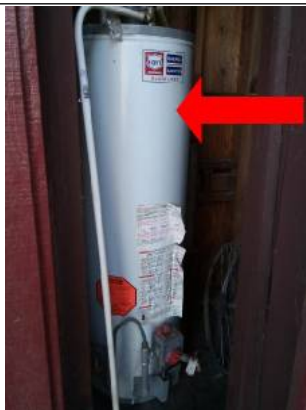
Recommend seismic strapping on water heater.

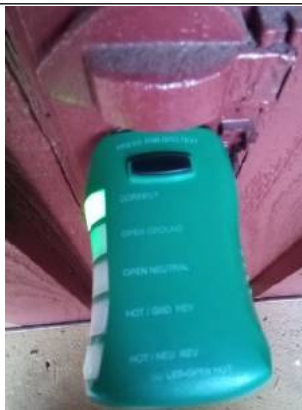
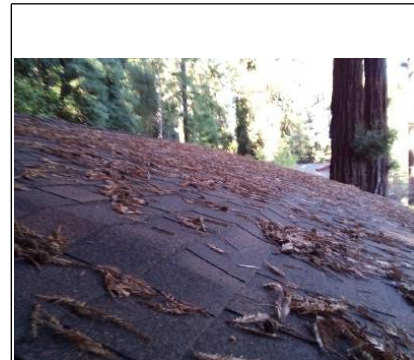
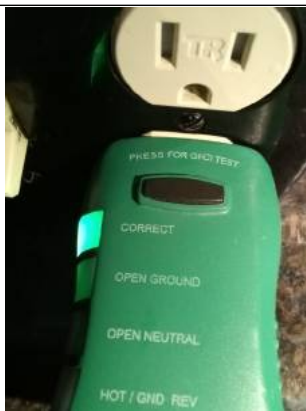
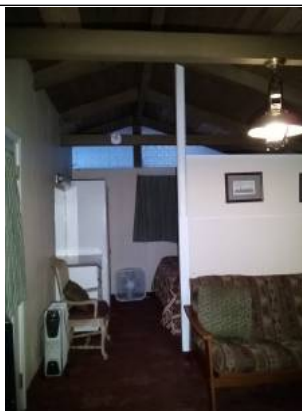
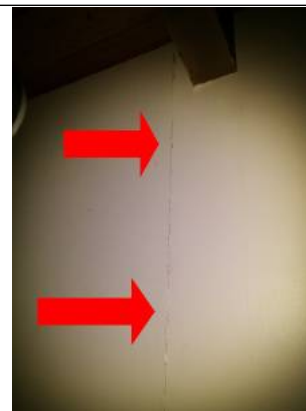
Open seam and drywall recommend repair and monitoring.

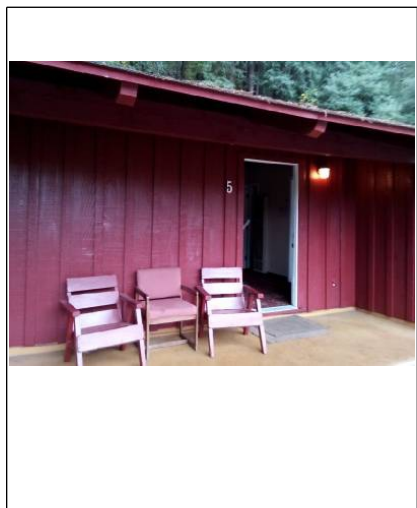
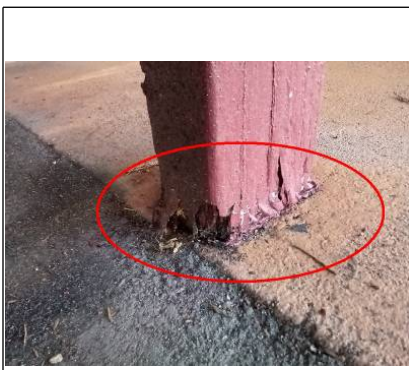
Fungus and dry rot noted on post at entry recommend contacting appropriate trades for repair.

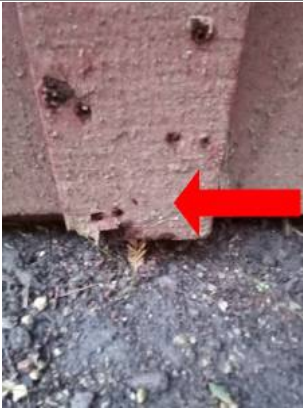
Fungus dry rot damage

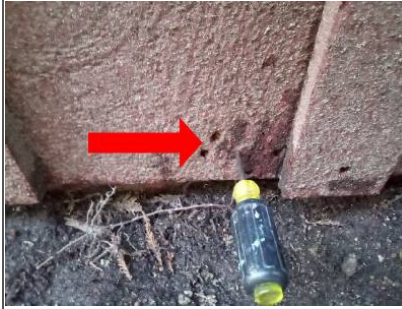
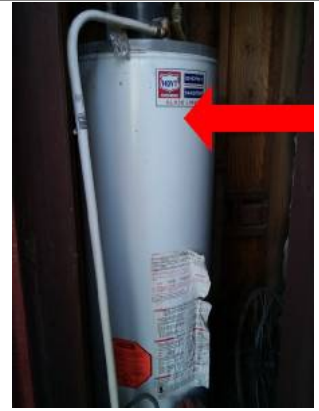
Recommend seismic strapping be installed.

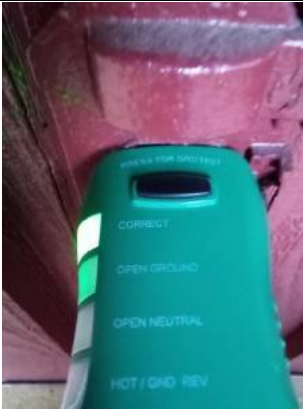
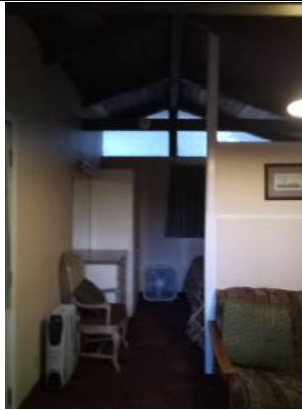
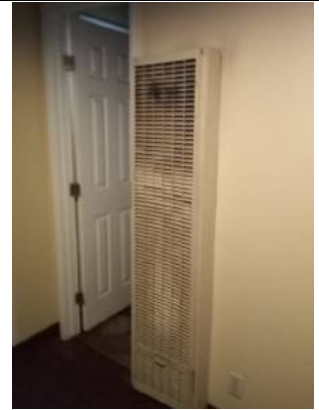
Fall furnace was tested and found to be in satisfactory condition at time of inspection.

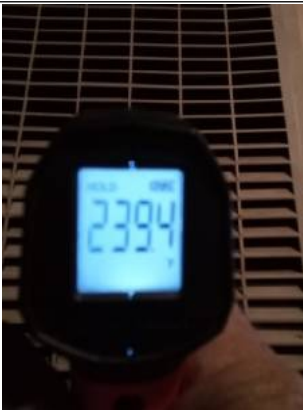
Temperature at wall furnace.

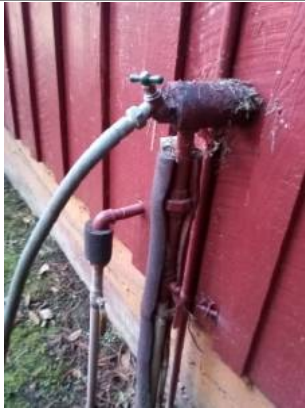
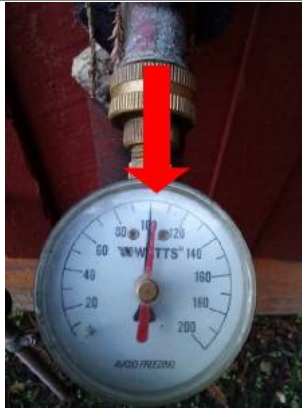
Excessive water pressure was noted at all units recommend contacting plumber to evaluate.

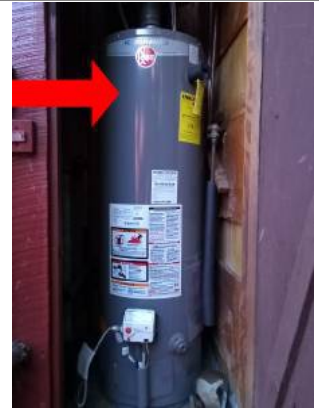
Recommend seismic strapping being installed on all water heaters.

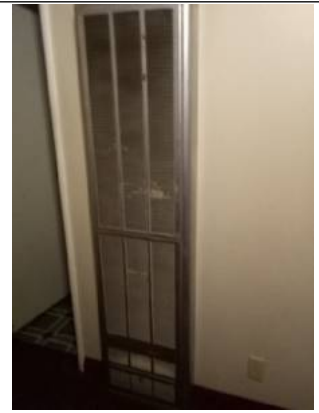
Well here was tested and found being satisfactory condition at time of inspection.

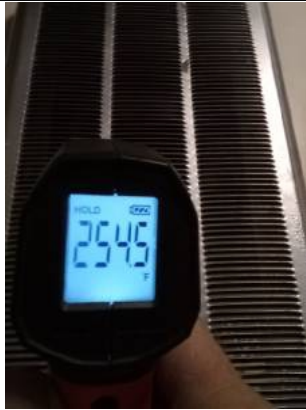
Temperature at wall heater.

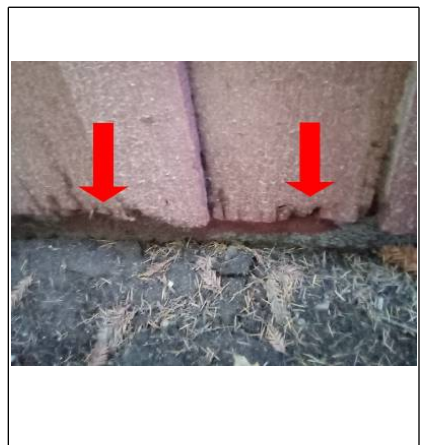
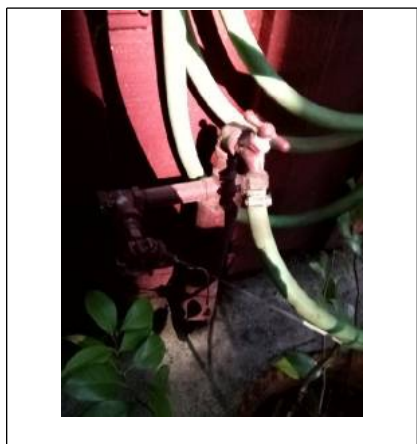
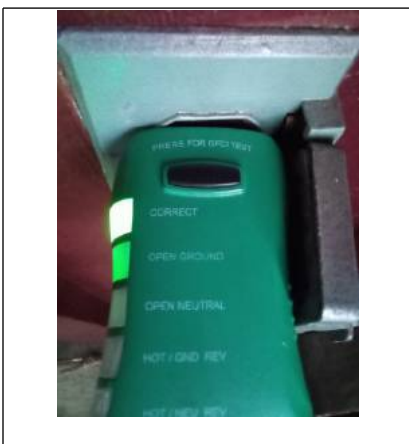
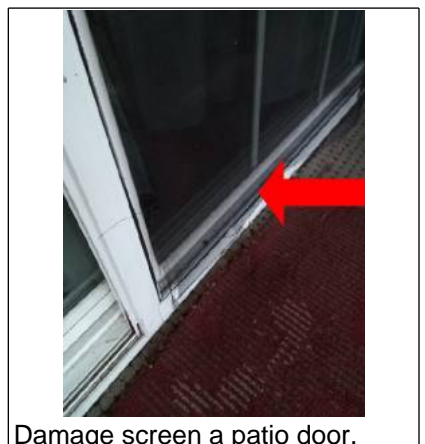
Damage screen a patio door.

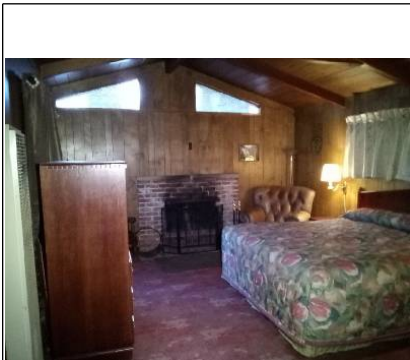
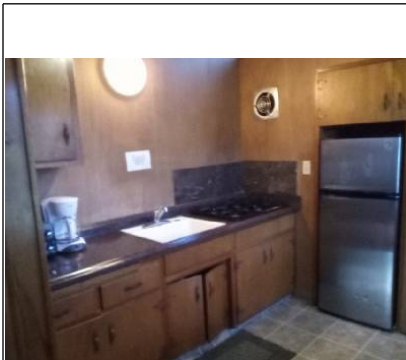
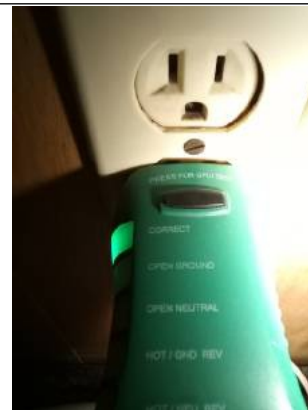
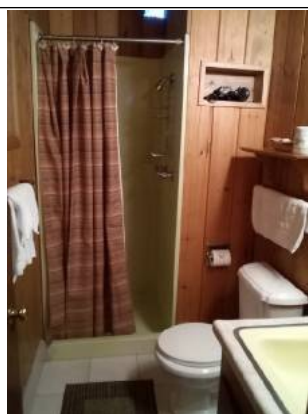
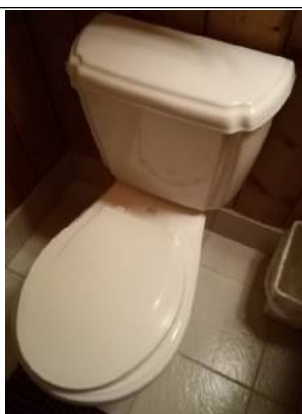
Low flow toilet noted.

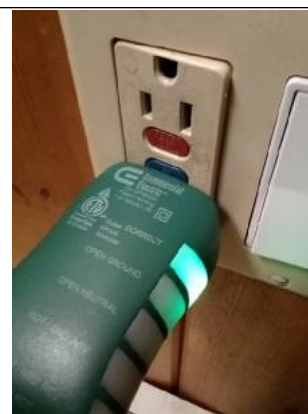
GFCI in bathroom did not respond to testing recommend license electrician to further evaluate.

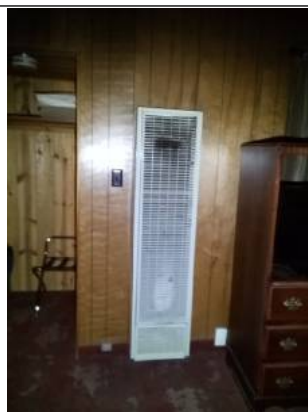
Call heater was tested and found to be in satisfactory condition at time of inspection.

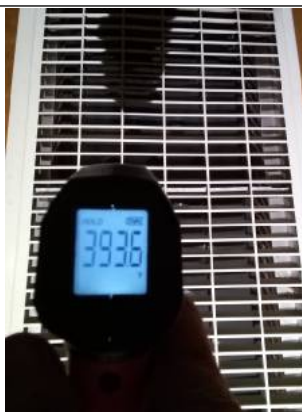
Temperature at wall heater.

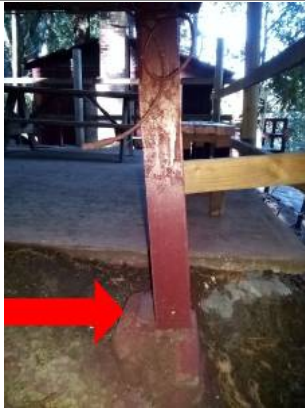
Settlement noted at post and Pier at corner of building recommend contacting licensed building contractor to evaluate and repair.

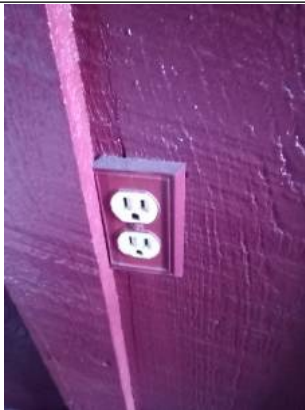
Recommend maintaining weather tight covers at all exterior receptacles.

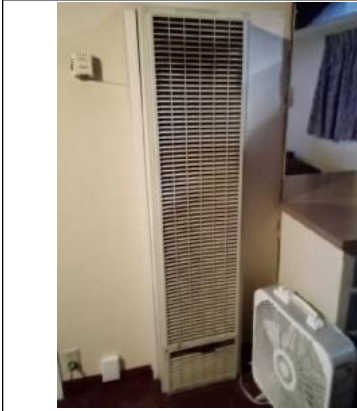
Fall furnace was tested and found to be in satisfactory condition at Town of inspection.

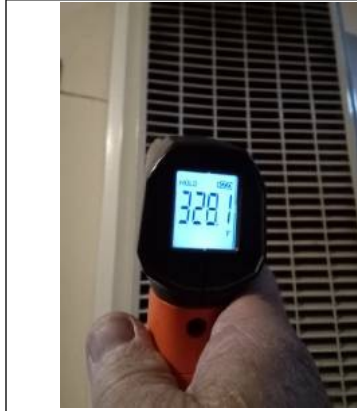
Temperature at wall furnace.

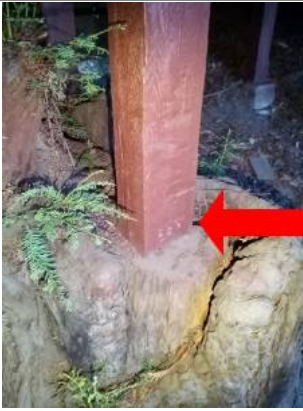
Improper support recommend contacting license building contractor to evaluate and repair.

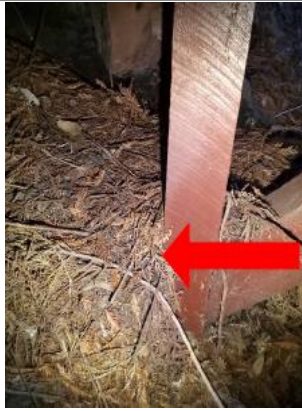
Ground contact. Recommend removing debris from all framing members to avoid water damage.

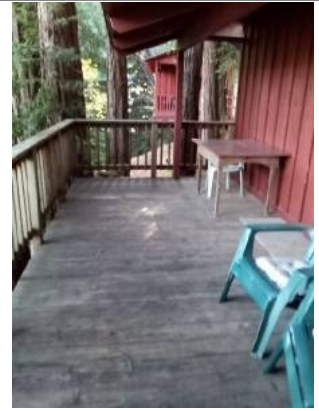
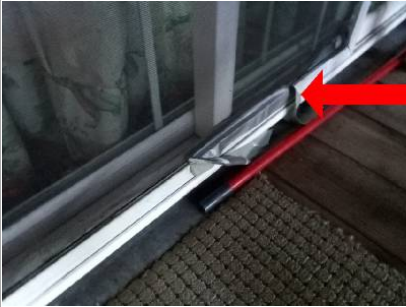
Damaged screen at patio door recommend repair.

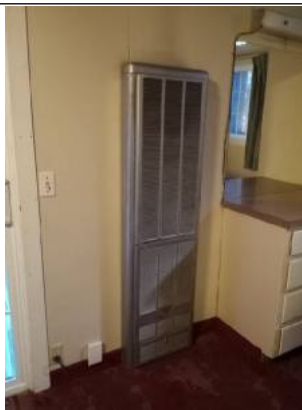
Wall furnace was tested and found to be in satisfactory condition at time of inspection.

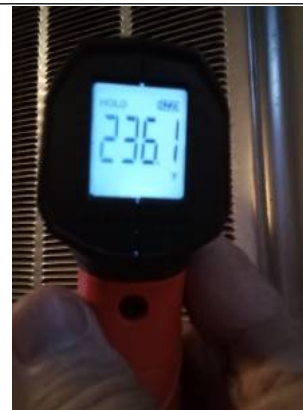
Temperature at wall furnace.

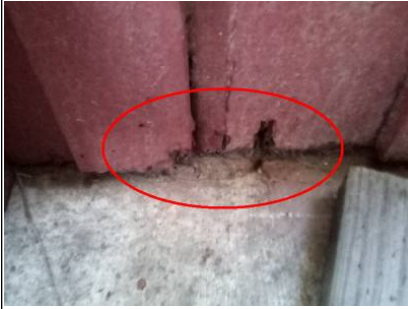
Dry rot and fungus damage.

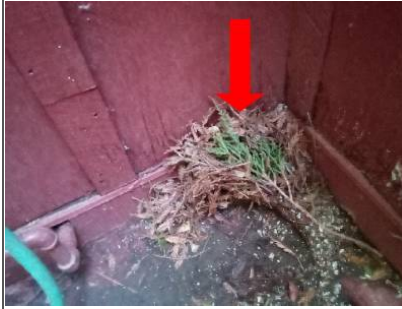
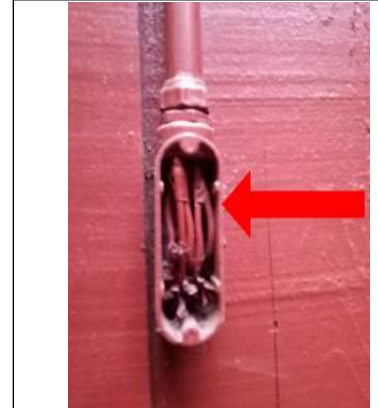
Mission cover recommend replacement to avoid moisture intrusion.

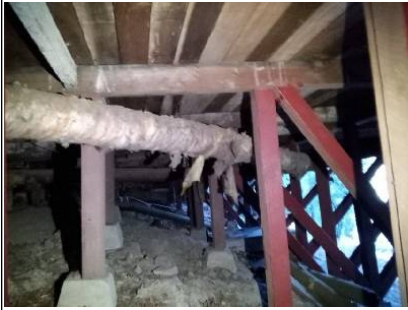
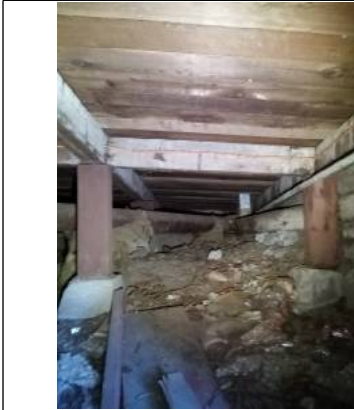
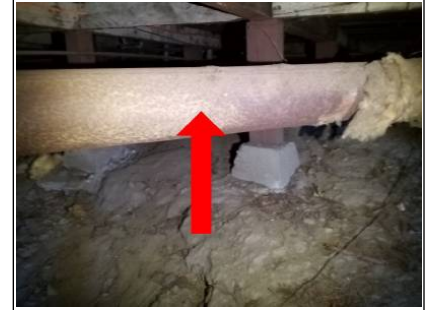
Insulation missing on ducting recommend replacement for better heat retention.

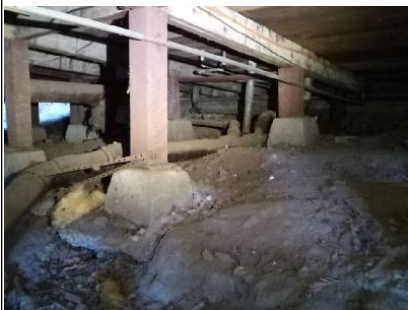
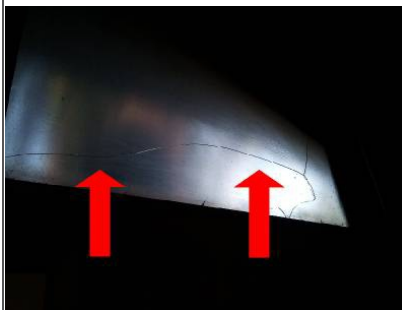
Cracked window panes recommend replacement this is a safety concern.

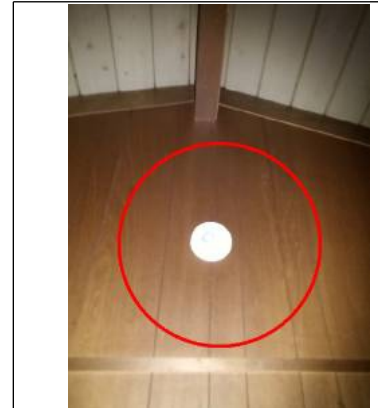
Carbon and smoke detectors were tested and found to be in satisfactory condition and time of inspection.

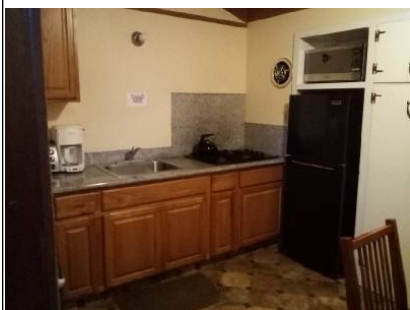
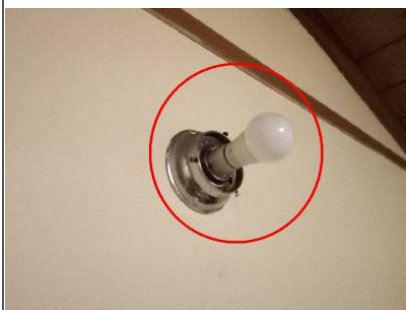
Exposed incandescent bulb.

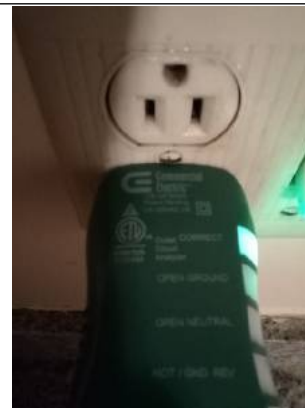
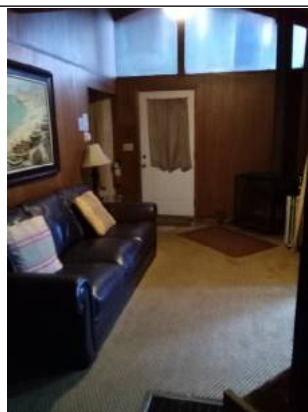
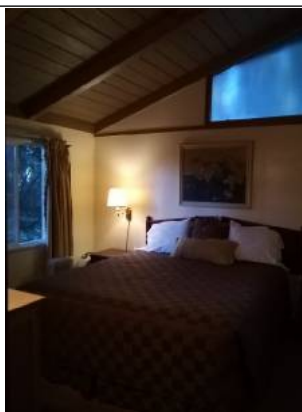
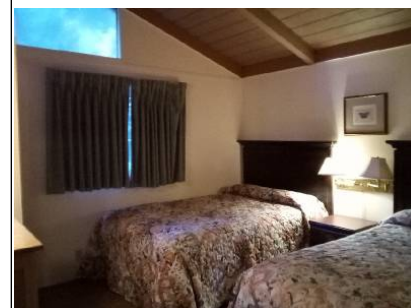
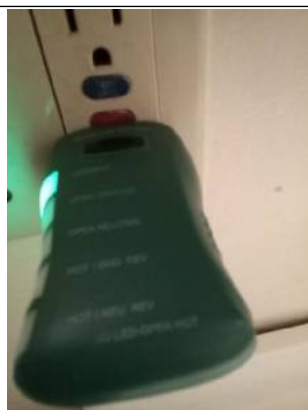
TFCI receptacle did not respond to testing. Recommend license electrician to evaluate and repair

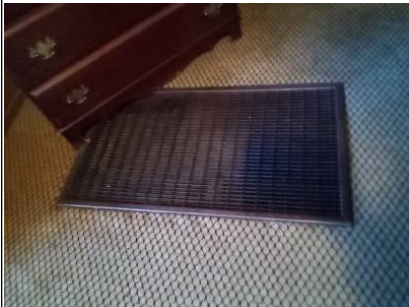
Floor furnace was tested and found to be in satisfactory condition at time of inspection.

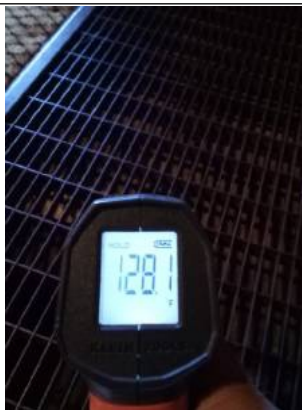
Temperature at floor furnace.

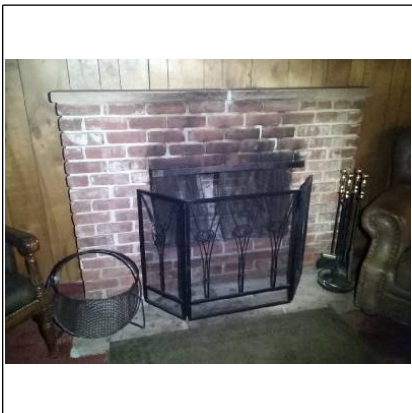
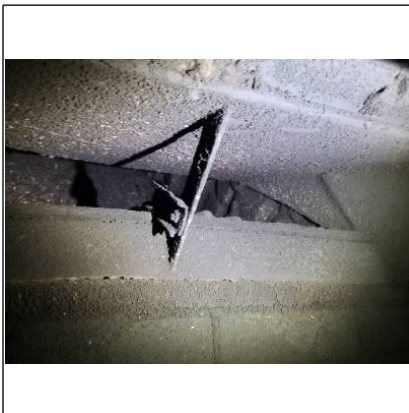
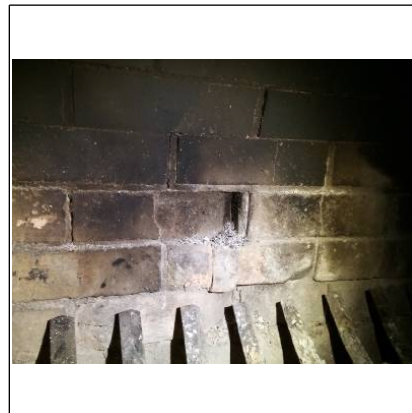
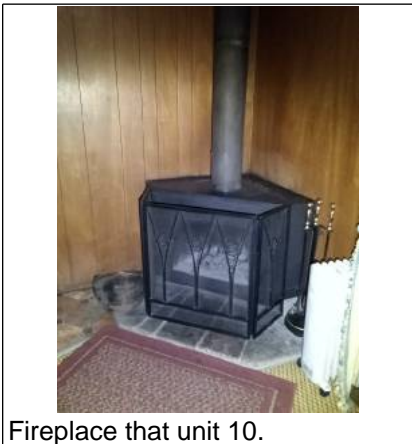
Fireplace that unit 10.

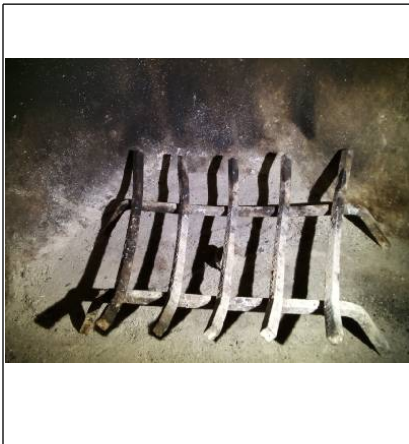
Smoke/Carbon Monoxide detectors

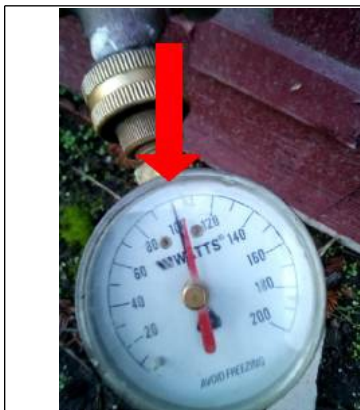
Water pressure 100 PSI.

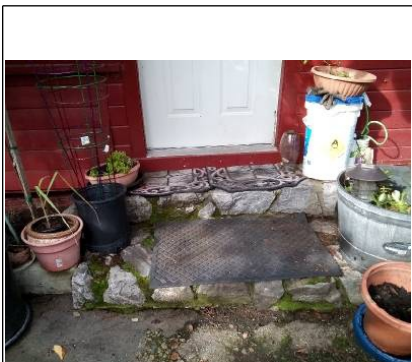
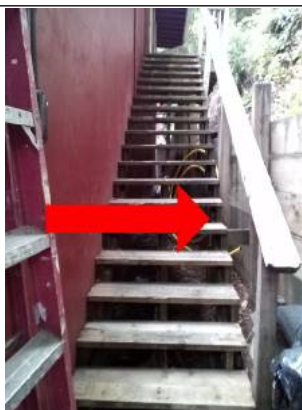
Recommend installing pickets and proper grab rails.

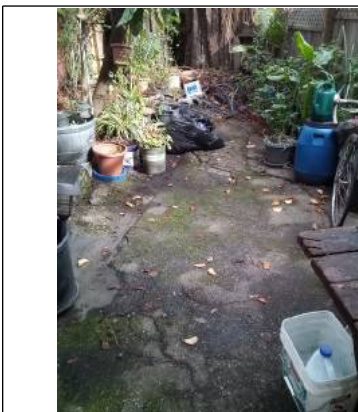
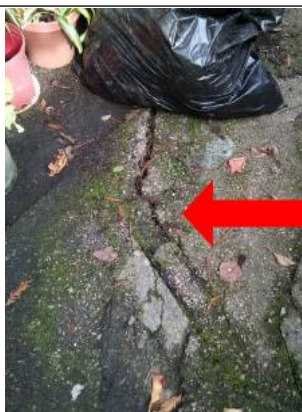
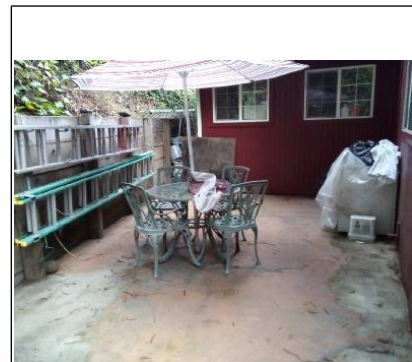
Patio at rear of house was found to be in satisfactory condition at time of inspection.

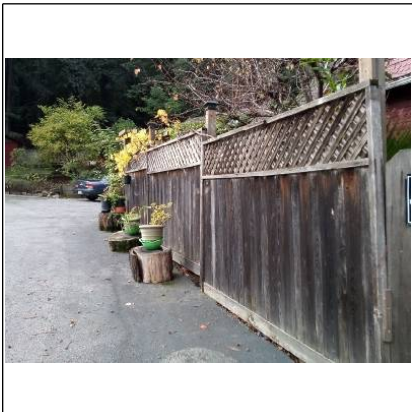
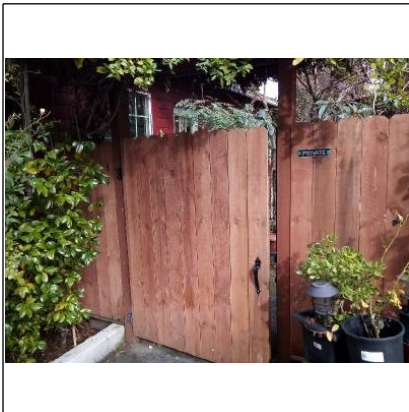
Landscaping affecting foundation

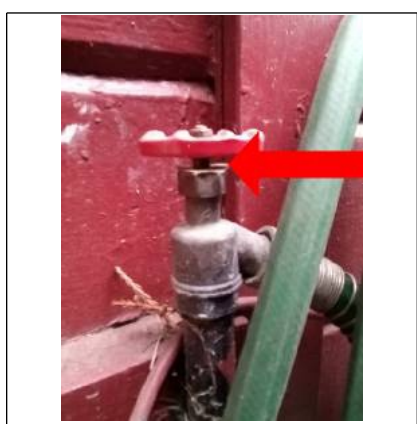
Hose bib leaking from stem.

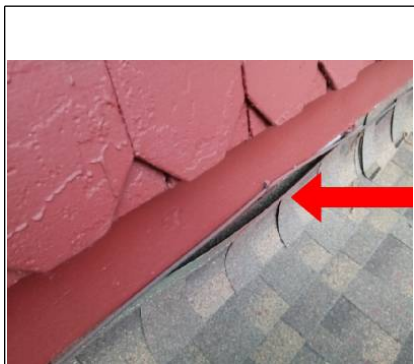
Flashing pulled away from home
recommend repai

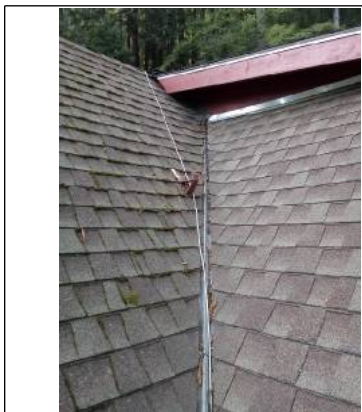
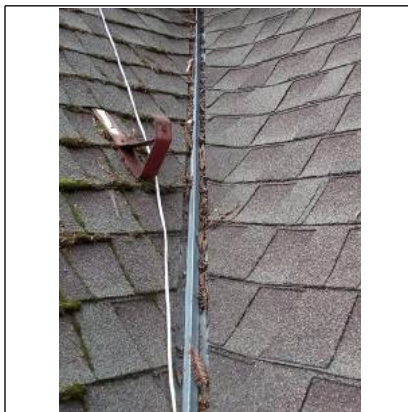
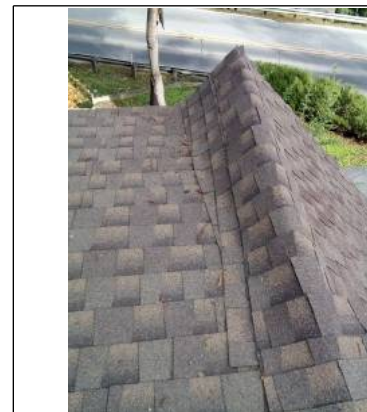
Condition of Roof Coverings

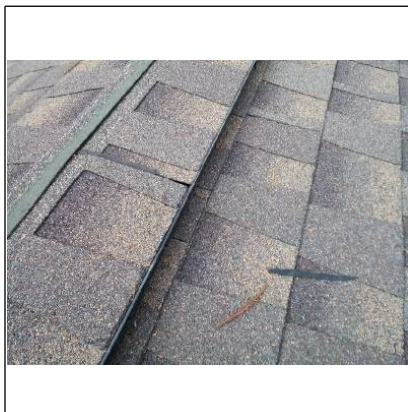
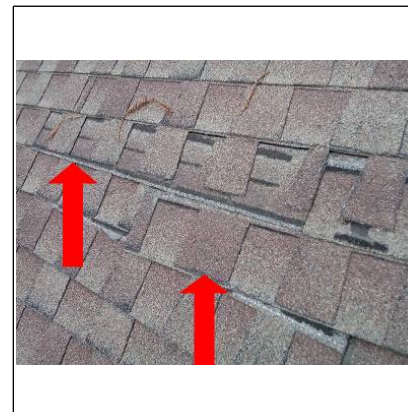
Loose mismatched shingles.

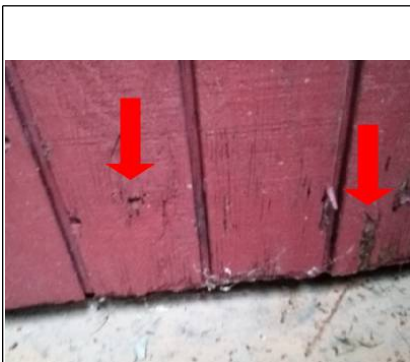
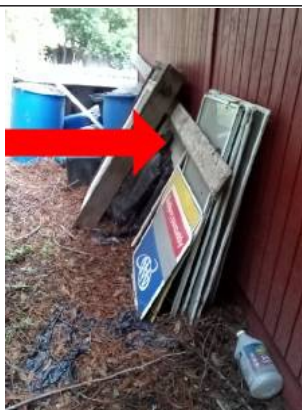
Recommend removing items from siding to prevent premature aging and deterioration.

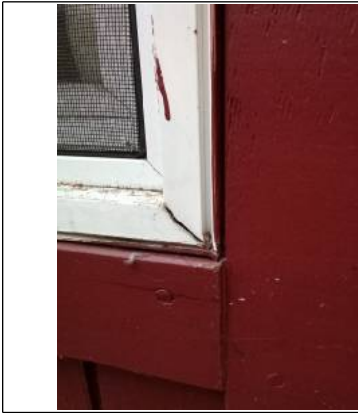
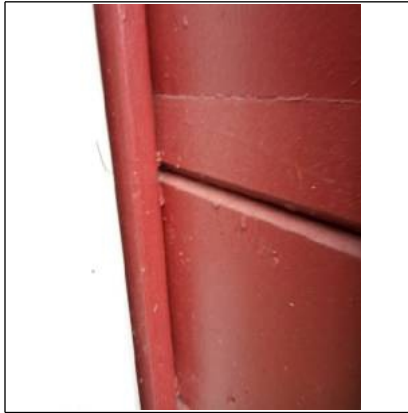
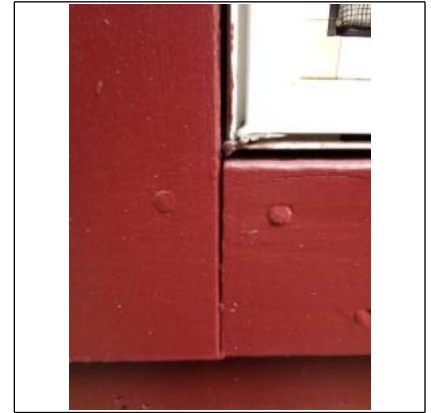
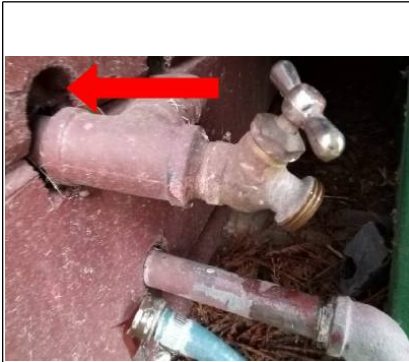
Recommend maintaining caulking at utility penetrations.

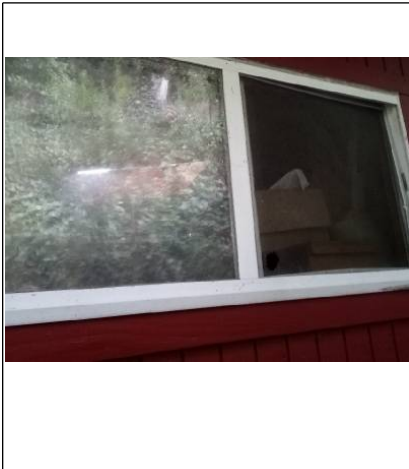
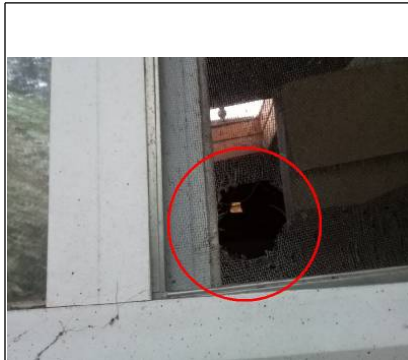
Hole in screen at garage window recommend repair.

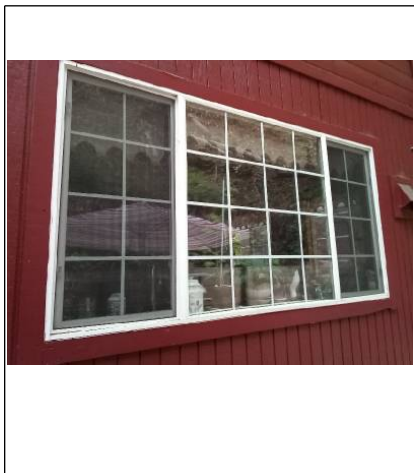
Slab-On-Grade/Foundation

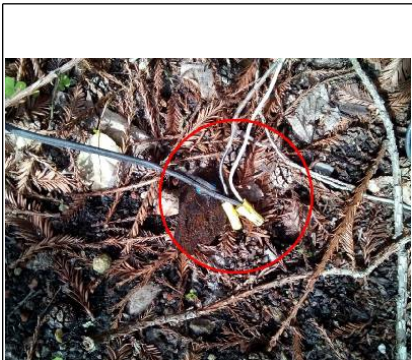
Open splice recommend contacting license electrician to evaluate and repair.

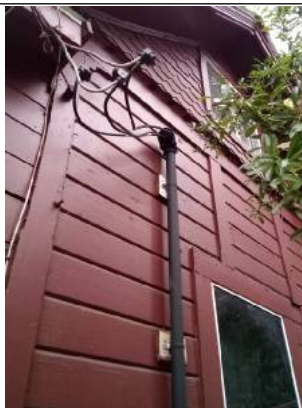
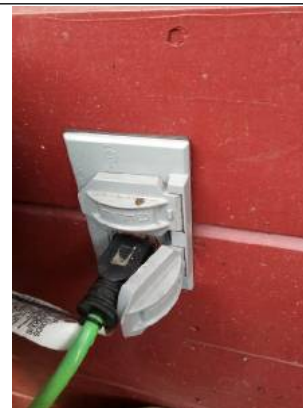
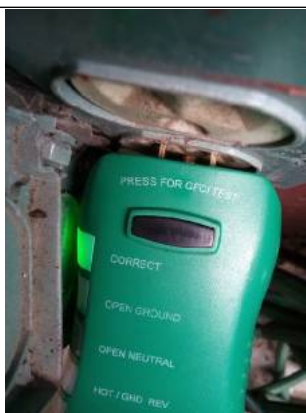
Building(s) Exterior Wall Construction

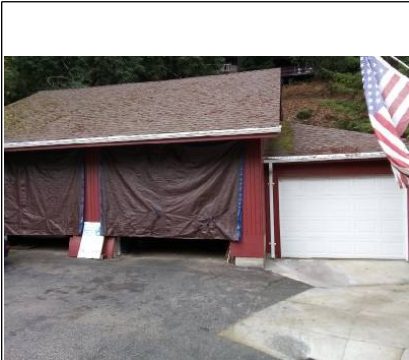
Recommend doors be installed at all garage openings.

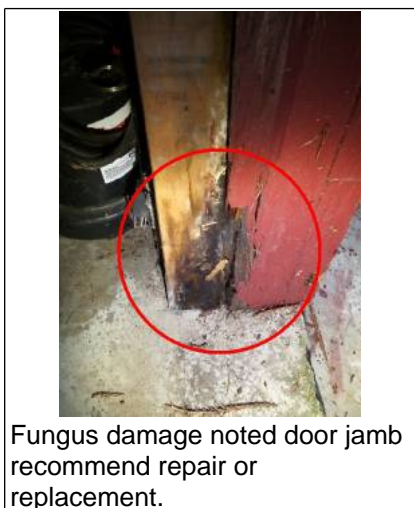
Fungus damage noted door jamb recommend repair or replacement.

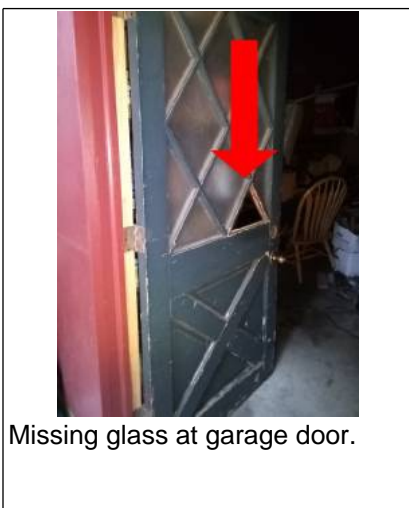
Missing glass at garage door.

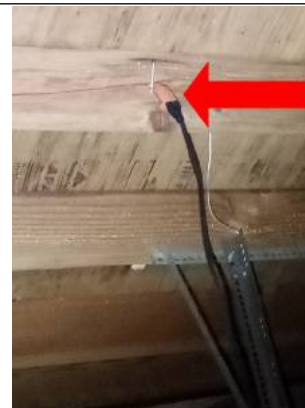
Extension cord handyman wiring recommend dedicated outlet.

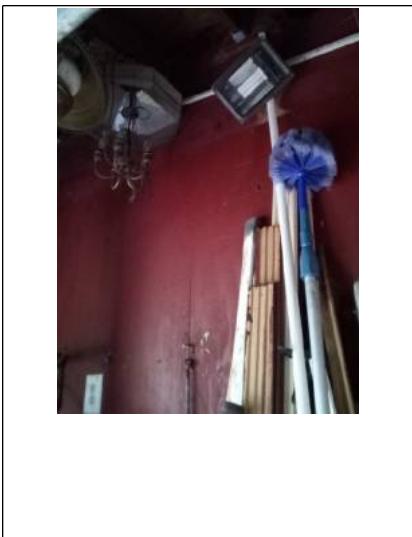
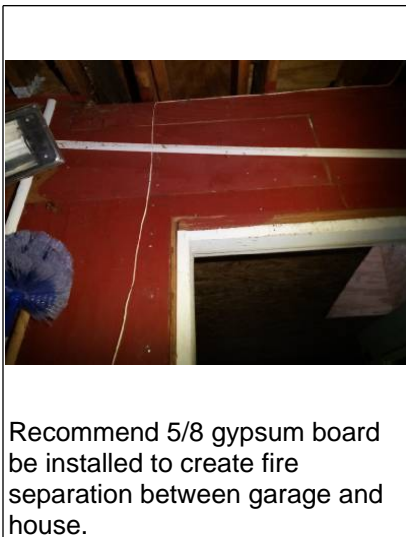
Recommend 5/8 gypsum board be installed to create fire separation between garage and house.

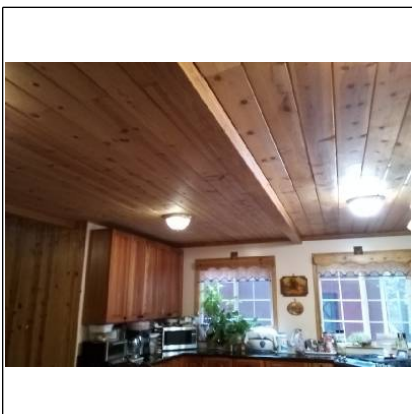
Heating/Cooling Source

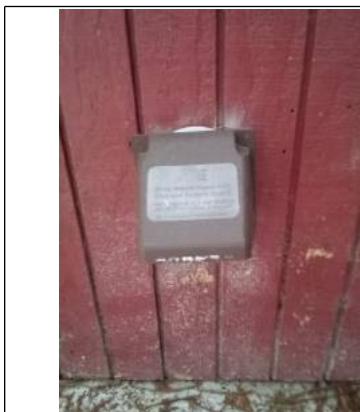
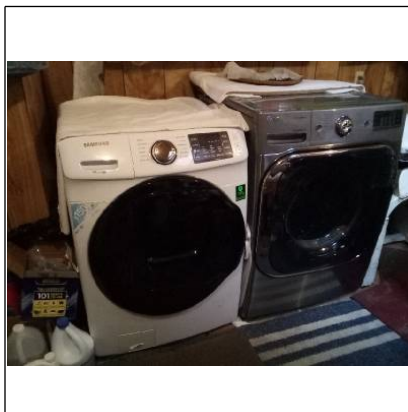
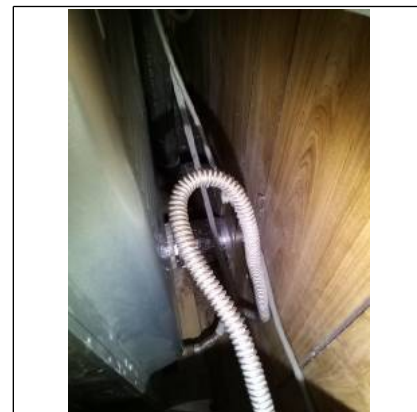
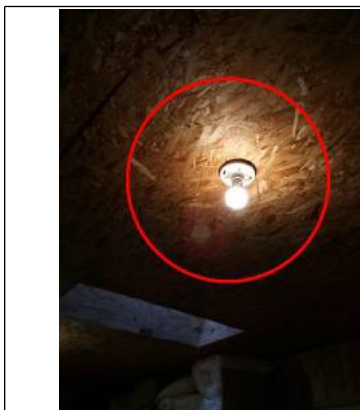
Exposed incandescent bulb.

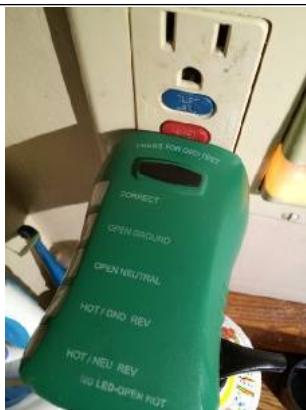
GFCI receptacle did not respond to testing witness recommend license contractor to evaluate and repair.

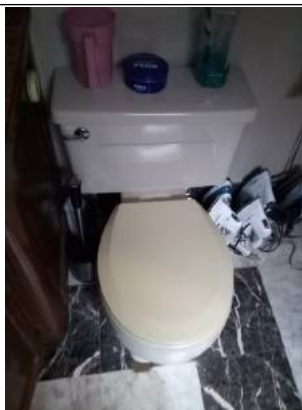
Non-low toilet noted.

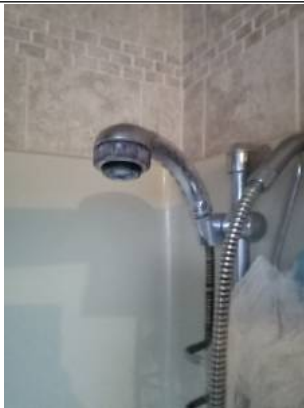
Low flow shower head noted.

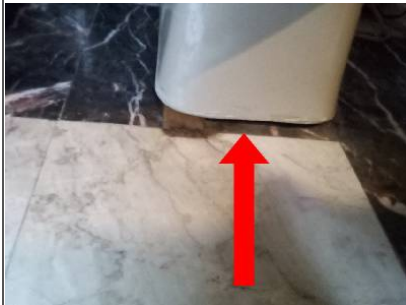
Recommend maintaining caulking at base of toilet.

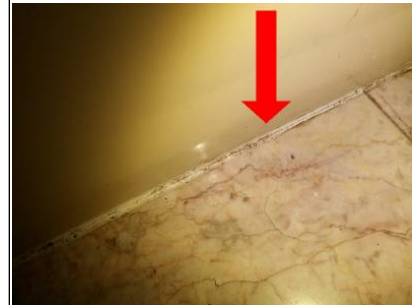
Recommend maintaining caulking at tub and floor junction to prevent moisture intrusion.

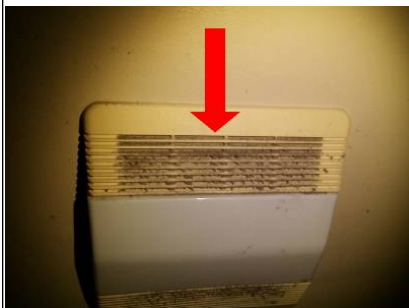
Recommend cleaning lint from exhaust grate.

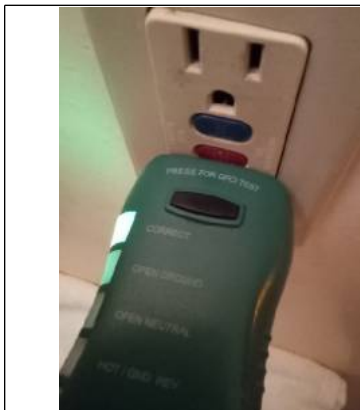
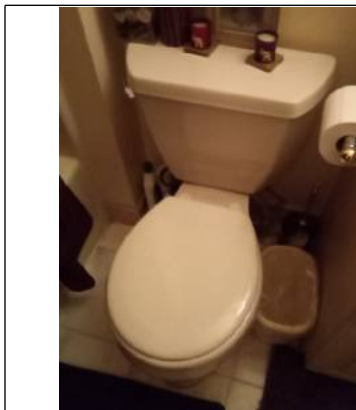
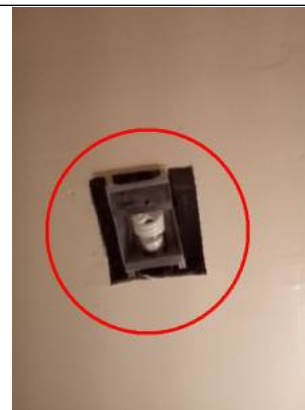
Missing grate at exhaust vent
recommend replacement.

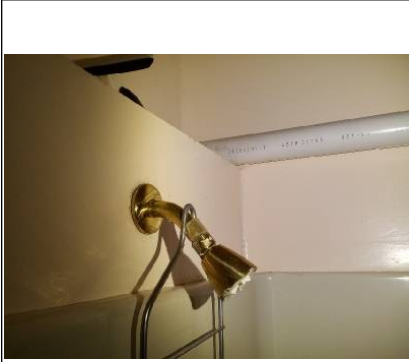
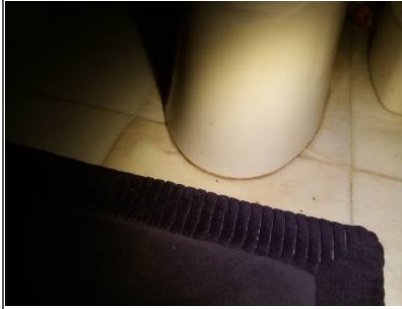
Recommend maintaining caulking
at base of toilet

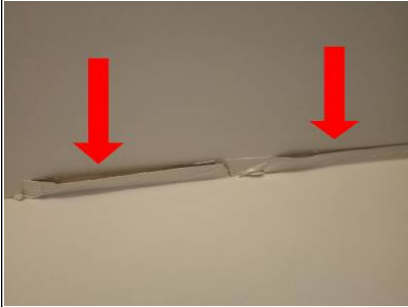
Recommend contacting drywall contractor to further evaluate open seams at ceiling.

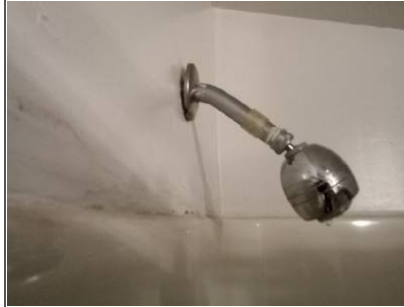
Low flow shower head noted.

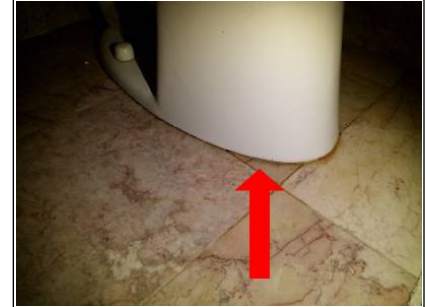
Recommend maintaining caulking at base of toilet.

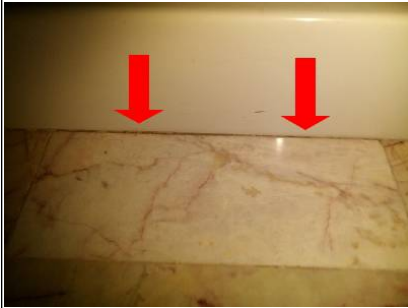
Recommend maintaining caulking for flooring shower meet to prevent moisture intrusion.

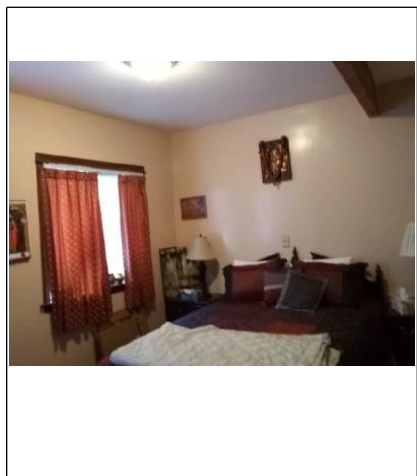
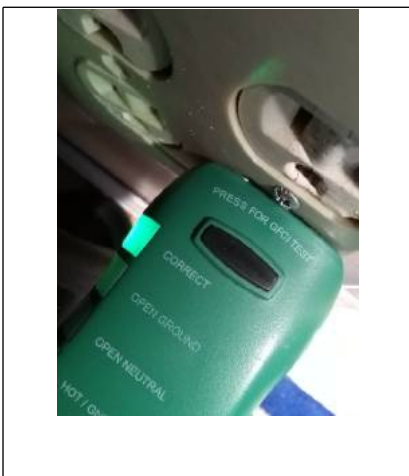
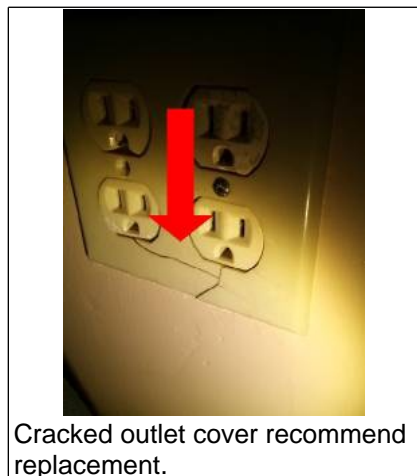
Cracked outlet cover recommend replacement.

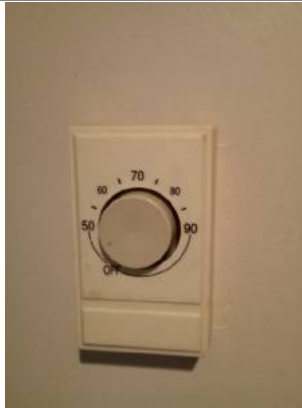
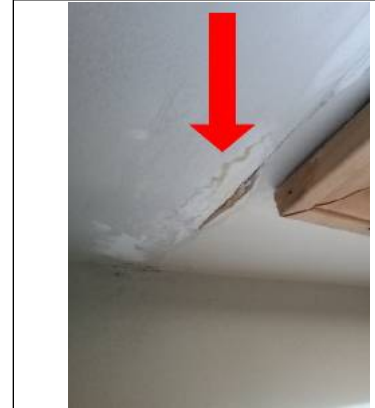
Drywall damage at ceiling recommend contacting appropriate trades for repair.

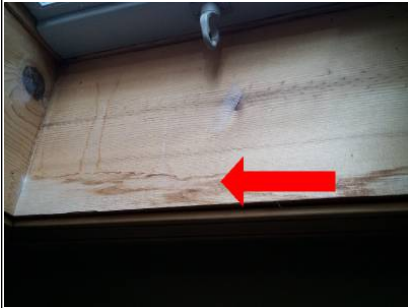
Moisture stains at skylight.

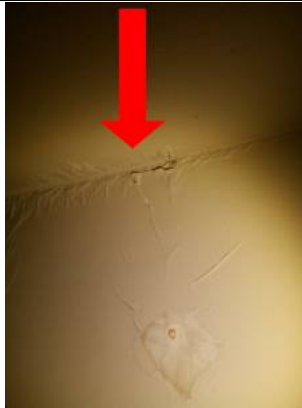
Damaged drywall ceiling recommend repair.

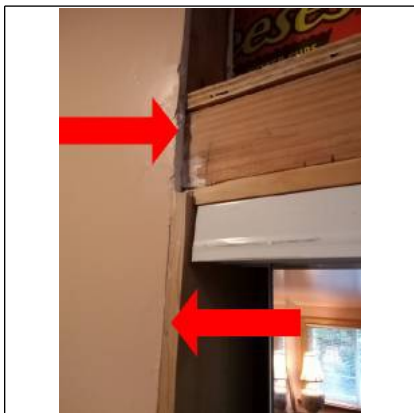
Trim and drywall missing at closet doors recommended repair and replacements.

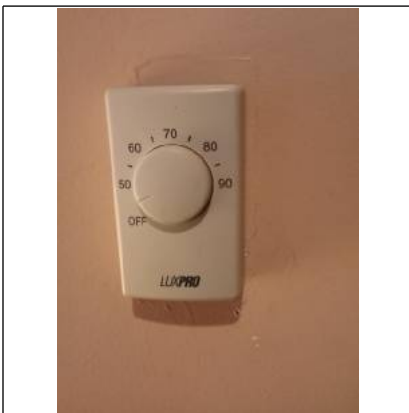
Thermostat present no baseboard heater was discovered in room.

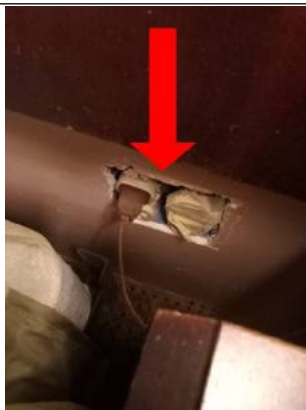
Missing outlet cover recommend replacement.
