HATCH LEGEND

ALUMINUM		CONTINUOUS LUMBER
	STEEL		PLYWOOD
	BATT INSULATION		GRANULAR MATERIAL
	RIGID INSULATION		EARTH
	CMU		CONCRETE
	BRICK		CMU GROUTED SOLID
	EIFS		GYPSUM BOARD

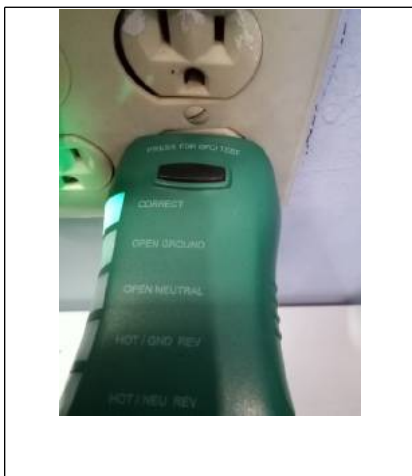
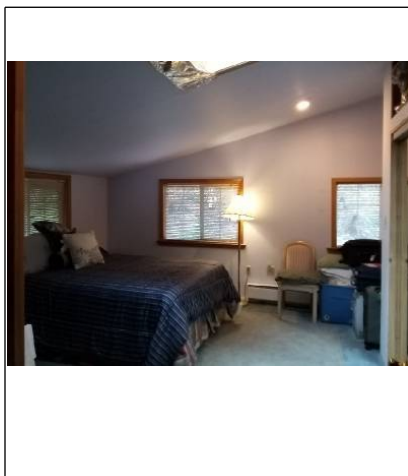
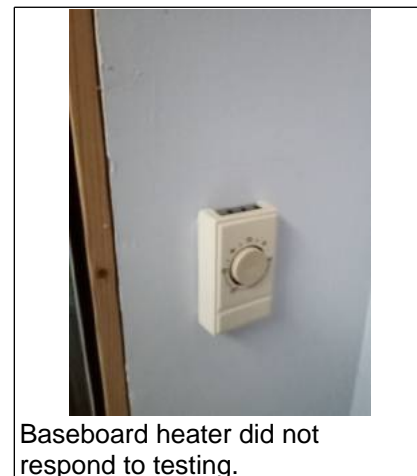
Baseboard heater did not respond to testing.

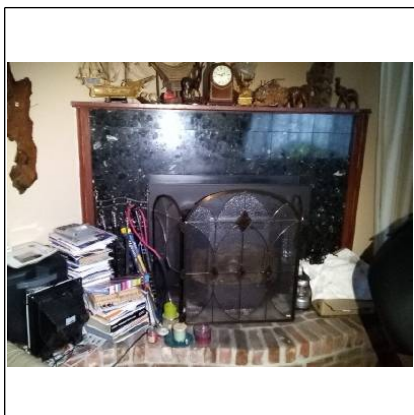
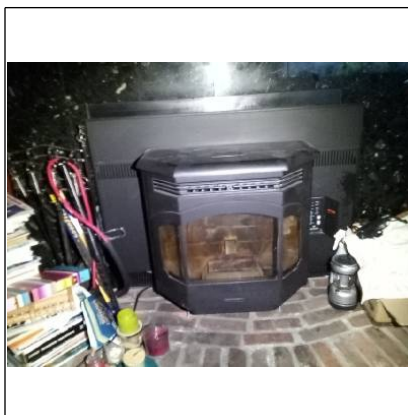
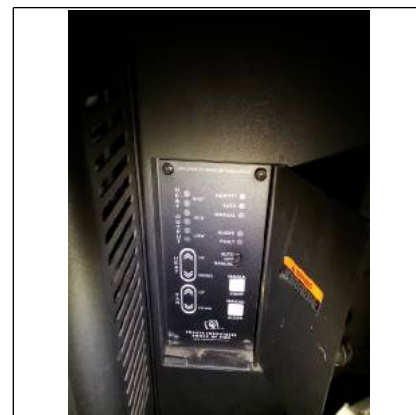
Stairs/Steps/Balconies

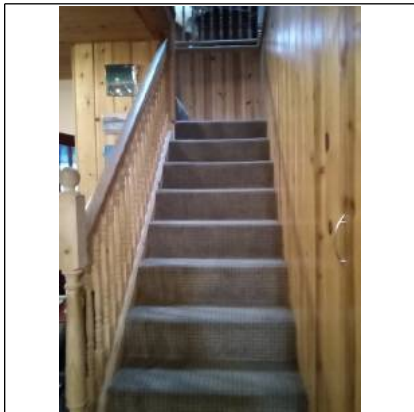
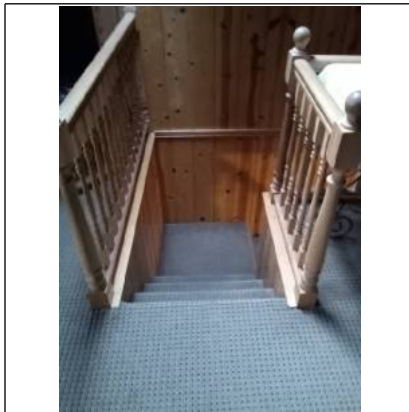
Smoke/Carbon Monoxide detectors

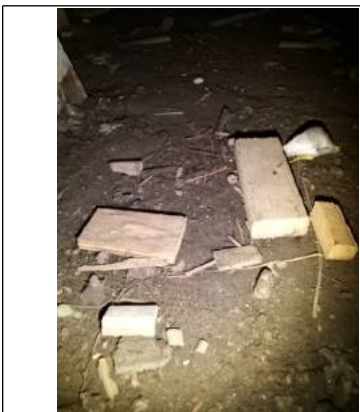
Recommend removing cellulose debris.

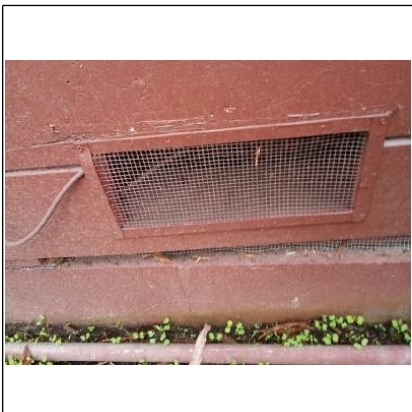
Girders/Beams/Columns

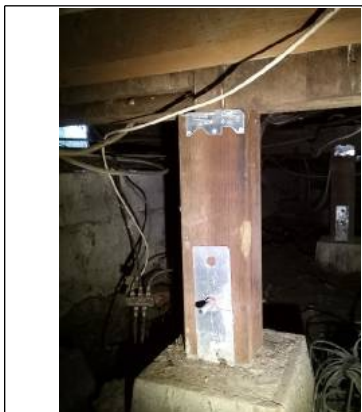
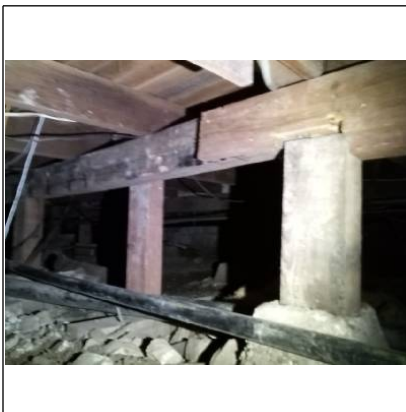
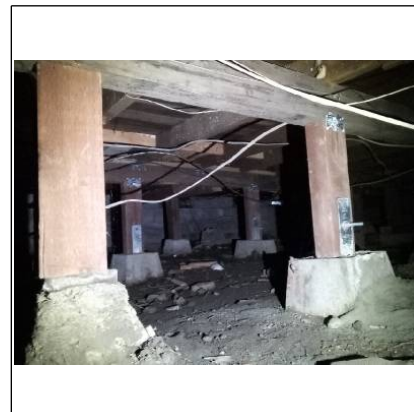
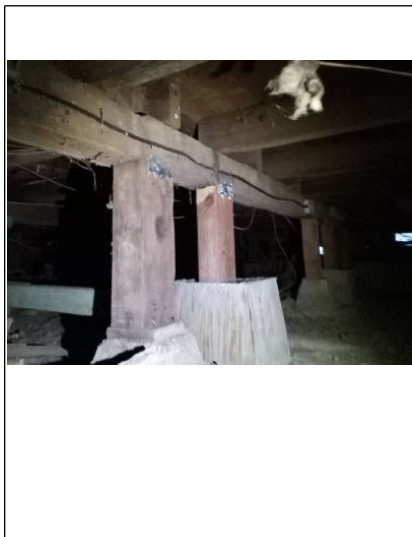
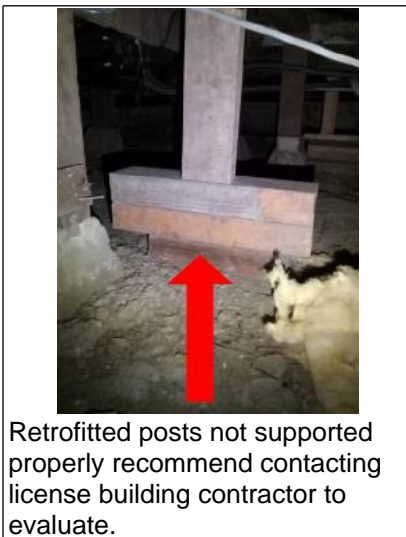
Retrofitted posts not supported properly recommend contacting license building contractor to evaluate.

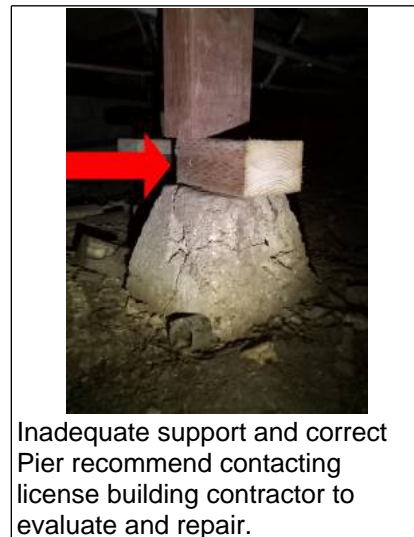
Inadequate support and correct Pier recommend contacting license building contractor to evaluate and repair.

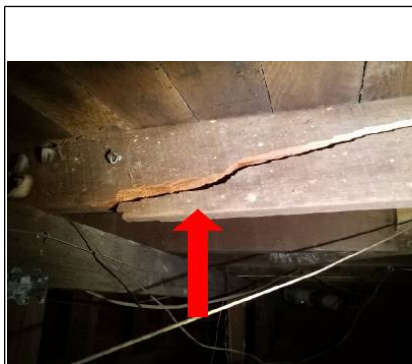
Cracked floor joist recommend contacting licensed contractor to evaluate and repair.

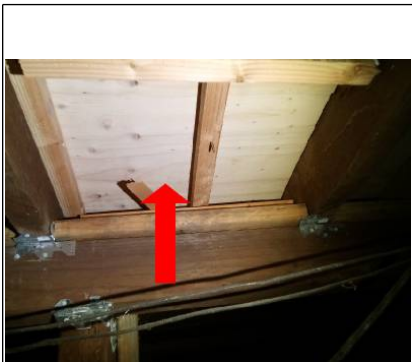
Subfloor repair noted.

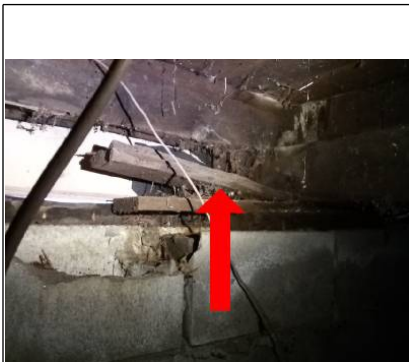
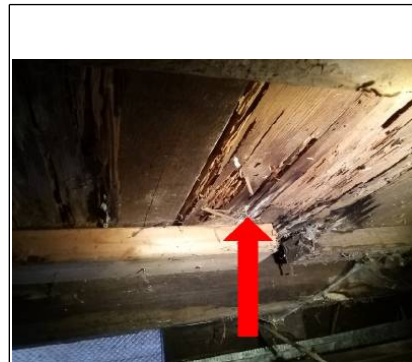
Moisture and pest damage.

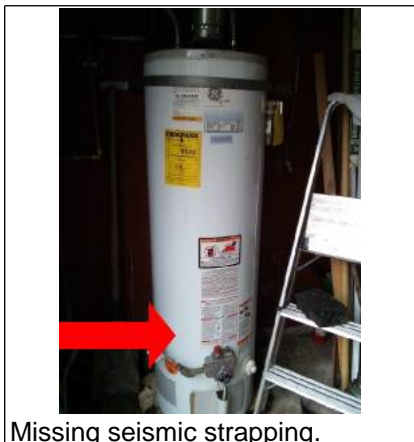
Missing seismic strapping.

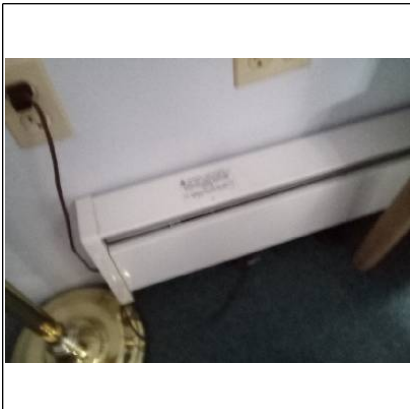
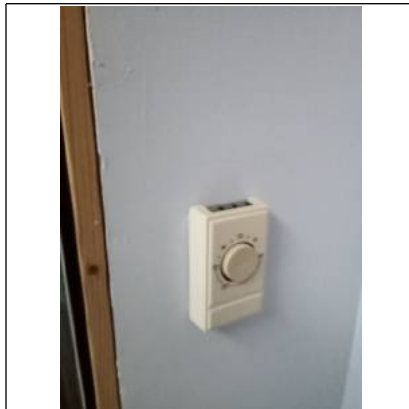
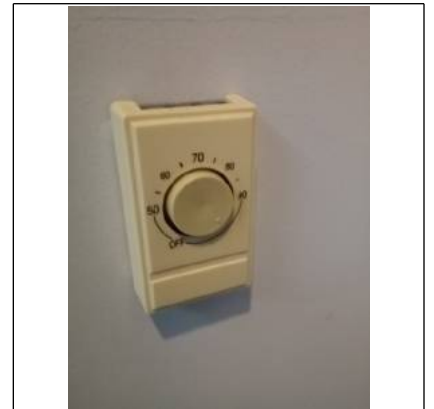
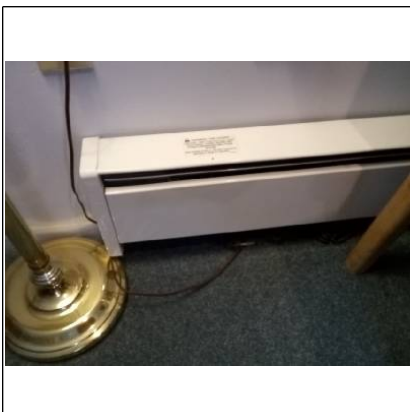
Electric/Cooling System

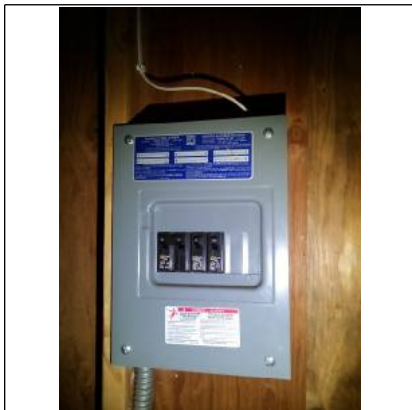
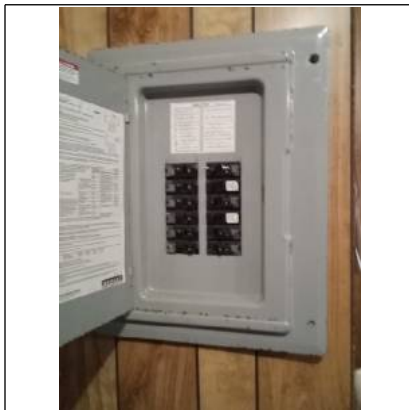
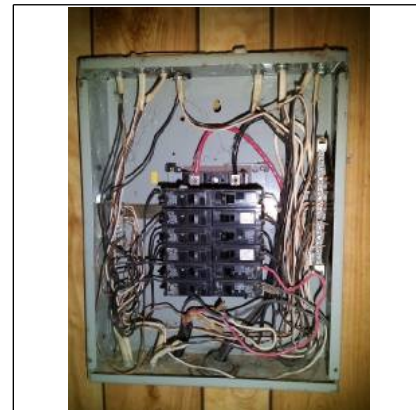
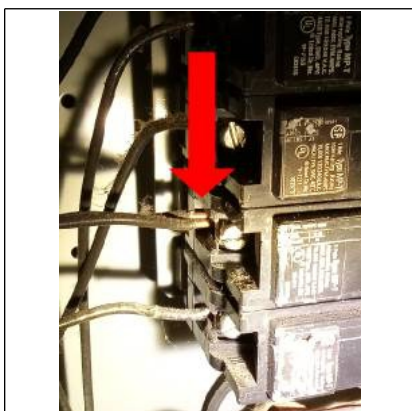
Double tapping of breaker recommend contacting license electrician to further evaluate and repair.

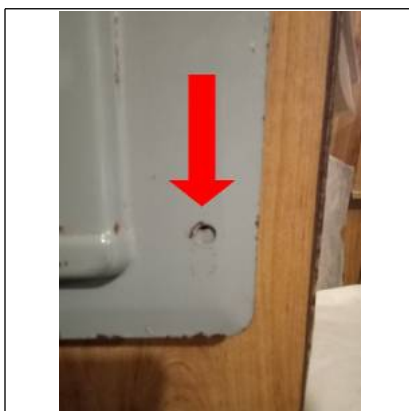
Missing screws recommend replacement.
