APPENDIX A

PHOTO APPENDIX

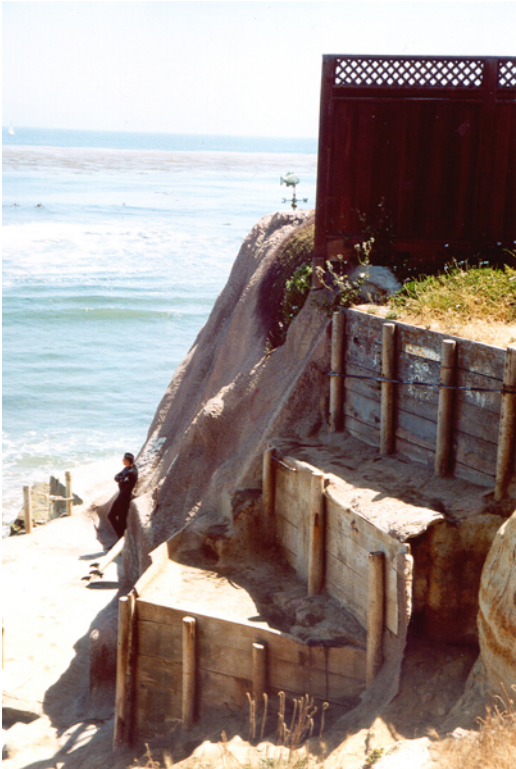
Photo 1. Private residence armoring, Adjacent to Pleasure Point Park.

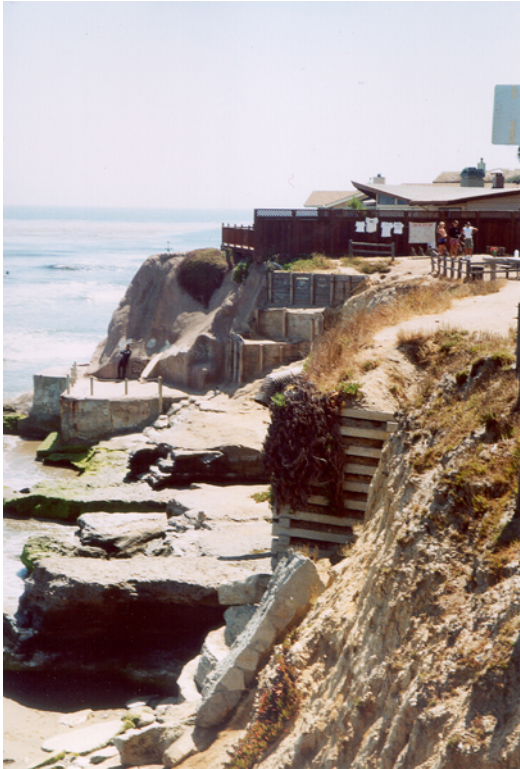
Photo 2. Bluff protection and engineered terraces near Pleasure Point Park.

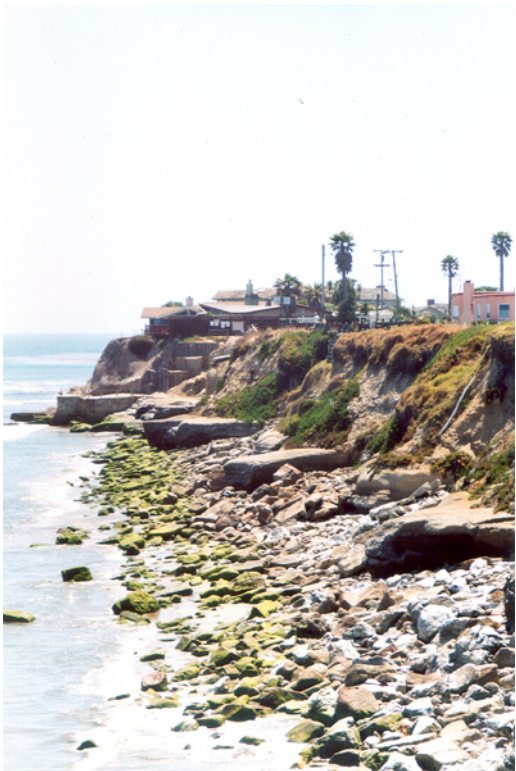
Photo 3. Beach rubble, looking upcoast towards Pleasure Point Park.

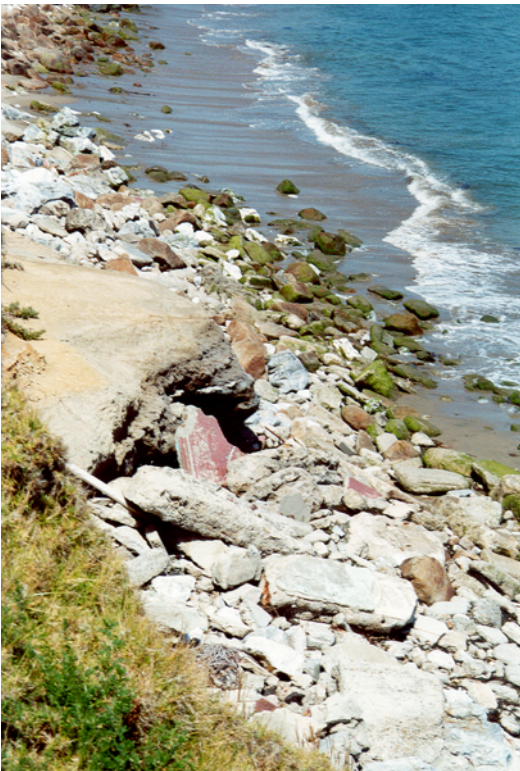
Photo 4. A close-up view of the concrete rubble and rock riprap.

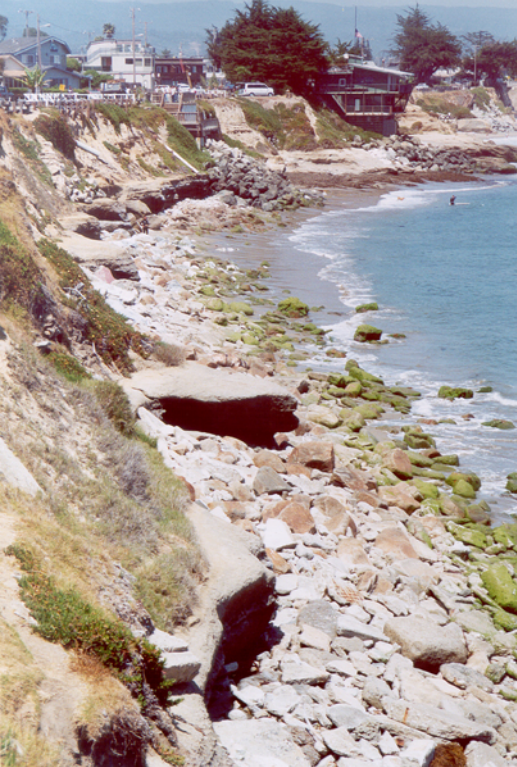
Photo 5. Rock riprap and concrete rubble, looking downcoast.

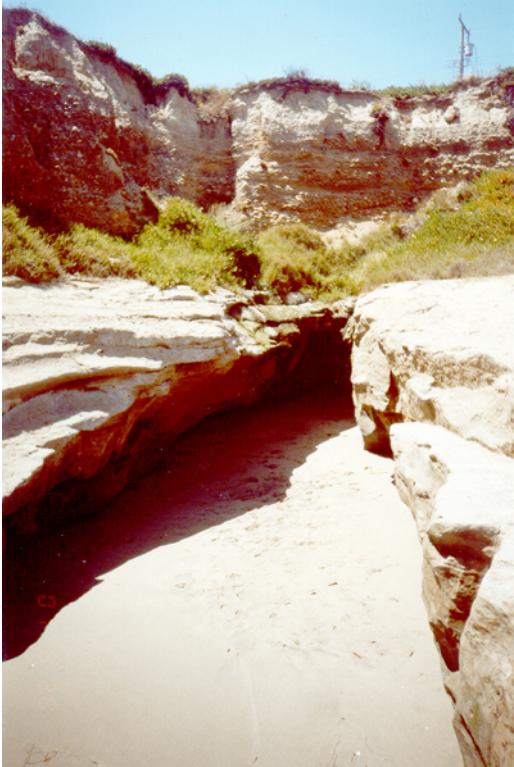
Photo 6. Wave cut in Purisima formation; marine terrace in background.

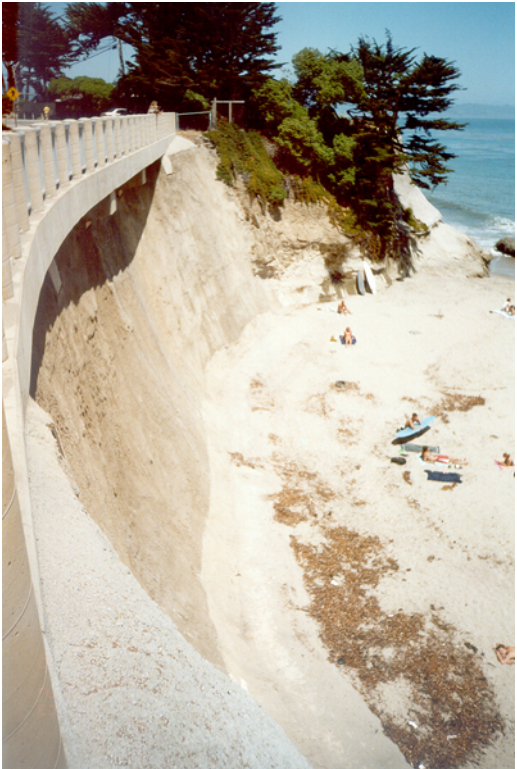
Photo 7. Larch Lane emergency armoring, looking downcoast.

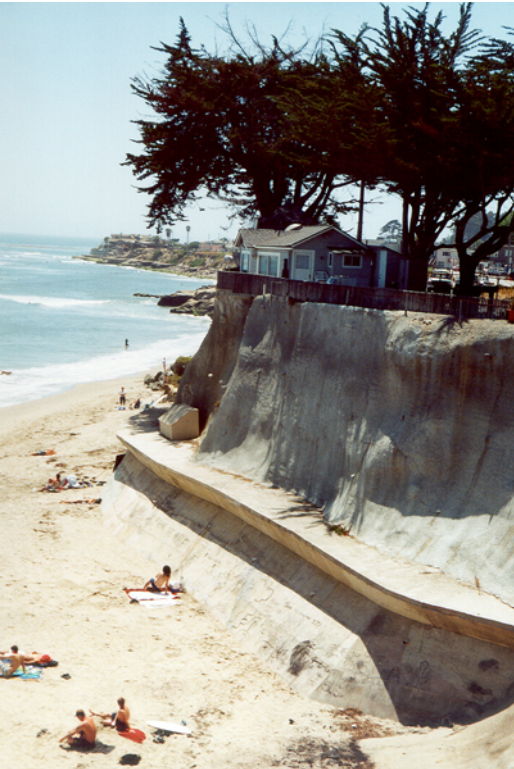
Photo 8. Private residence armoring and seawall, west of Larch Lane.

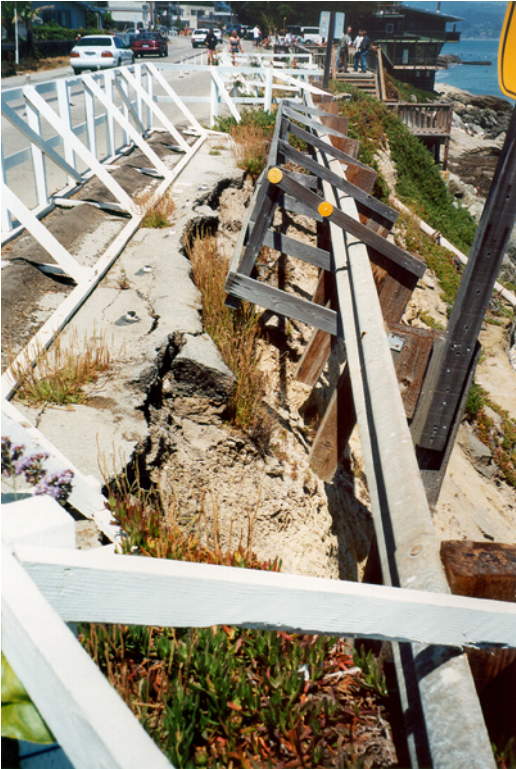
Photo 9. East Cliff Drive cliff face erosion and proposed build-out location.

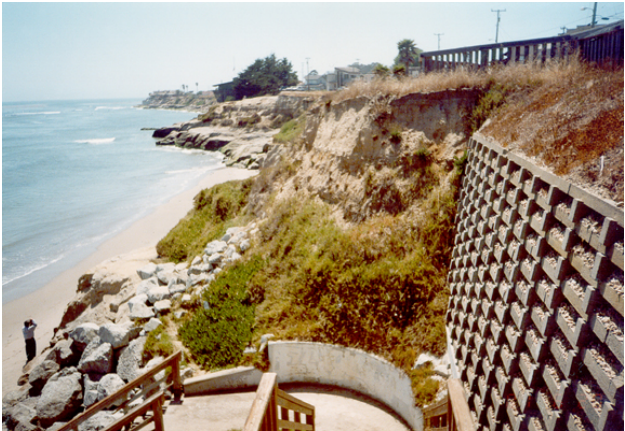
Photo 10. Stairs and crib wall (retaining wall) at 38th Avenue.

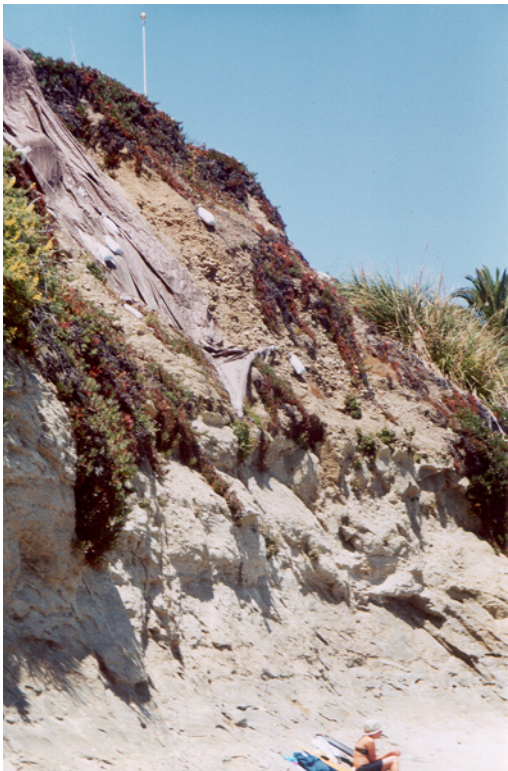
Photo 11. Erosion of the existing cliff face.

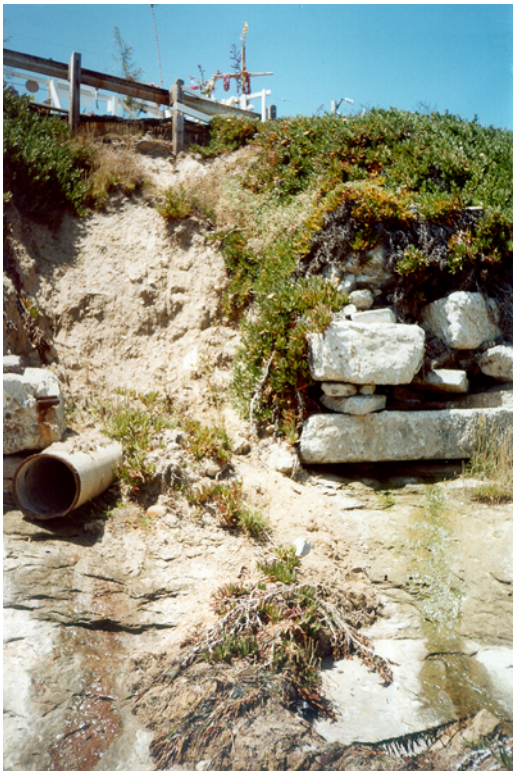
Photo 12. Drainage below East Cliff Drive.

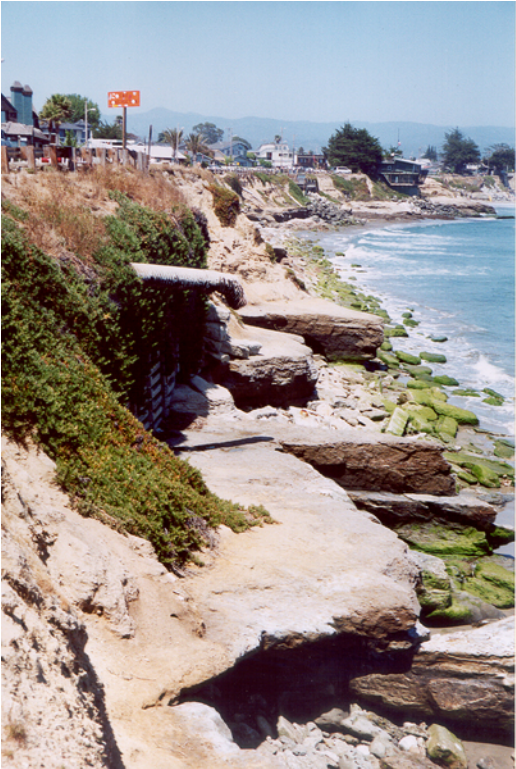
Photo 13. Wave cuts in Purisima foundation and drainage below East Cliff Drive.

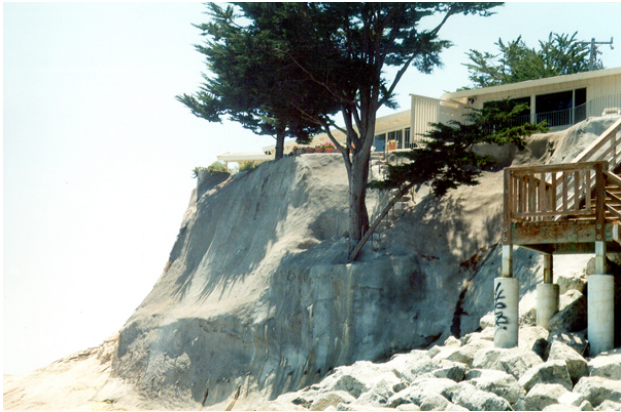
Photo 15. Private residence bluff armoring next to 41st Avenue stairway.

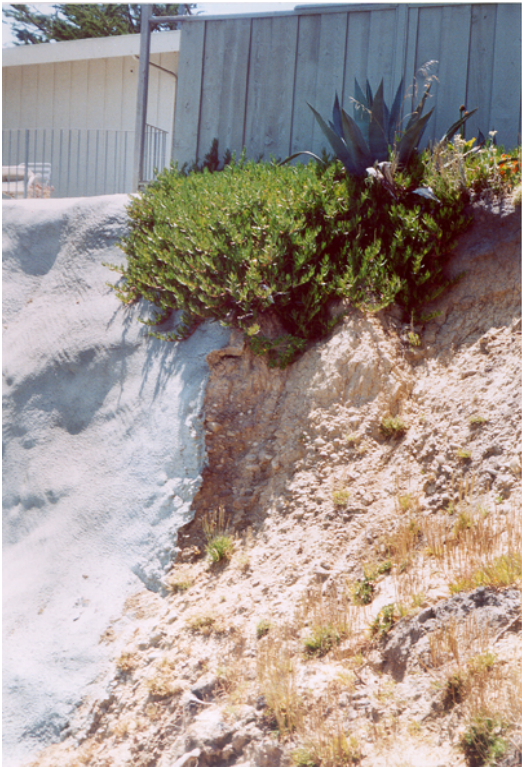
Photo 16. Armoring (private residence) against exposed cliff face, near 41st Avenue.

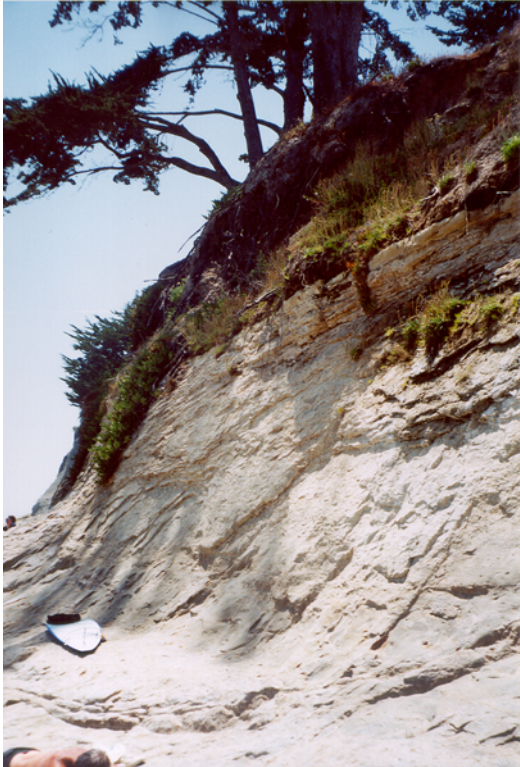
Photo 22. Thick Purisima formation with vegetation covering terrace.

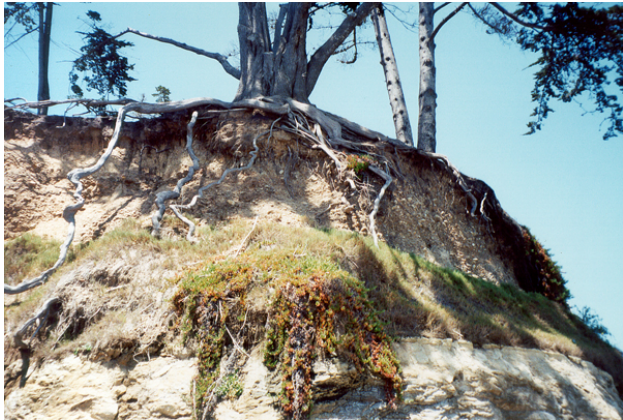
Photo 23. Exposed Cypress tree root system due to bluff erosion at 41st Avenue.

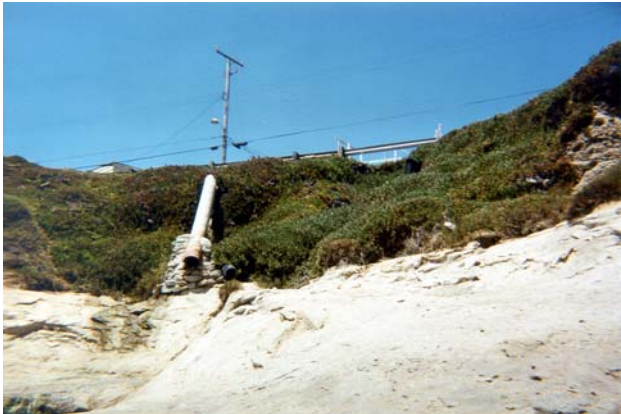
Photo 27. Typical cliff face showing exotic vegetation. Near Manzanita Avenue.

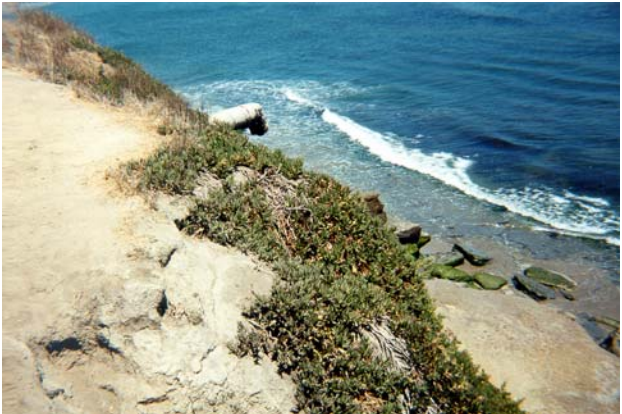
Photo 28. Typical cliff top showing exotic vegetation. Near 34th Avenue.

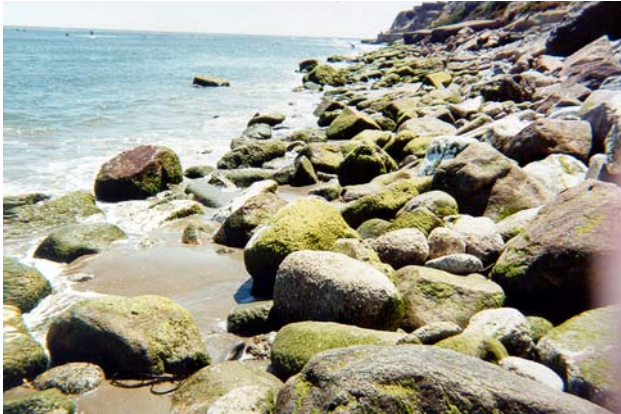
Photo 29. Algae on existing rock riprap. Looking upcoast from stairway and restroom, near 35th Avenue.

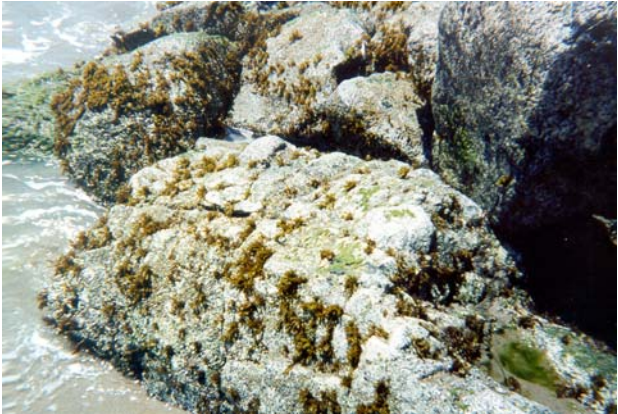
Photo 30. Algae on existing rock riprap. Looking upcoast from stairs near Larch Lane.
