ARBORIST REPORT-
Tree Survey & Preliminary Construction Impact

41st & Soquel Drive

Soquel, CA 95073

7/27/2024

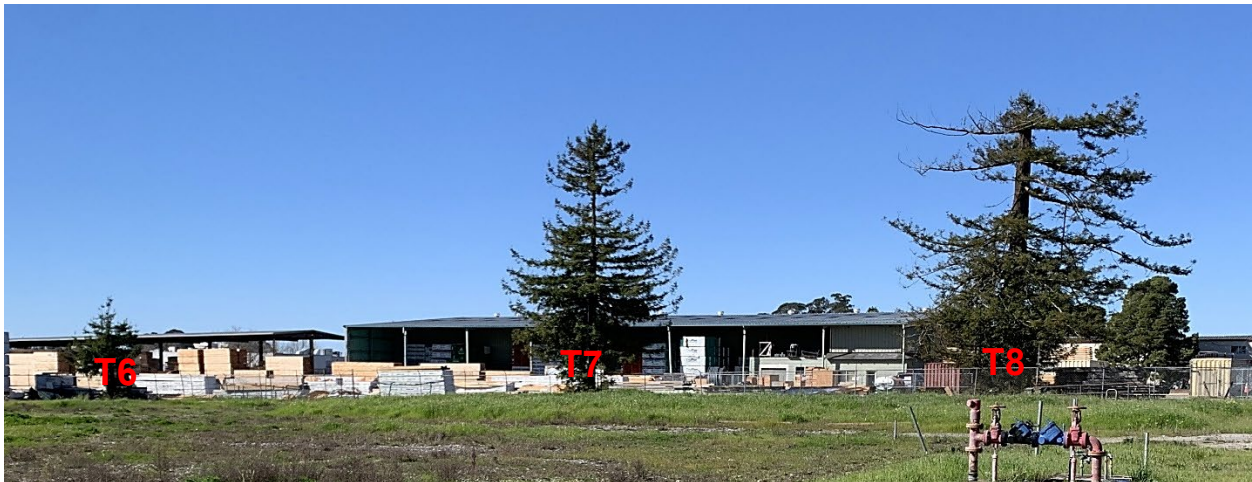
Image #1 – Trees T6, T7 & T8, coast redwood, grow in the lumber yard and have canopies that overhang applicants property.

T6 is a young redwood with a trunk diameter below protected size. The trees limbs have been pruned on one side only, to allow access to stored wood for the lumberyard. A few limbs overhang the applicants property by about 10-feet.

Trees T7, a 24" diameter, semi-mature redwood, and T8, a 48" mature redwood both have canopies that overhang the applicants property.

Tree T7 has minor tip dieback, fair canopy density and is pushing new growth at the branch ends. The branch arrangement is somewhat irregular, and the tree may have received some indiscriminate pruning in the past. Overall, the tree is in fair condition.

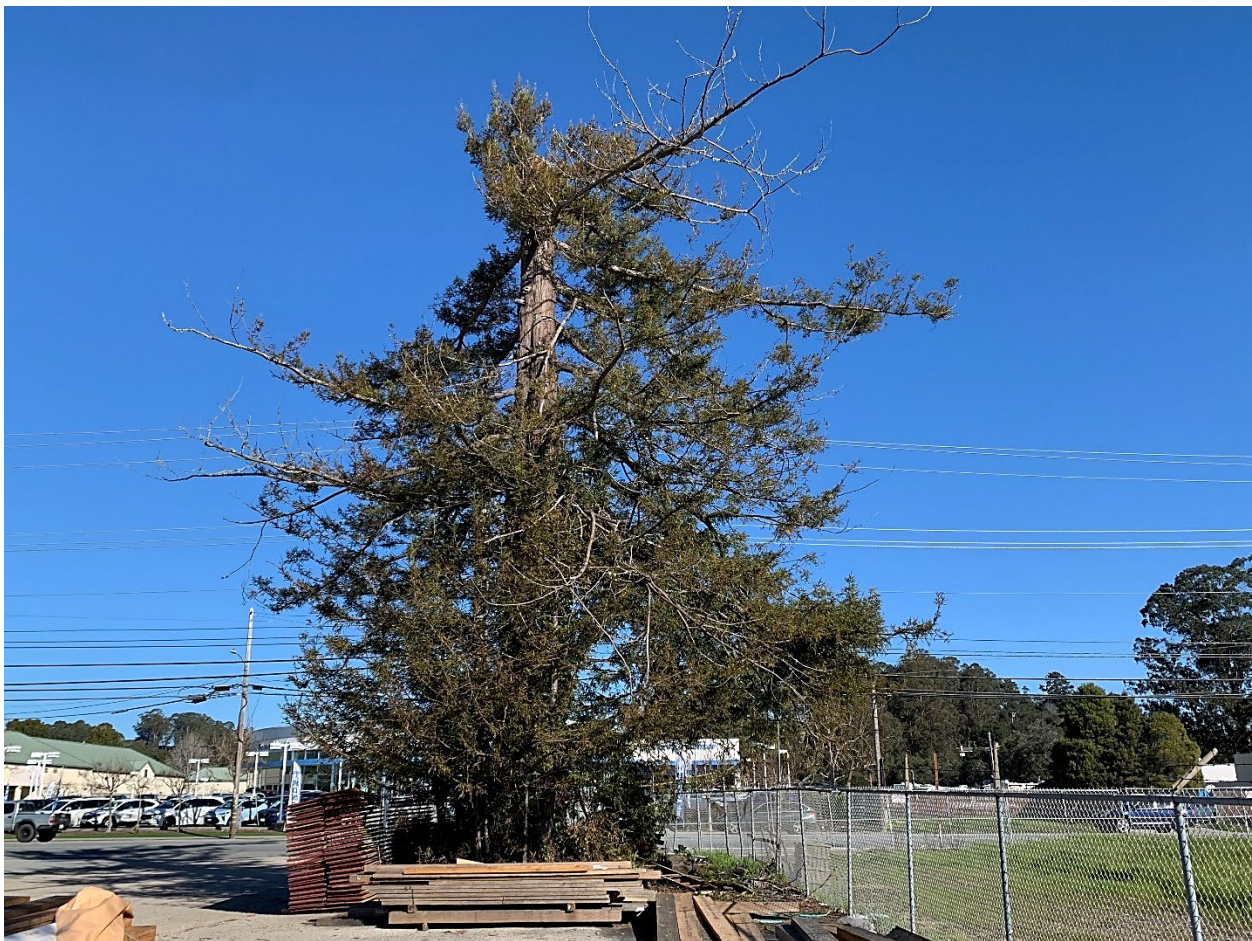
Tree T8 is a mature redwood that grows near the northwest corner of the property but is on the lumber yard property. The tree has been topped at 50-feet above grade and has received additional indiscriminate pruning over the course of its lifetime. Because of this pruning the trees branching arrangement is irregular.

Grading has occurred near the trunk and the trees buttress roots, (roots at the trunk base that help support the tree), are exposed. Despite the exposed roots, the tree appears stable.

In association with the grading, it is likely that some root loss has occurred. As a result of the root loss, I observed extensive tip dieback over more than half of the trees canopy, (Image #2).

Image #2 – Tree T8, coast redwood. Note extensive tip dieback. Also note tree was topped.

Because of the past management of this tree, resulting in tip dieback, poor structure, and root loss, I rate the condition of the tree as poor.

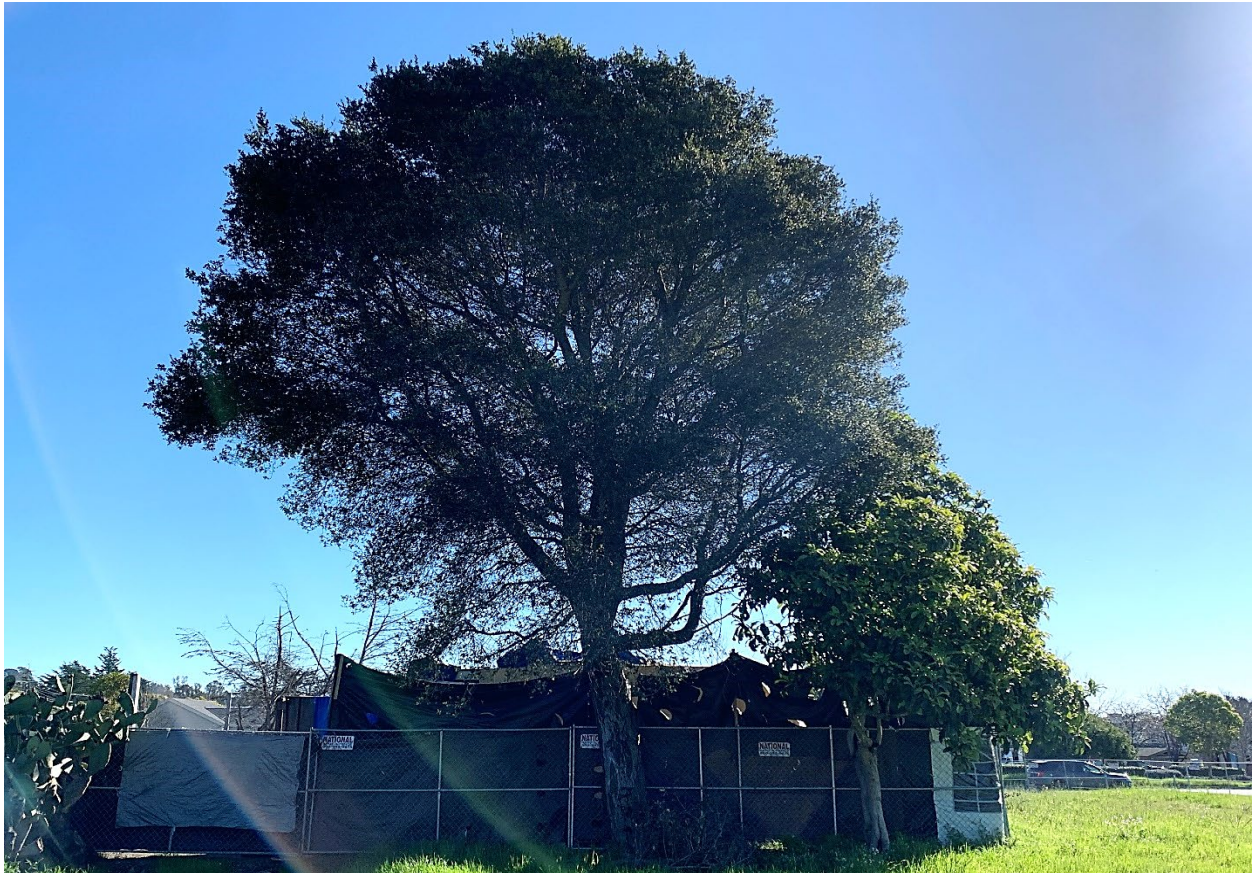
Image #3 – Tree T1, coast live oak grows near the center of the property.

The oak has two codominant trunks that form a union at 9-feet above grade. The canopy density is somewhat thin. Branches are well attached, and the tree appears stable.

I noted a horizontal seam at the tree trunk at 5-feet above grade. Sometime in the past a wire or rope was tied around the circumference of the tree and over time the trees trunk expansion has grown over the wire or rope. The tree does not currently show any ill effects from the girdling wire or rope, but it could cause problems for the tree in the future. Girdling, or restrictions to a trees trunk can cause destruction of the trees vascular system by inhibiting the flow of water and photosynthates.

Overall, the tree is in fair condition.

Tree T1, a 23" coast live oak, is within the building footprint and it's removal will be necessary.

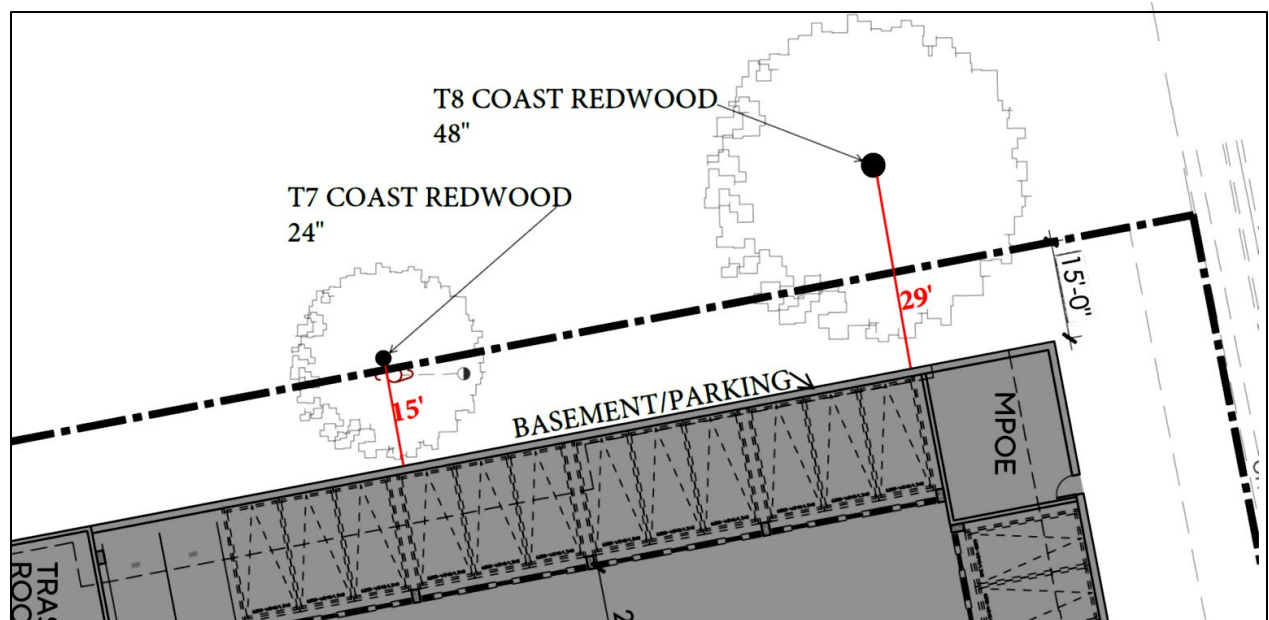
There are two significant trees on an adjacent property, including trees T7, a 24" coast redwood, and T8, a 48" coast redwood, (Image #4). Tree T7 grows on the lumber yard property at the fence line and is 15-feet from the building foundation and basement, (Image #4). With 5 feet allowed for over excavation, soil disturbance will occur 10-feet from the tree. At 10-feet the excavation for the foundation will occur within the critical root zone of tree T7, $10' \times 12" \div 24"$ trunk diameter = 5 X the trunk diameter. With mitigation, impacts are within the trees root loss tolerance. The redwood will suffer some root loss which it can tolerate and needs tree protection treatments to reduce root loss impacts. Tree T7 will need minor clearance pruning to allow building construction.

Image #4 – Trees T7 & T8 coast redwood, and distance to basement/ foundation.

Tree T8 grows on the lumber yard property and is 14-feet from the fence line. It is approximately 29-feet from the building foundation and basement, (Image #4). With over excavation for the basement, the soil disturbance distance will be roughly 24-feet from the tree. This is 6X the trunk diameter and outside the critical root zone. With mitigation, impacts are within the trees root loss tolerance. The redwood will suffer moderate root loss which it can tolerate, and needs tree protection treatments to reduce root loss impacts. Tree T8, will need minor clearance pruning to allow room for building construction.
