Santa Cruz Countywide

# PARTNERS IN RESTORATION PERMIT COORDINATION PROGRAM

## 2020 ANNUAL REPORT

Prepared by the  
Resource Conservation District of Santa Cruz County

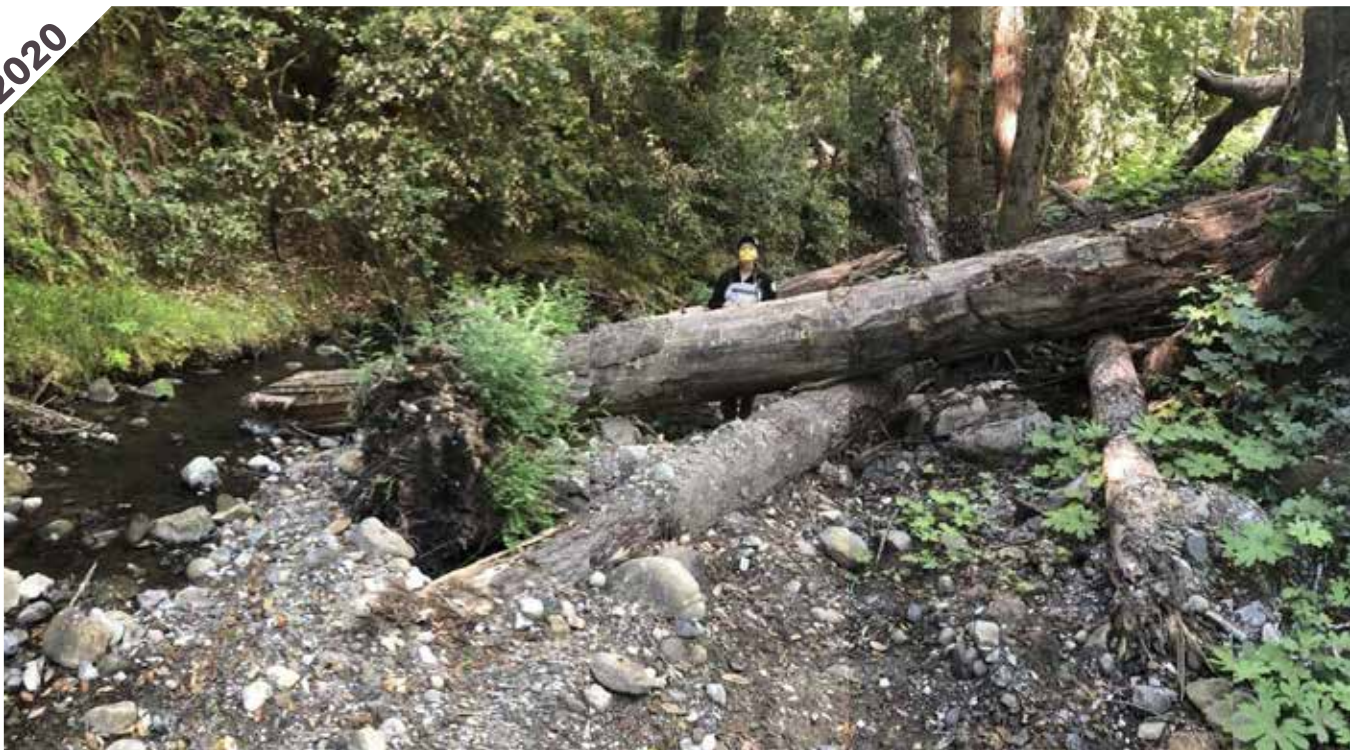
Photo point 20: Type 1. Looking downstream at Type 1 structure. Rootwads visible and are sprouting. No significant wrack up visible due to low flow events in 19-20 wet

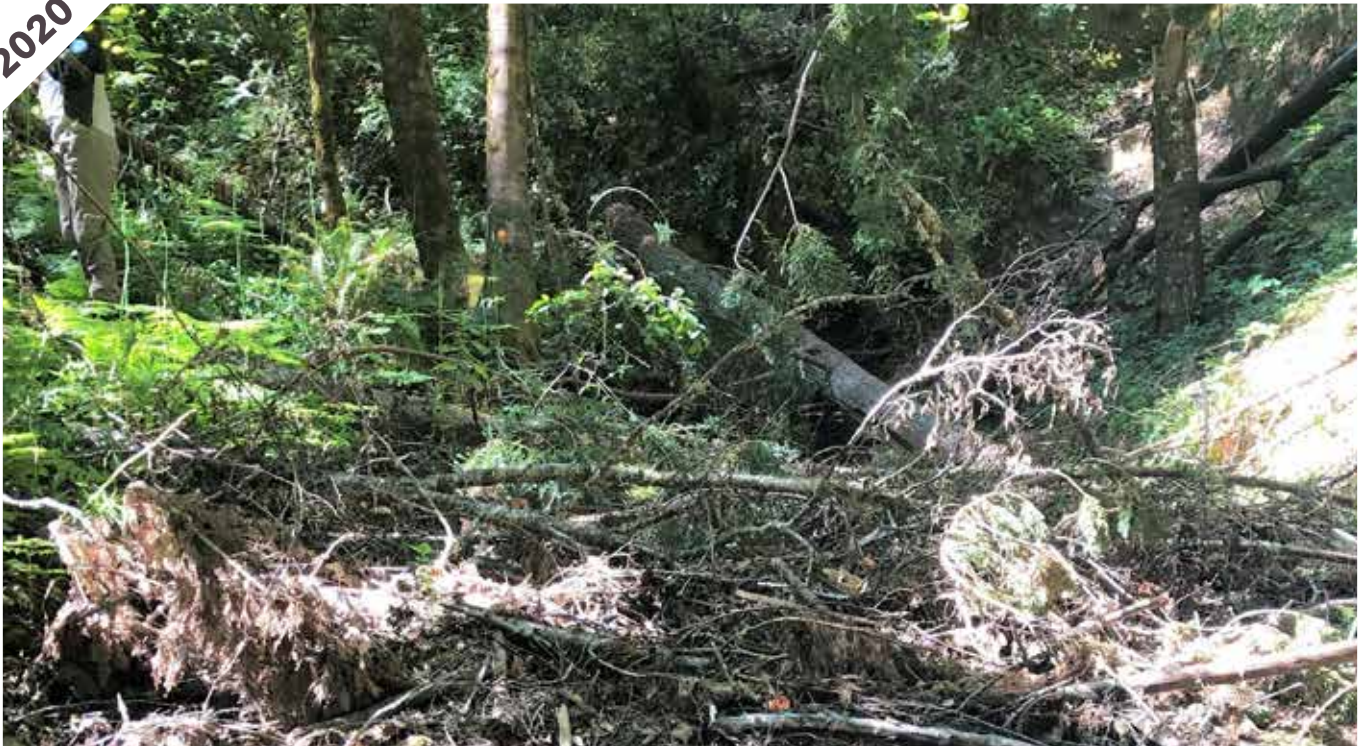
Photo point 23: Type 3. Looking downstream at Type 3 structure. Historic landslide visible still slightly visible in background, bedrock hidden by branches. Pooling on downstream end of structure. Significant wrack up occurring of small branches at upstream end. Bank vegetation grown in significantly.

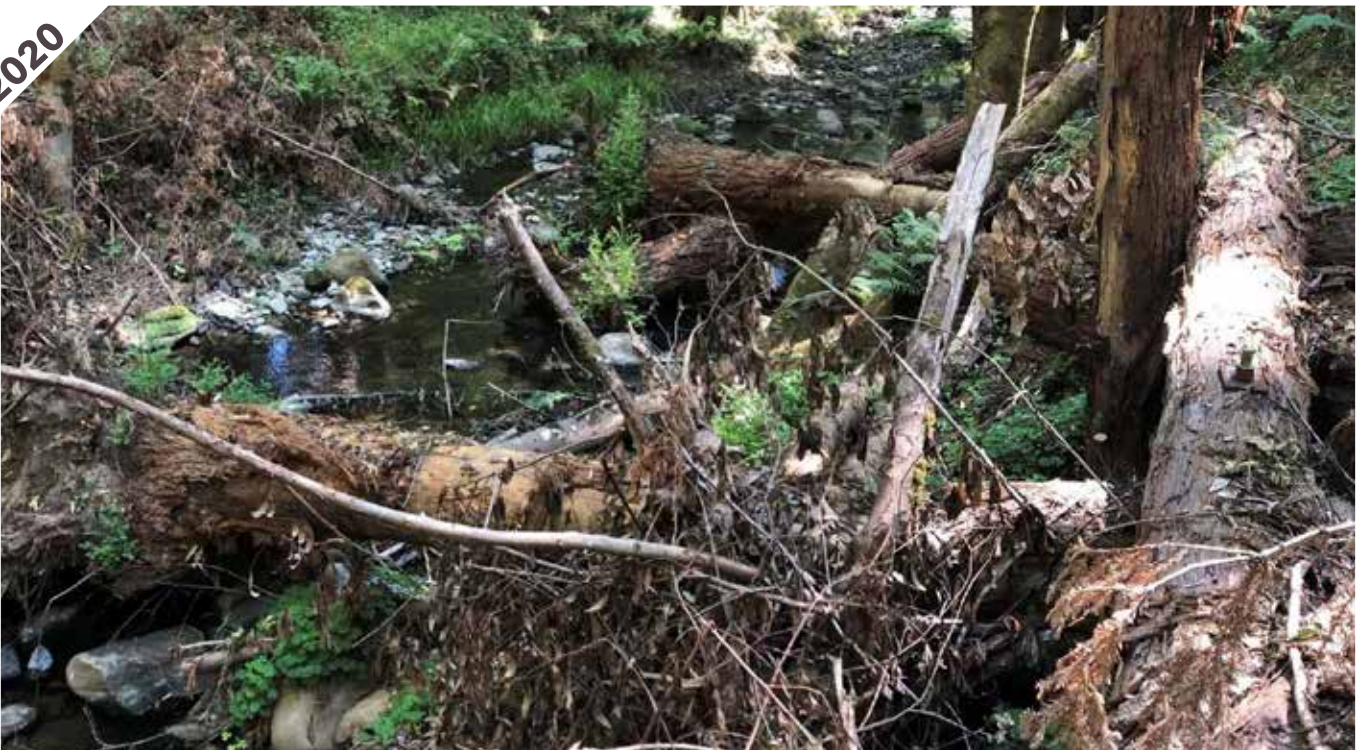
Photo point 25: Type 2. Looking upstream. Structure ultimately built slightly upstream of where pre-photo taken. Rocky bank visible in lower right of the photo. Rootwads visible, and sprouting in creek. No significant pooling present or changes in morphology.

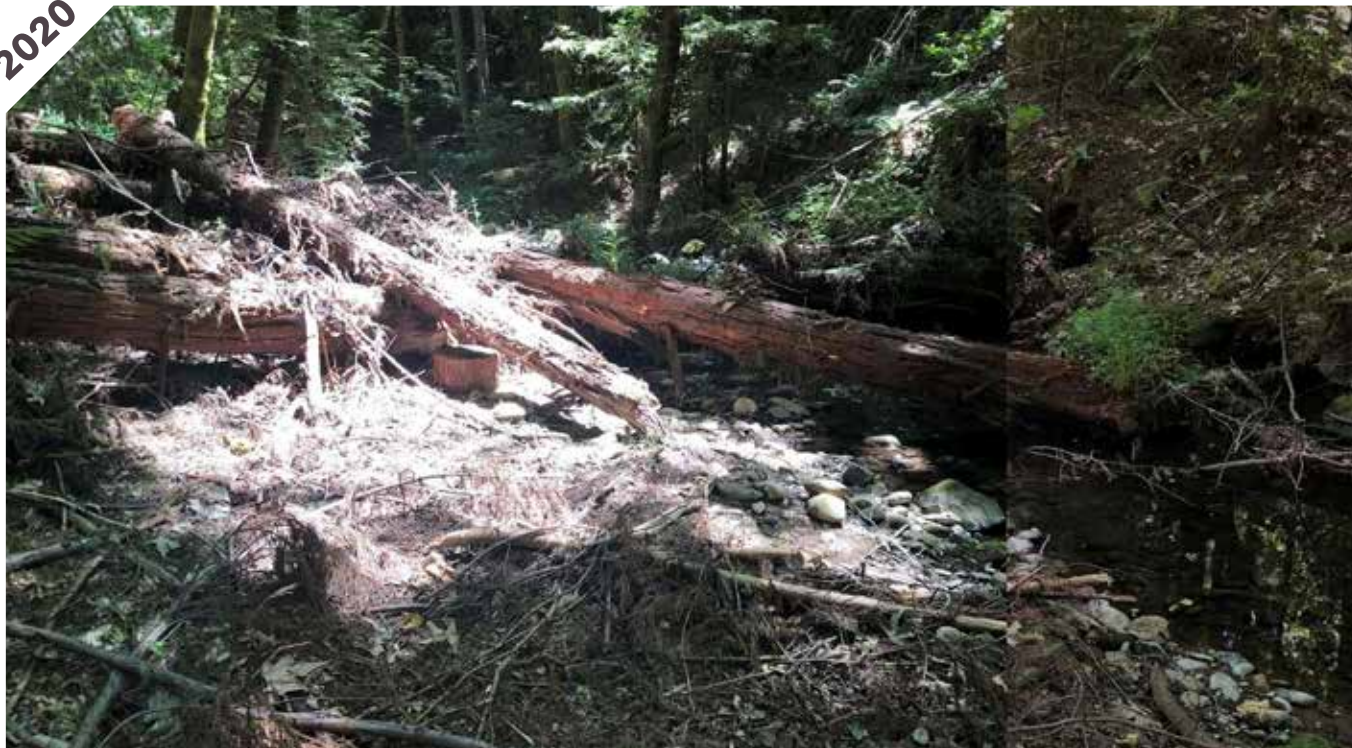
Photo point 34: Type 4. Looking upstream. Small woody debris wracking. Rootwad in creek sprouting.

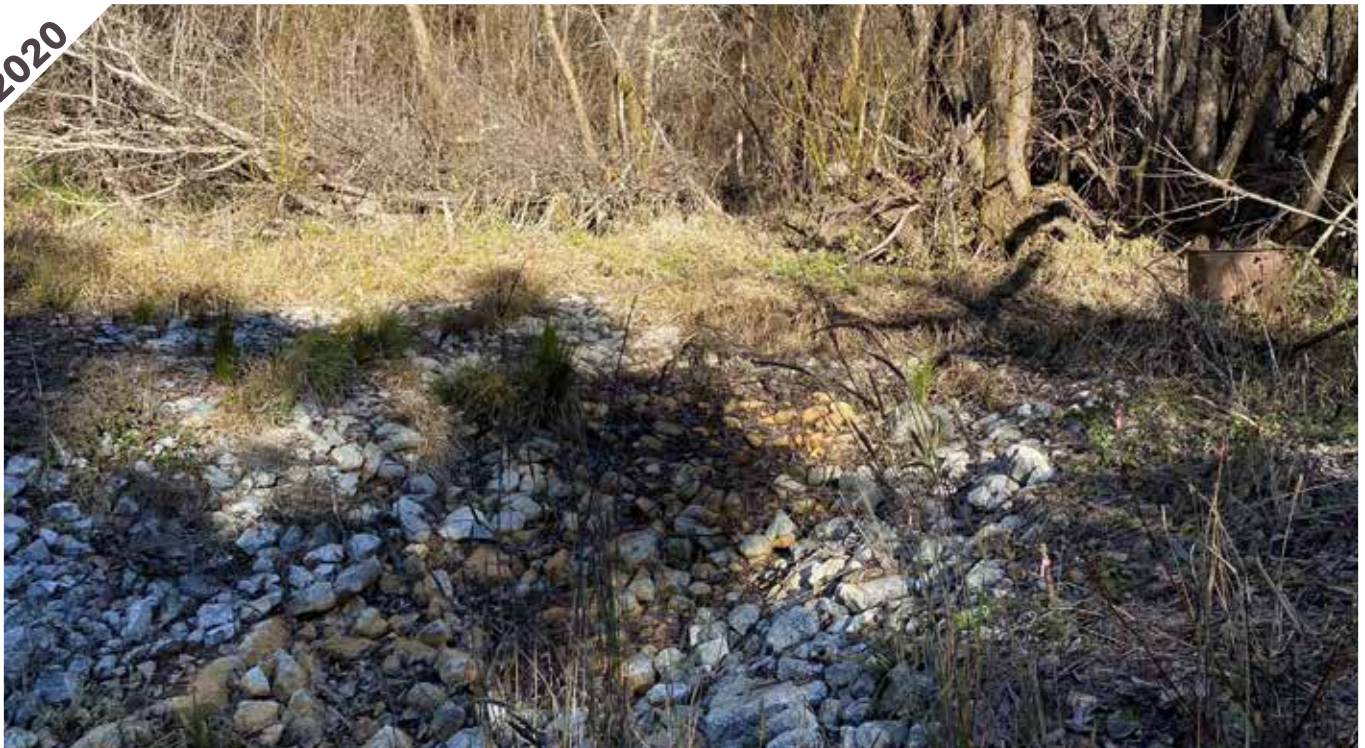
Photo point 1: Looking upstream, the rock-lined open channel that replaced the undersized culvert has become revegetated with willows and herbaceous vegetation.

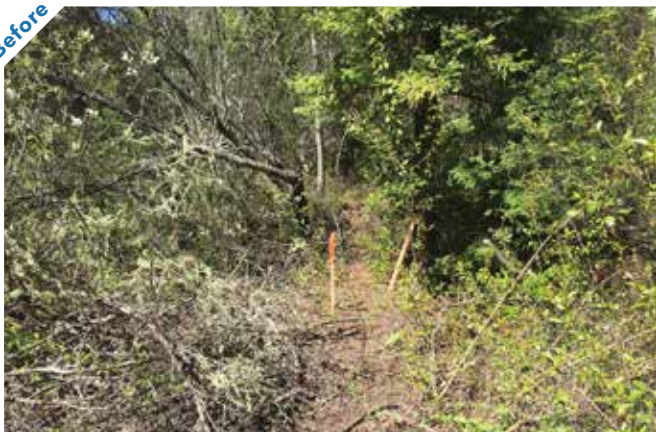
Photo point 3: Standing on and looking north across the failing embankment.

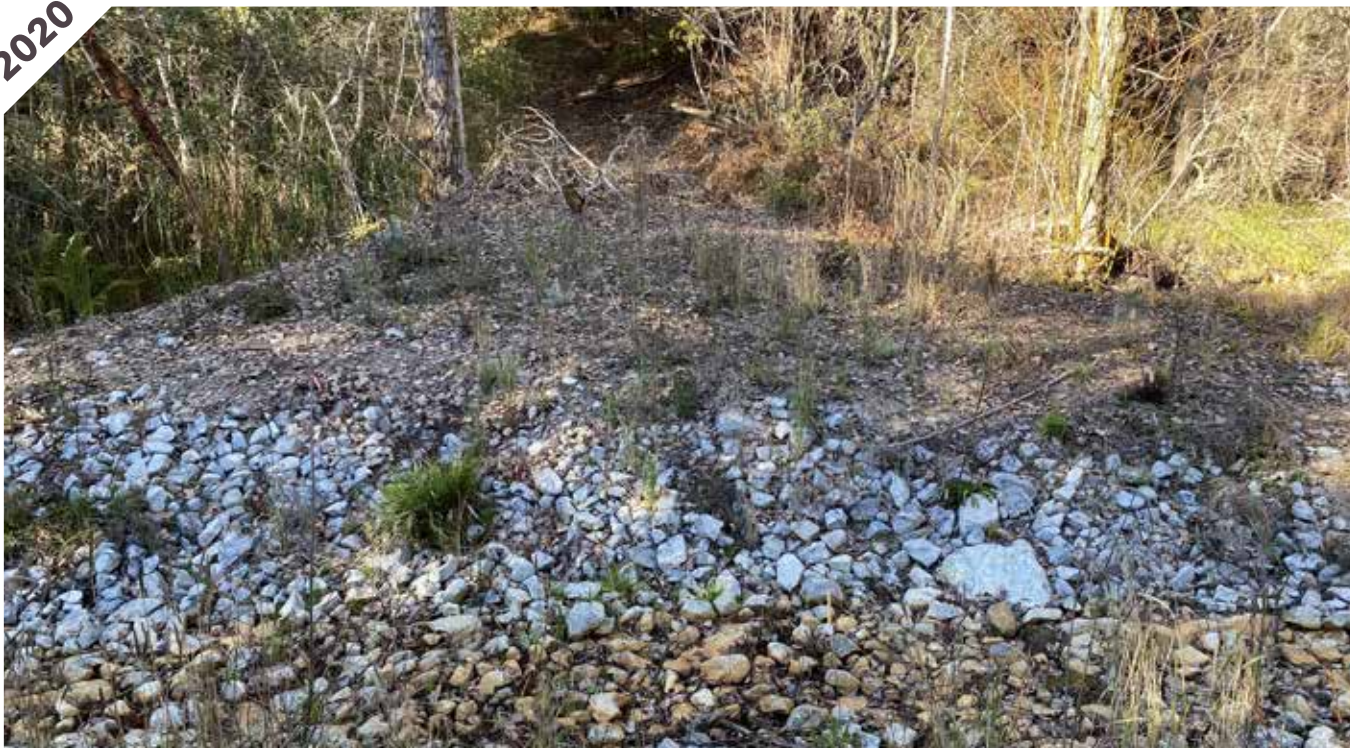
Photo point 3: Standing on the embankment and looking north, the rock lined channel is stable and the project area is becoming revegetated with willows and herbaceous vegetation.

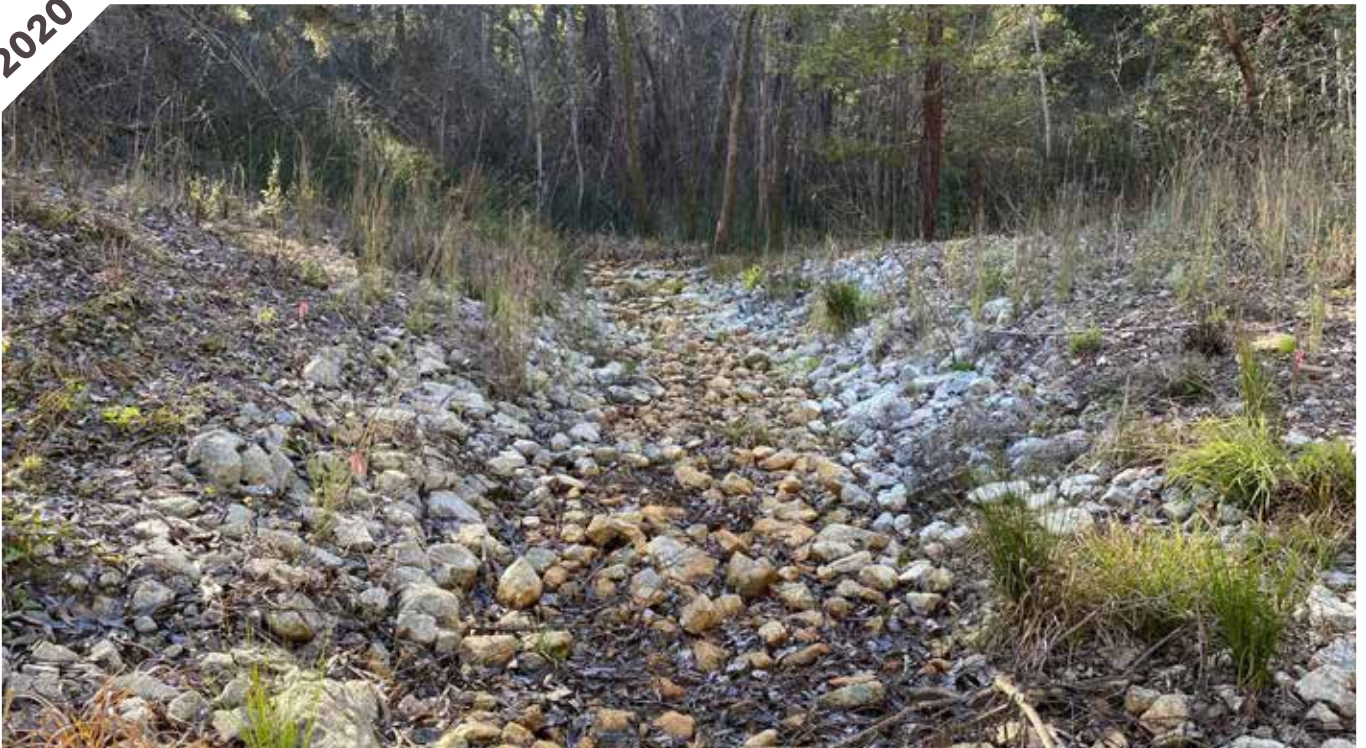
Photo point 4: Looking downstream, the rock-lined open channel that replaced the undersized culvert is becoming revegetated with willows and herbaceous vegetation.

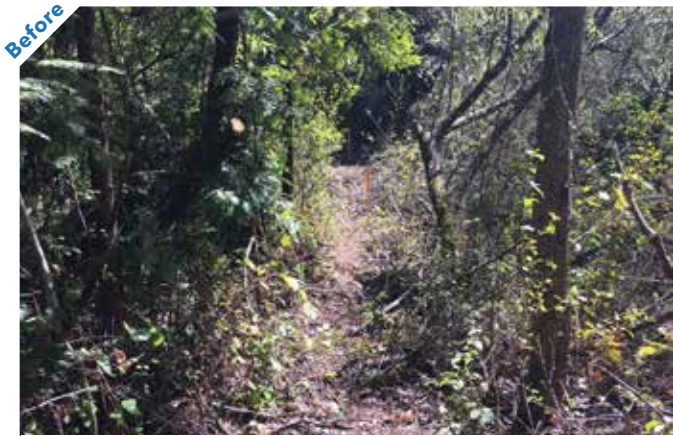
Photo point 5: Standing on and looking south across the failing embankment. The low spot/scour area is visible just before the stake on the downstream side of the embankment.

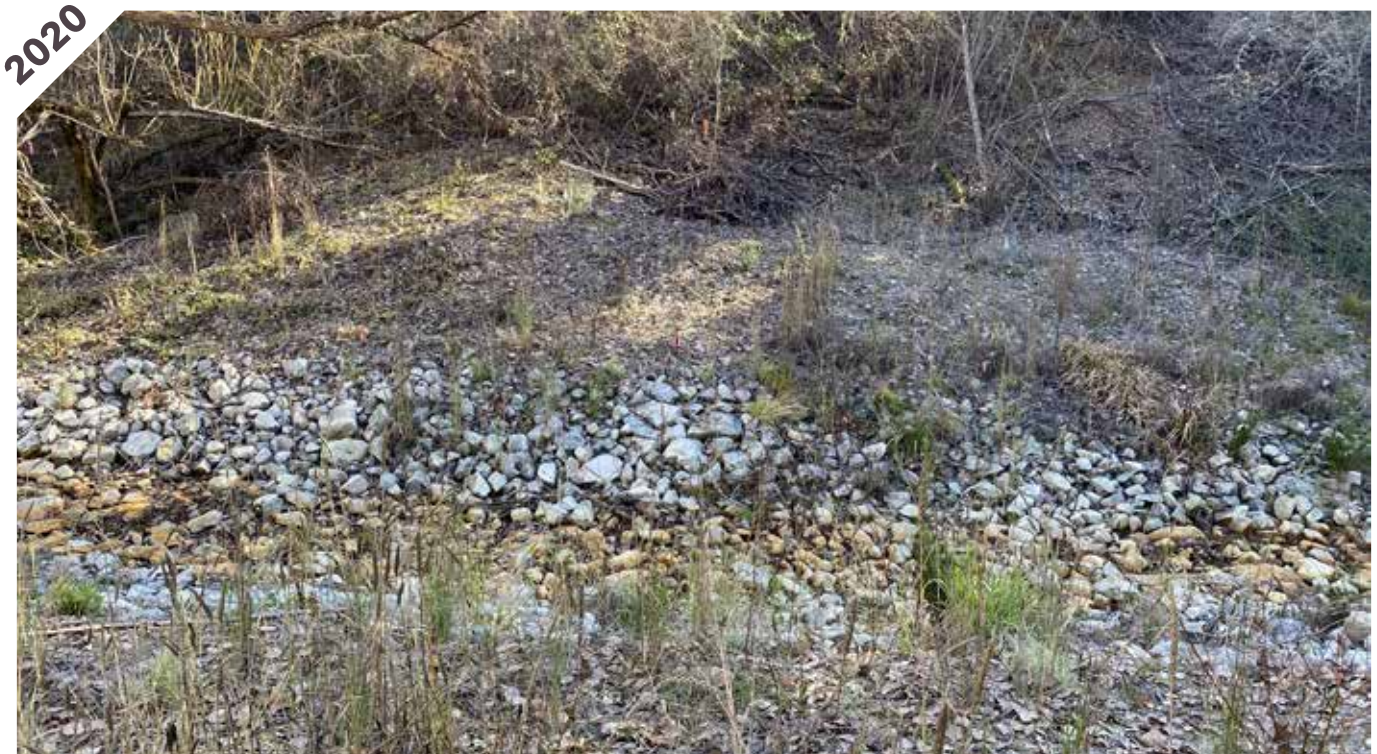
Photo point 5: Standing on the embankment and looking south. the rock lined channel is stable and the project area is becoming revegetated with willows and herbaceous vegetation.

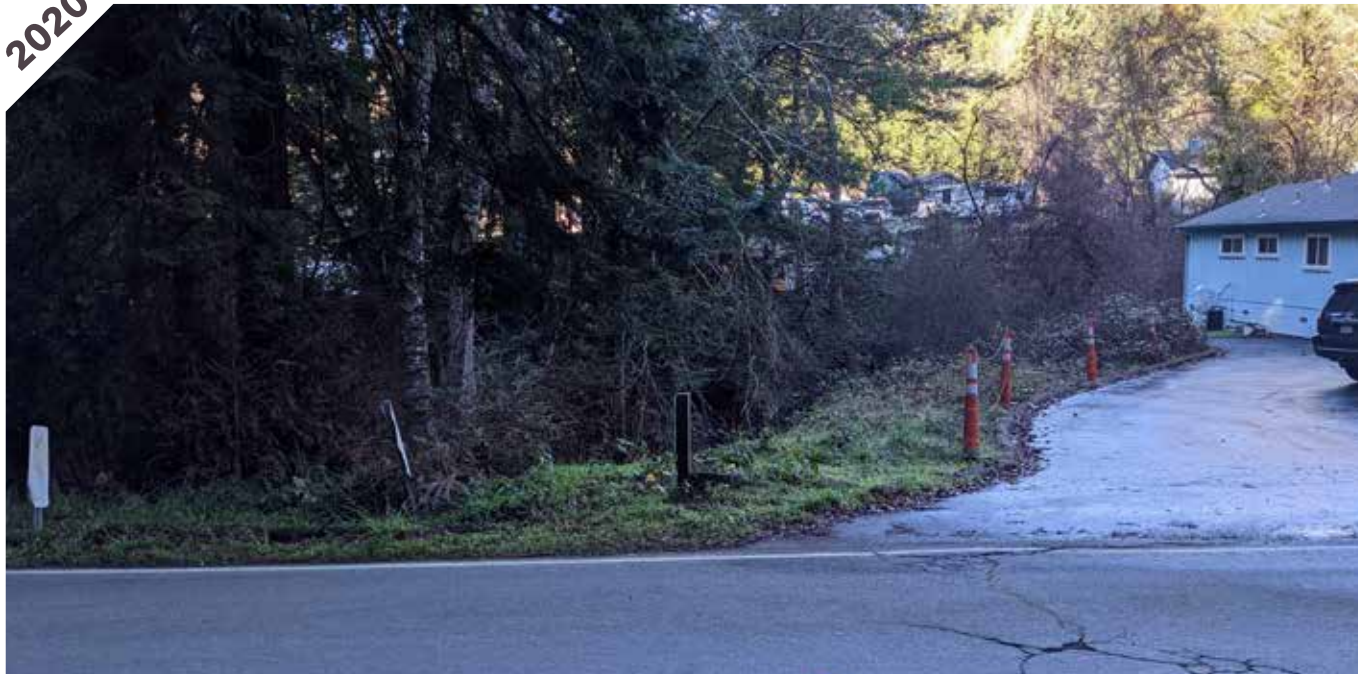
Photo point 3: The site has become well established with CA blackberry.

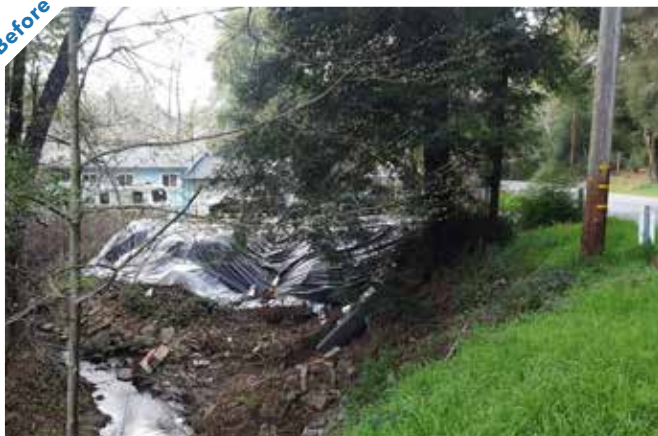
Photo point 5: Looking north. The plastic can be observed on the far bank with Branciforte Creek in the foreground.

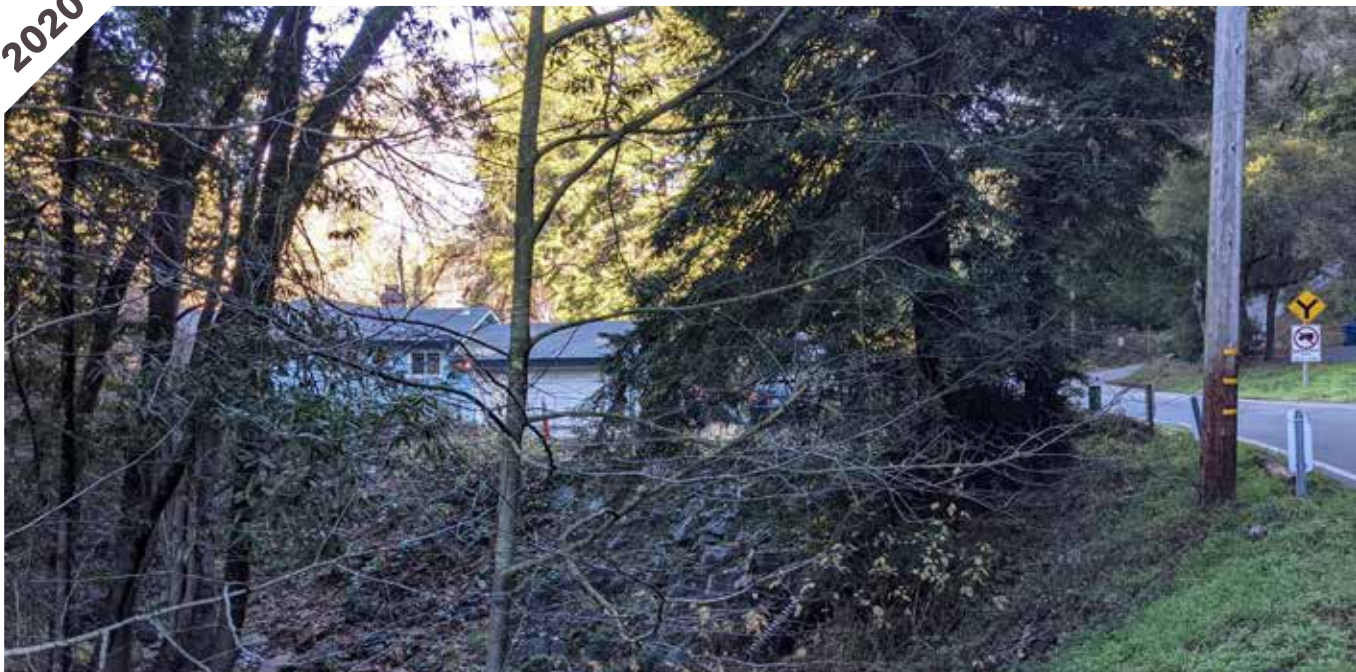
Photo point 5: The bank repaired has been repaired with the rock barely visible due to duff and native plantings.

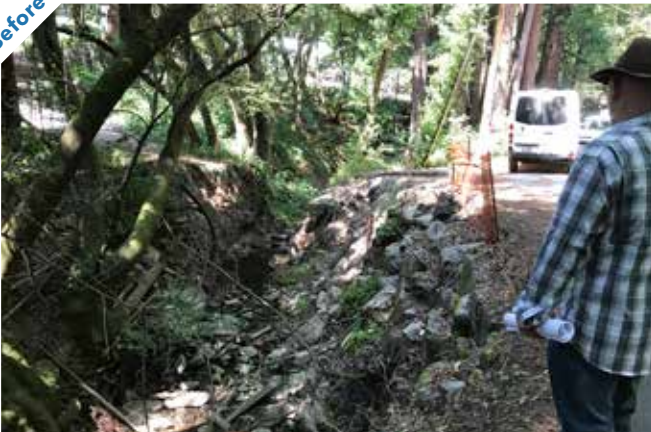
Photo point 1A: Looking upstream at the failed upper crossing from Mountain View Drive.

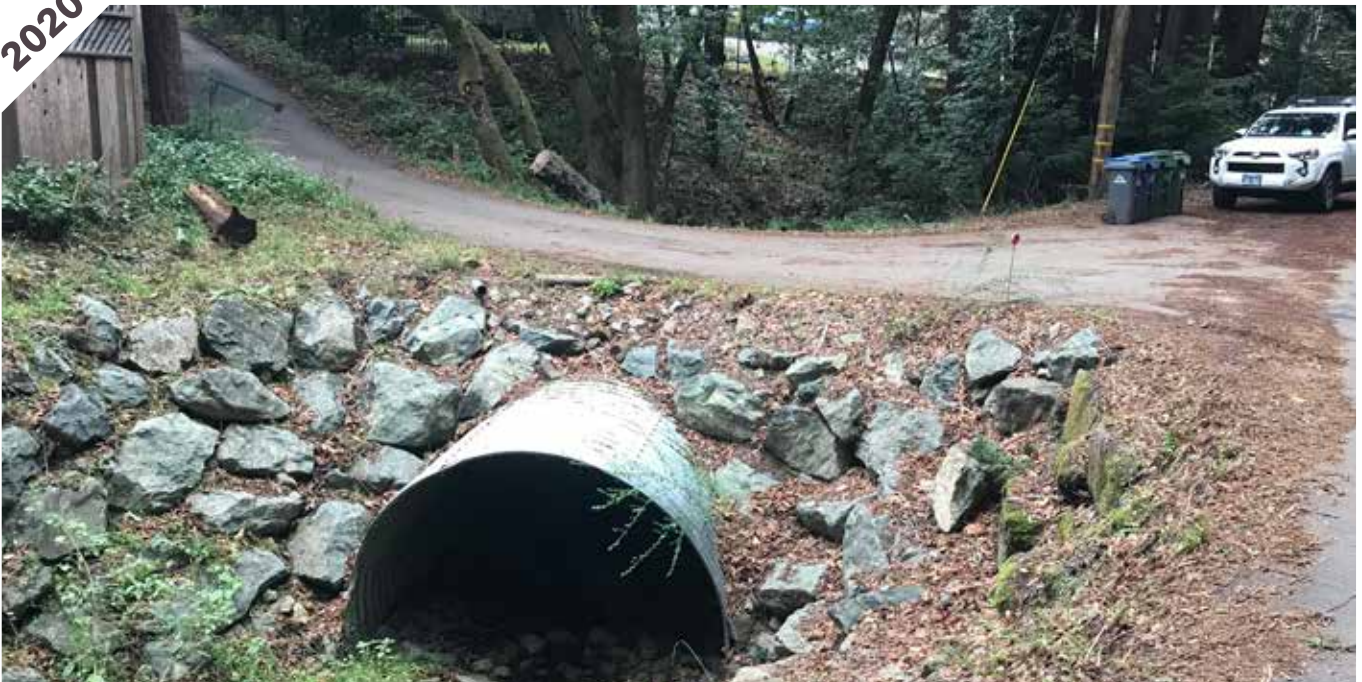
Photo point 1A: The engineered stream materials in the culvert have stayed in place and there is still no erosion present around the culvert.

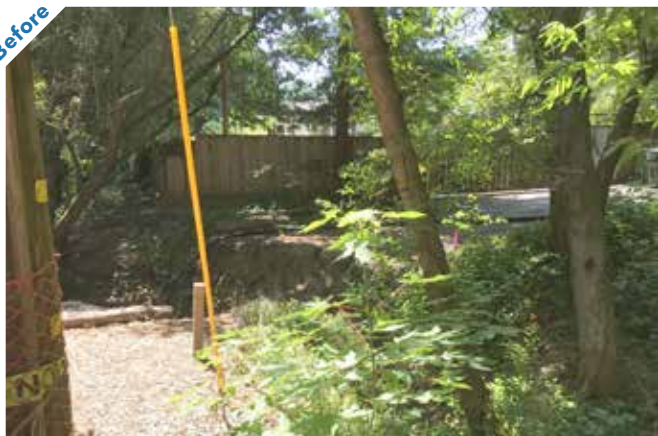
Photo point 3A: Looking downstream at the upper crossing failure.

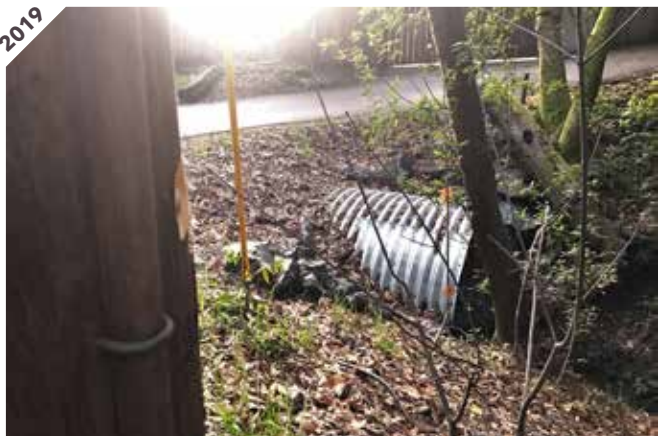
Photo point 3A: The culvert is functioning well and no erosion is present. Note the tree that fell on the right that was partially cut to unblock the road but the trunk was left in place.

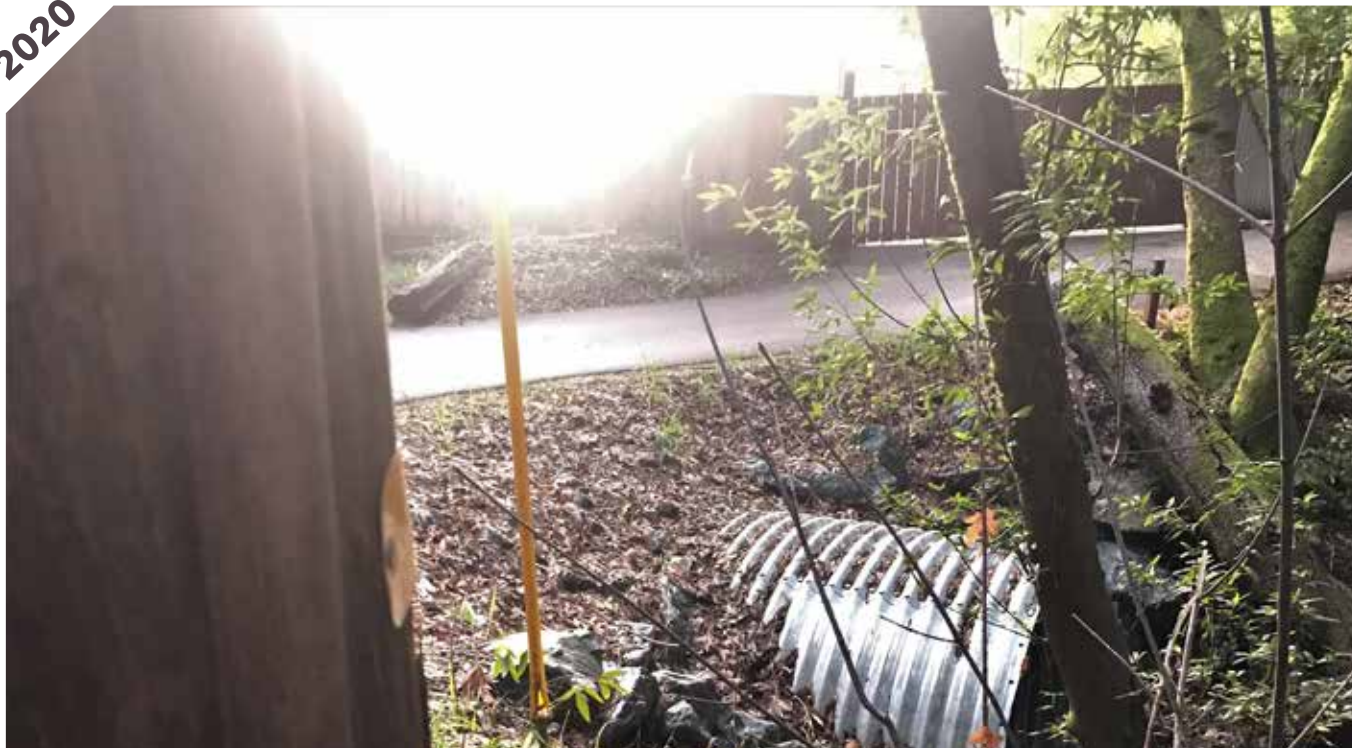
Photo point 3A: Looking downstream. The culvert is functioning well and no erosion is present.

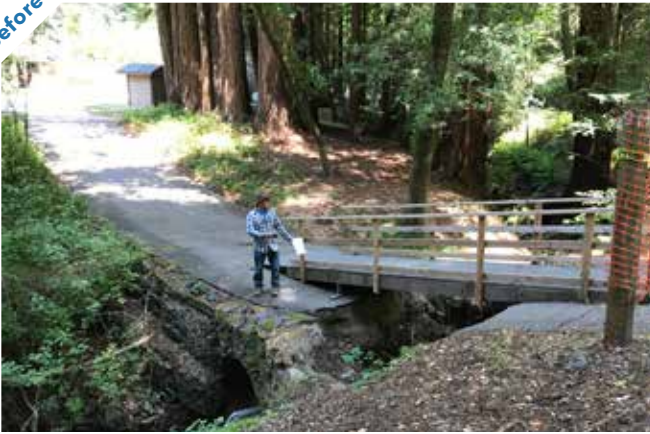
Photo point 1B: Looking upstream at the lower failed crossing.

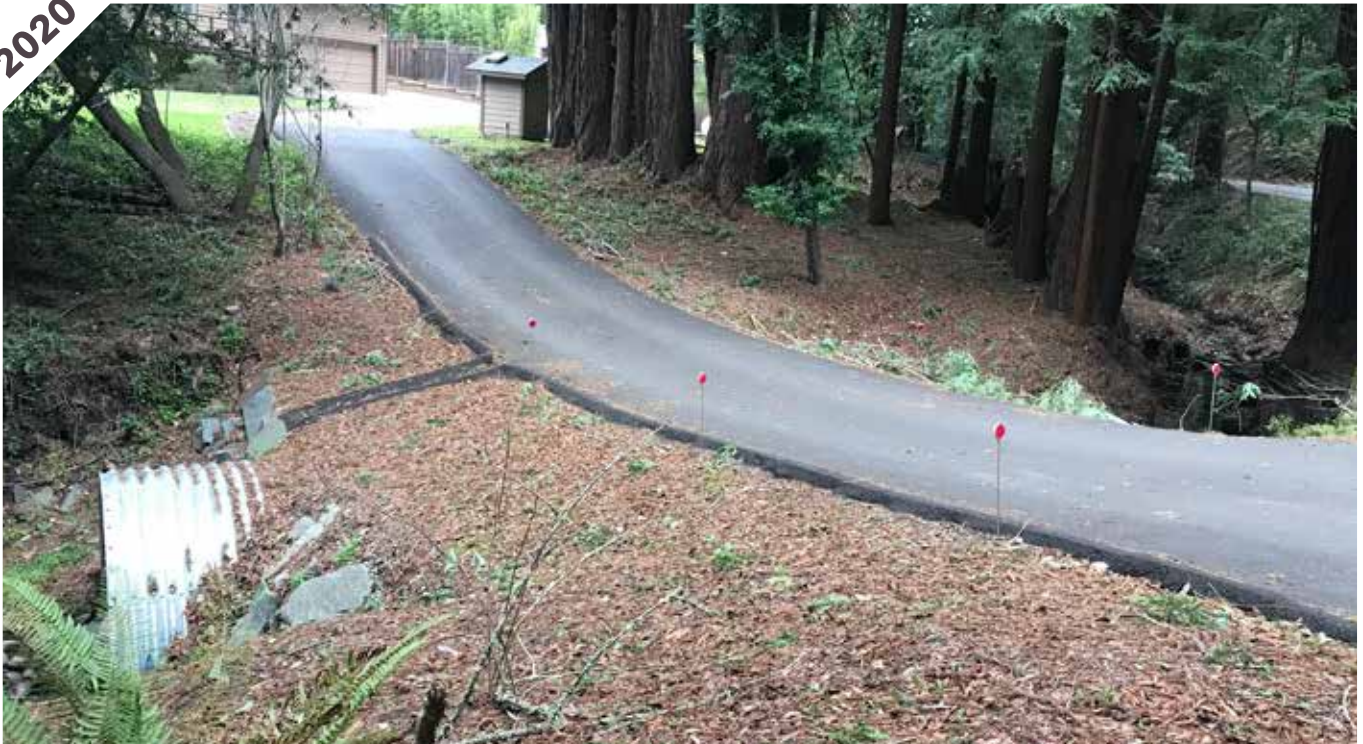
Photo point 1B: Looking upstream. Banks are stable and the culvert is functioning as intended.

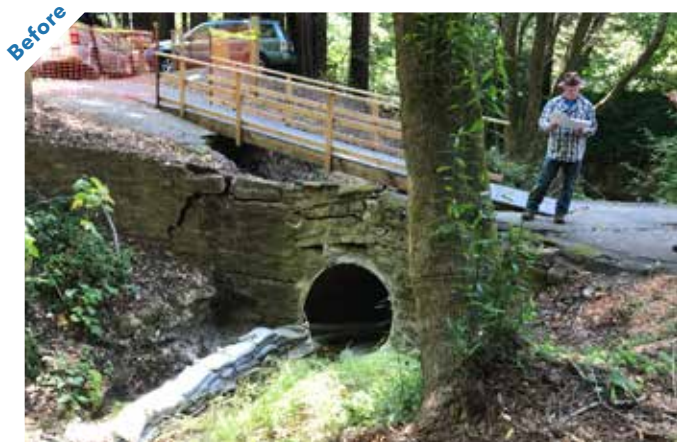
Photo point 3B: Looking downstream at the failed crossing.

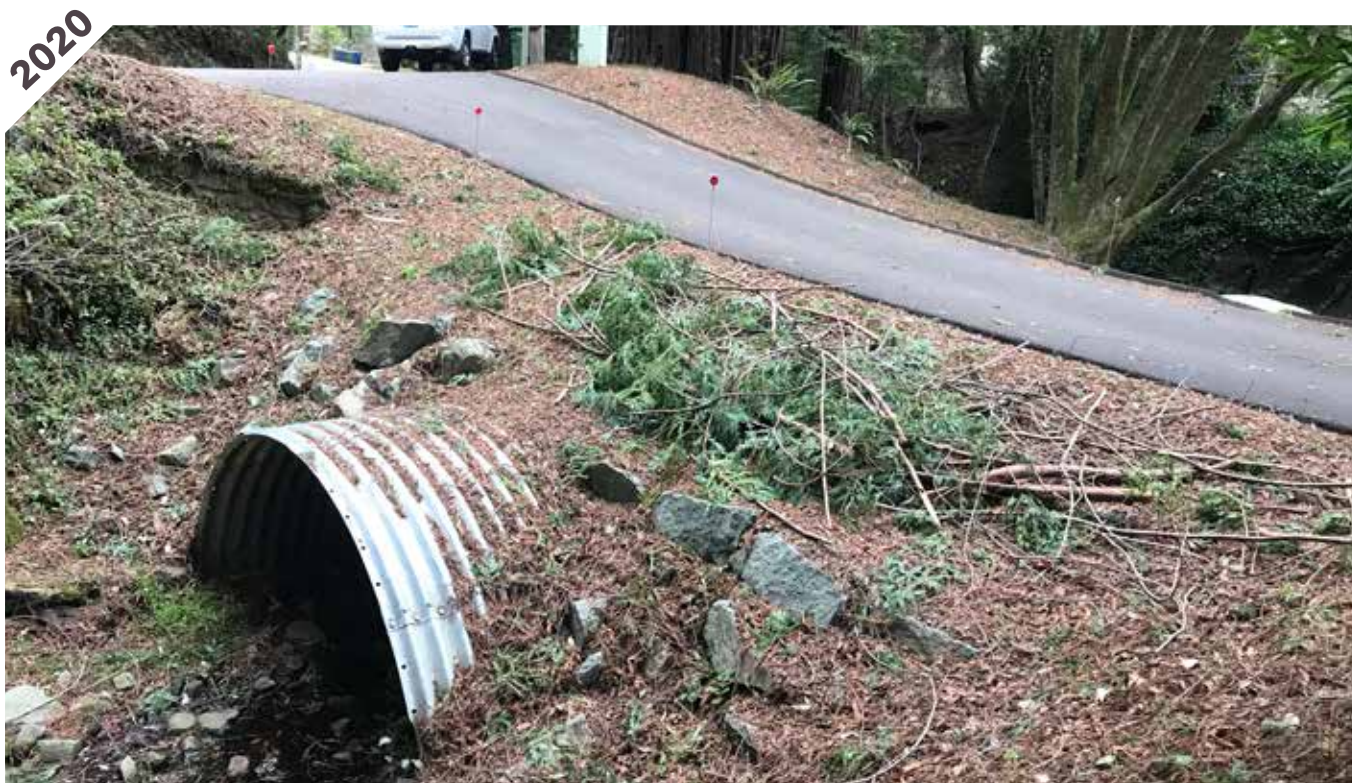
Photo point 3B: There is still no erosion present at the culvert inlet. Banks are stable with a good cover of native duff.

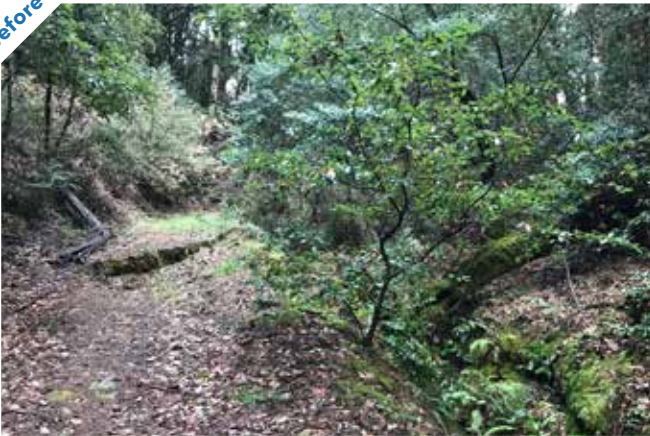
Photo point 5: Looking up the old access road that was decommissioned. Notice the road failure from concentrated runoff and a fallen tree.

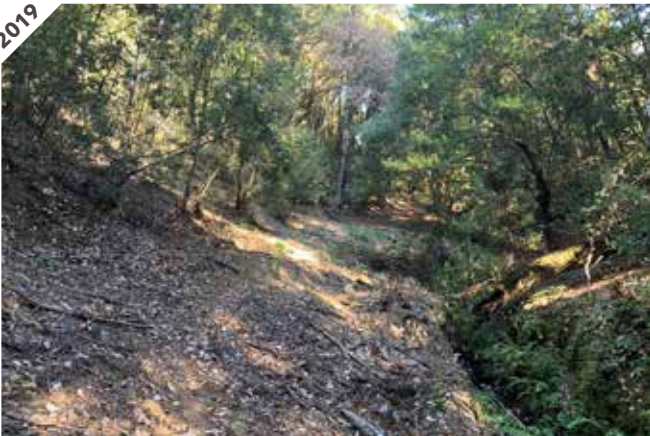
The decommissioned road has done very well, with ample native recruitment in the footprint and drainage working as anticipated. As noted last year, the site of the original scarp failure where a natural seep appeared to create some slumping has not changed, and as such has not needed additional management at this time. The landowner will continue to monitor the slip and implement an adaptive management plan if necessary.

Photo point 5: Looking north at scarp failure. There is some slumping due to a natural seep. Landowner is monitoring.

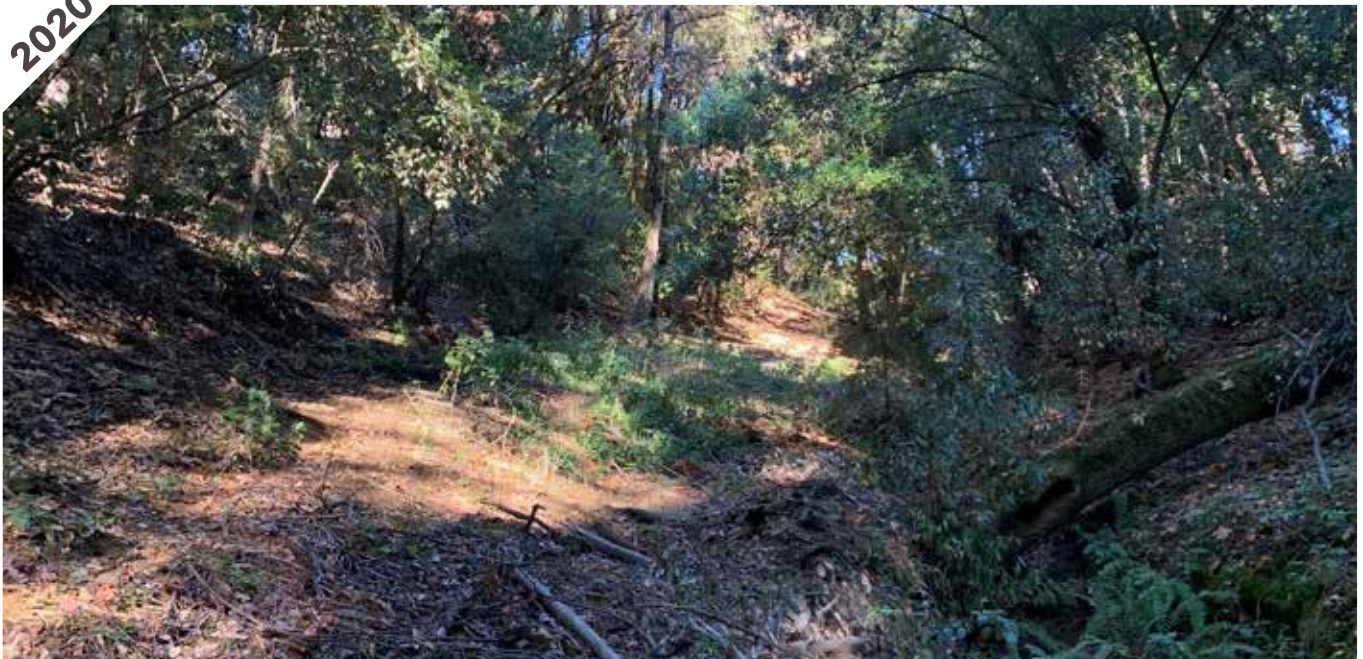
Photo point 5: Looking north at scarp failure. The natural slumping due to a natural seep has stabilized and the landowner is monitoring.

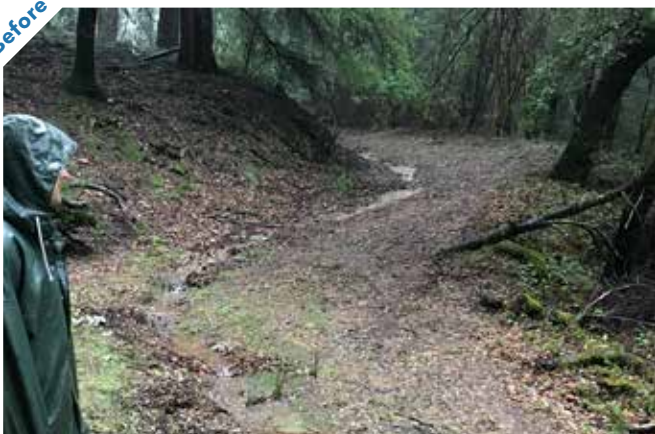
Photo point 9: Looking uphill long the upland portion of the road. The road is insloped the whole stretch above this point with no ditch relief thus contributing to runoff created erosion,

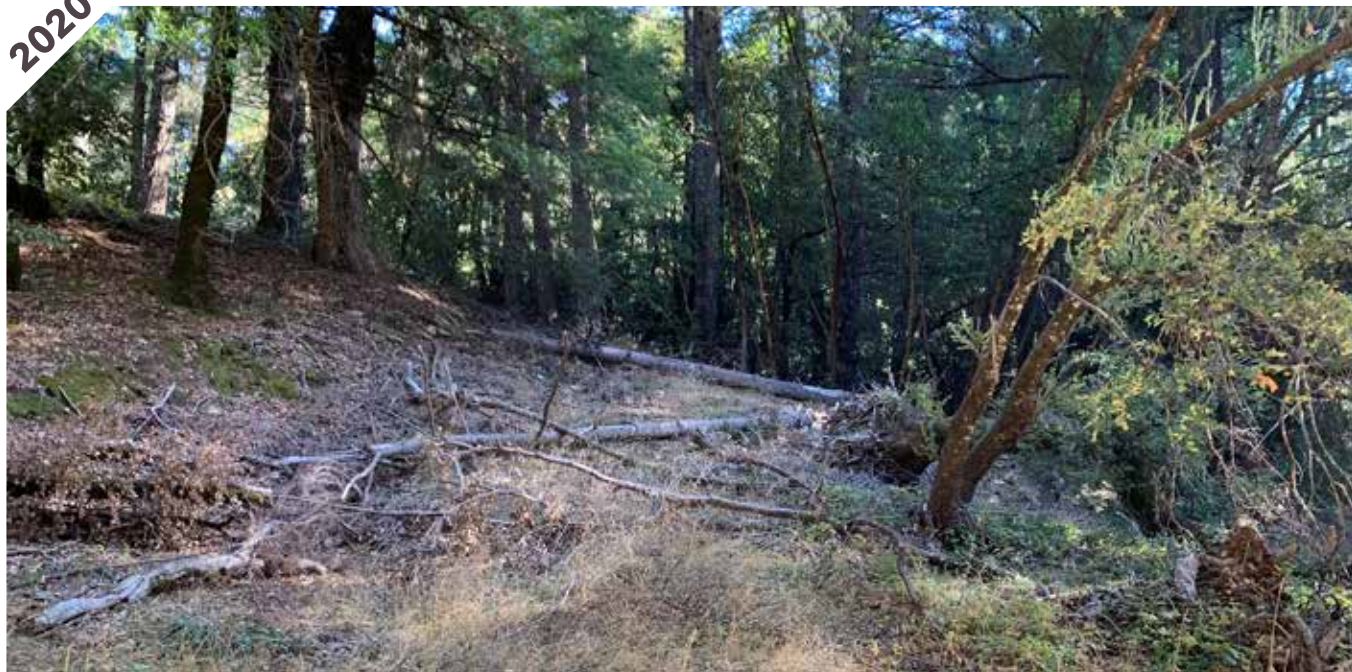
Photo point 9. Decommission is effectively reducing runoff and sediment

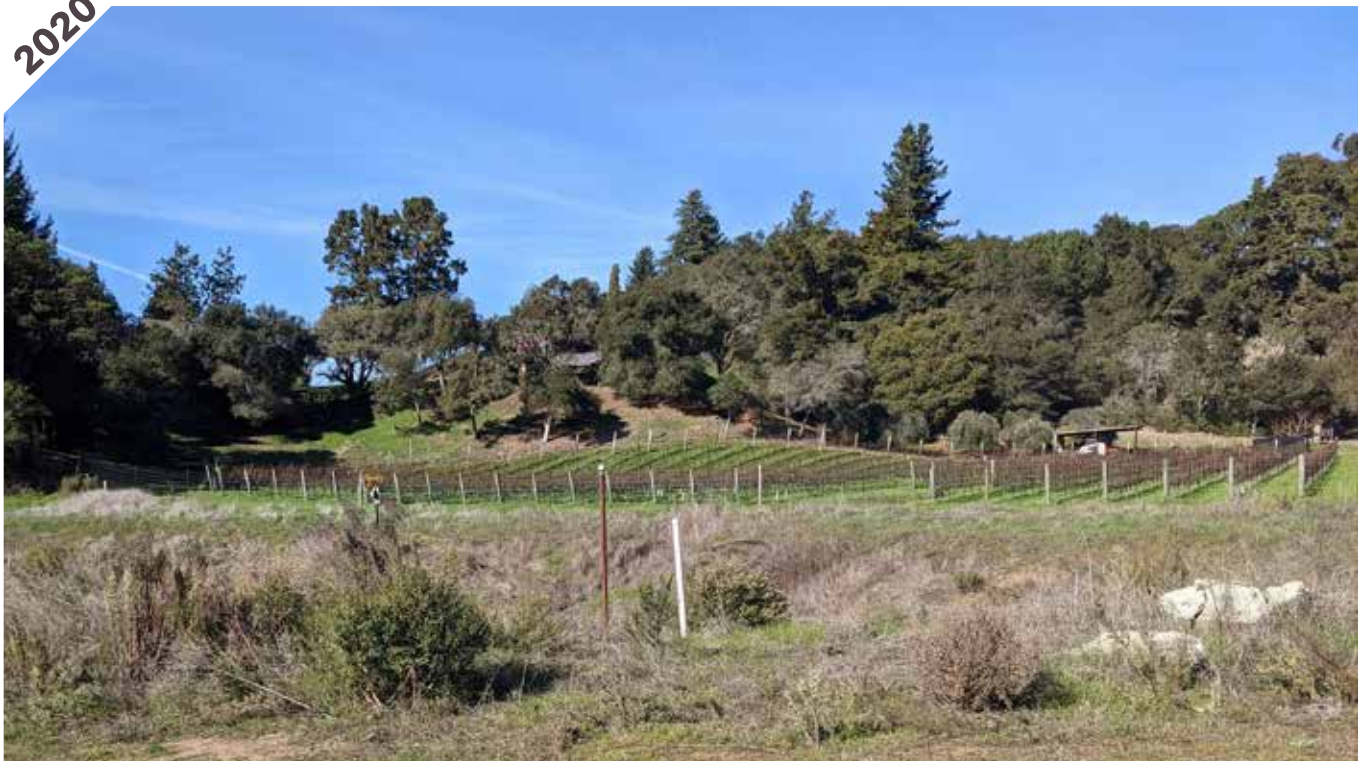
Photo point 5: Vegetation is slow to become established on this access road due to continued use. However, the site is flat without concentrated flow and vegetation has become well established surrounding this area.

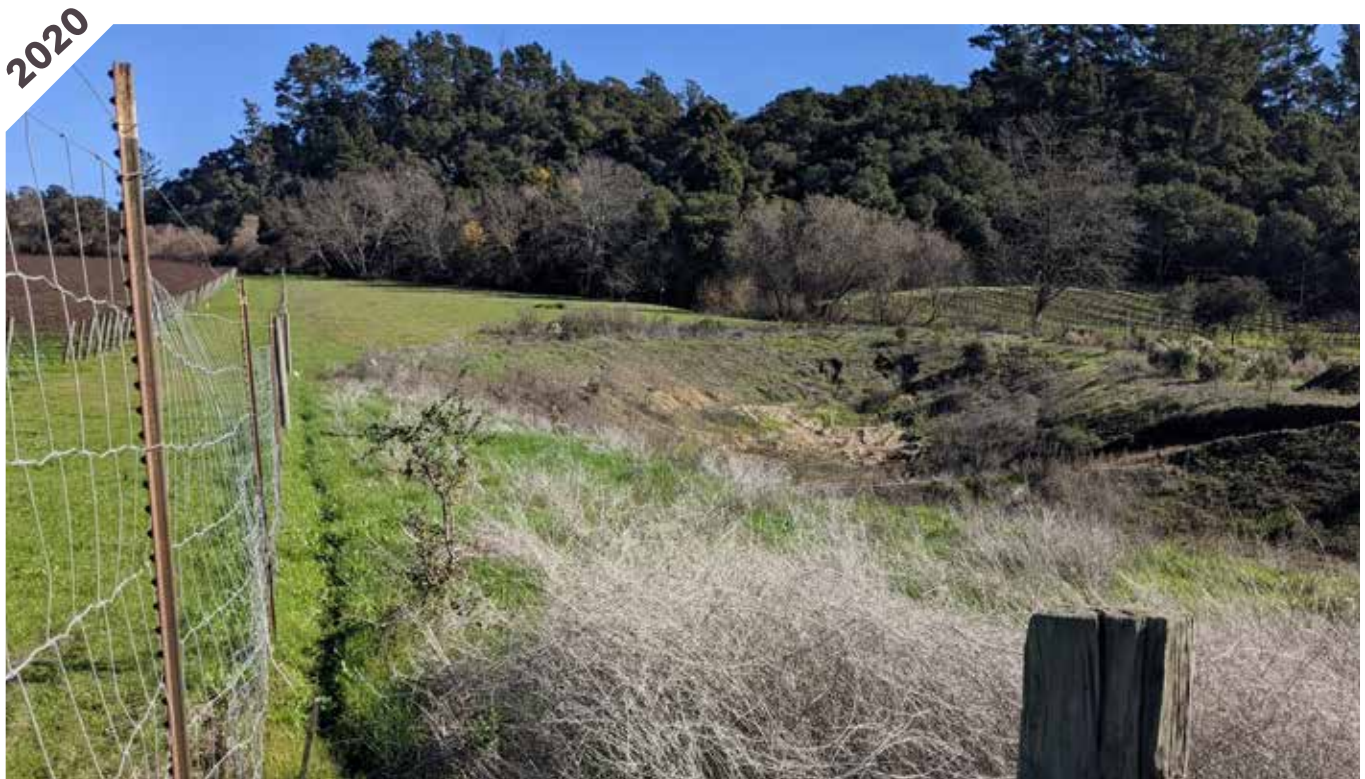
Photo point 7: Looking northeast, accumulated sediment has been removed from the basin and the weir repaired. Vegetation has become well established on the slopes.
