Santa Cruz Countywide

# PARTNERS IN RESTORATION PERMIT COORDINATION PROGRAM

## 2020 ANNUAL REPORT

Prepared by the  
Resource Conservation District of Santa Cruz County

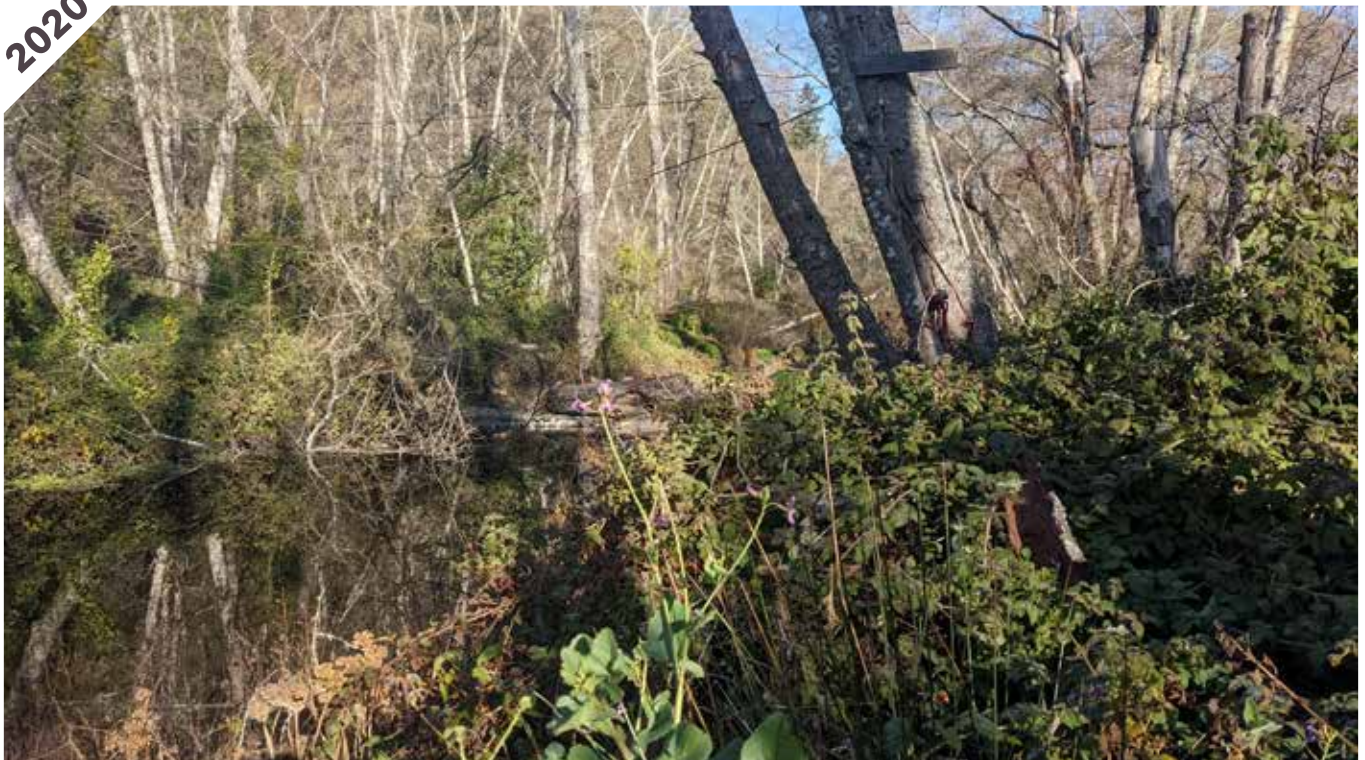
Photo point 2: The log wood structure, comprised of alder, redwood and eucalyptus can be seen to the right of the photo, is continuing to catch wood and cause scour benefitting habitat.

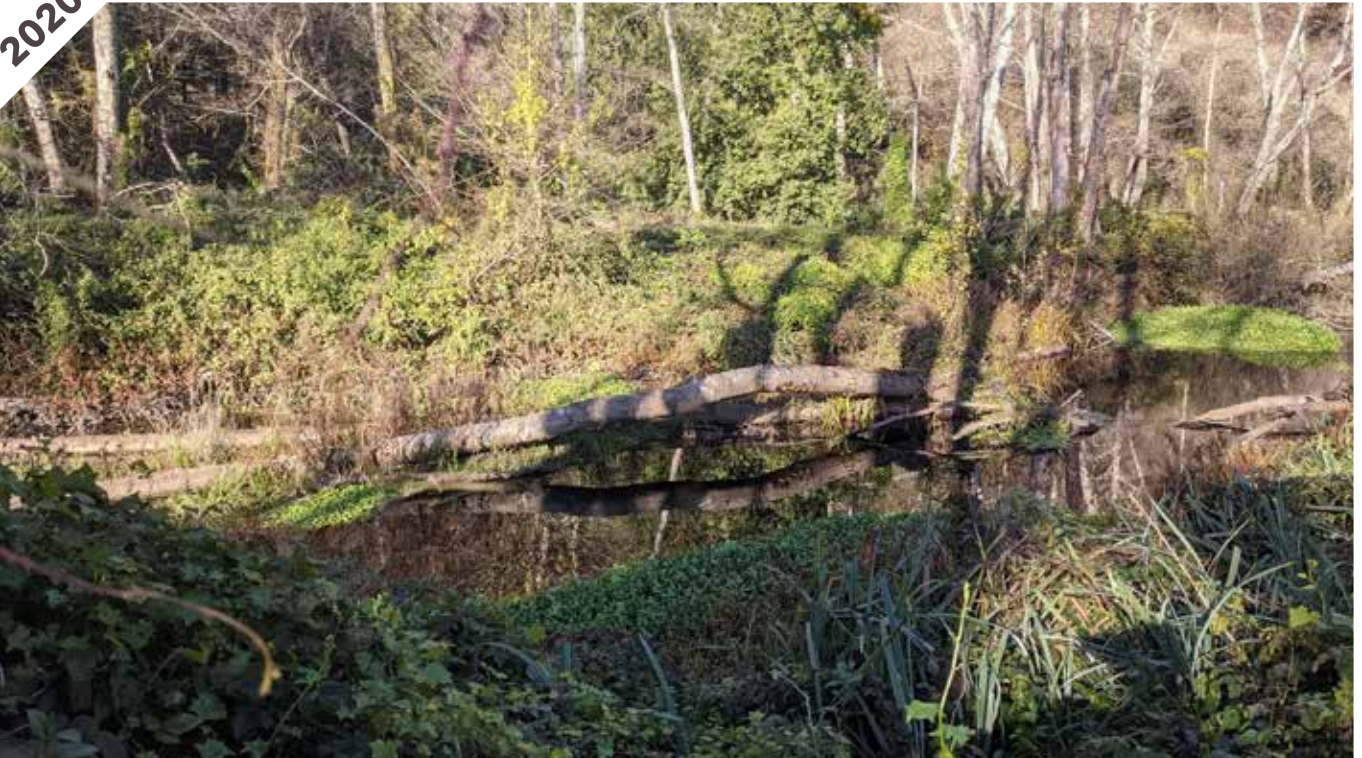
Photo point 4: The log wood structure continues to increase in-stream habitat complexity.

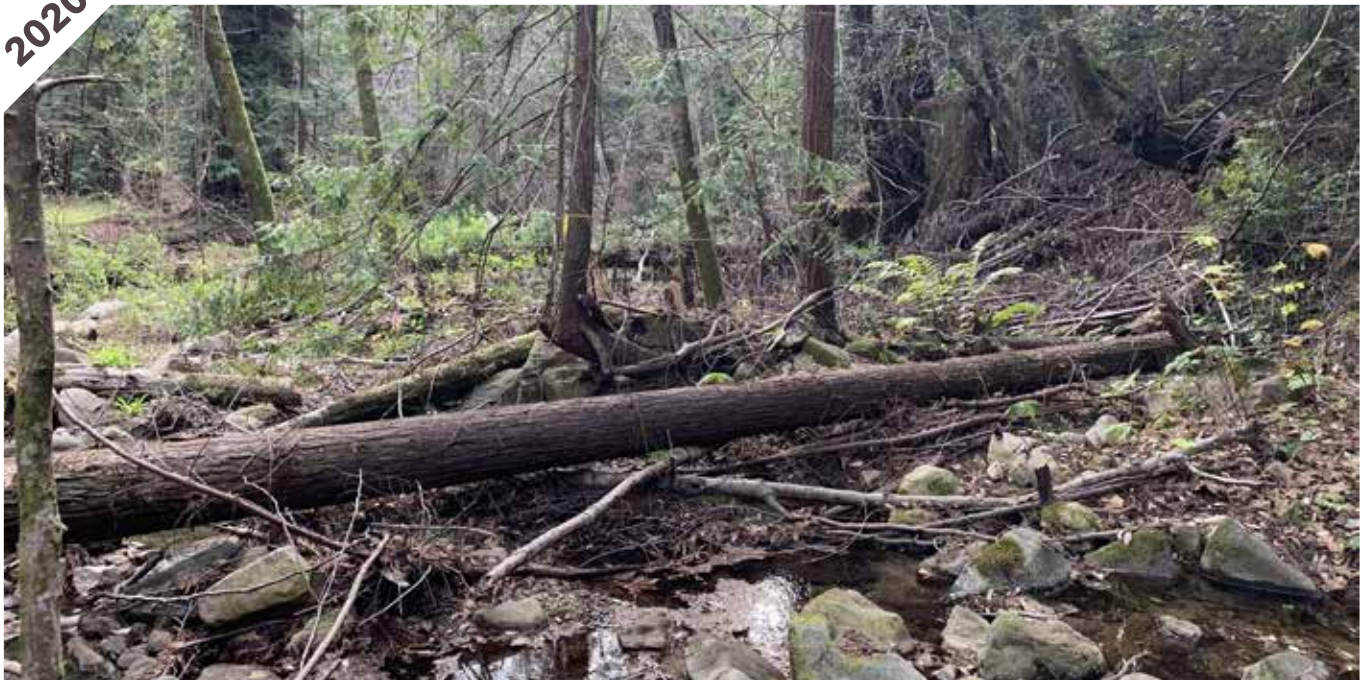
Photo point 2: After project implementation, large wood can be seen spanning the channel. While minimal additional wood accumulation has occurred here, numerous sites have developed sandbars and/or gravel accumulations, and many have also formed pools in the vicinity of the structure.

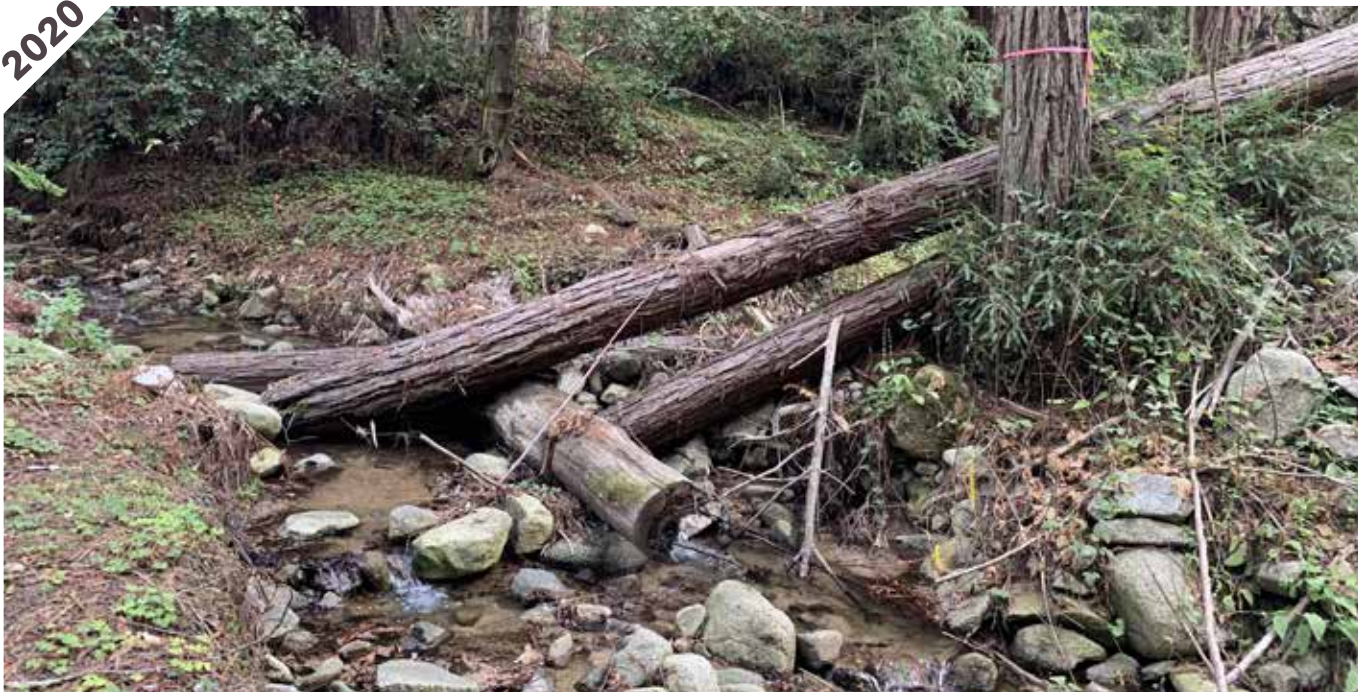
Photo point 5: The large wood and notch in the side channel has successfully diverted flow onto the floodplain, which has created a seasonal braided channel that runs roughly 300-400 feet downstream through the floodplain before rejoining San Vicente Creek.

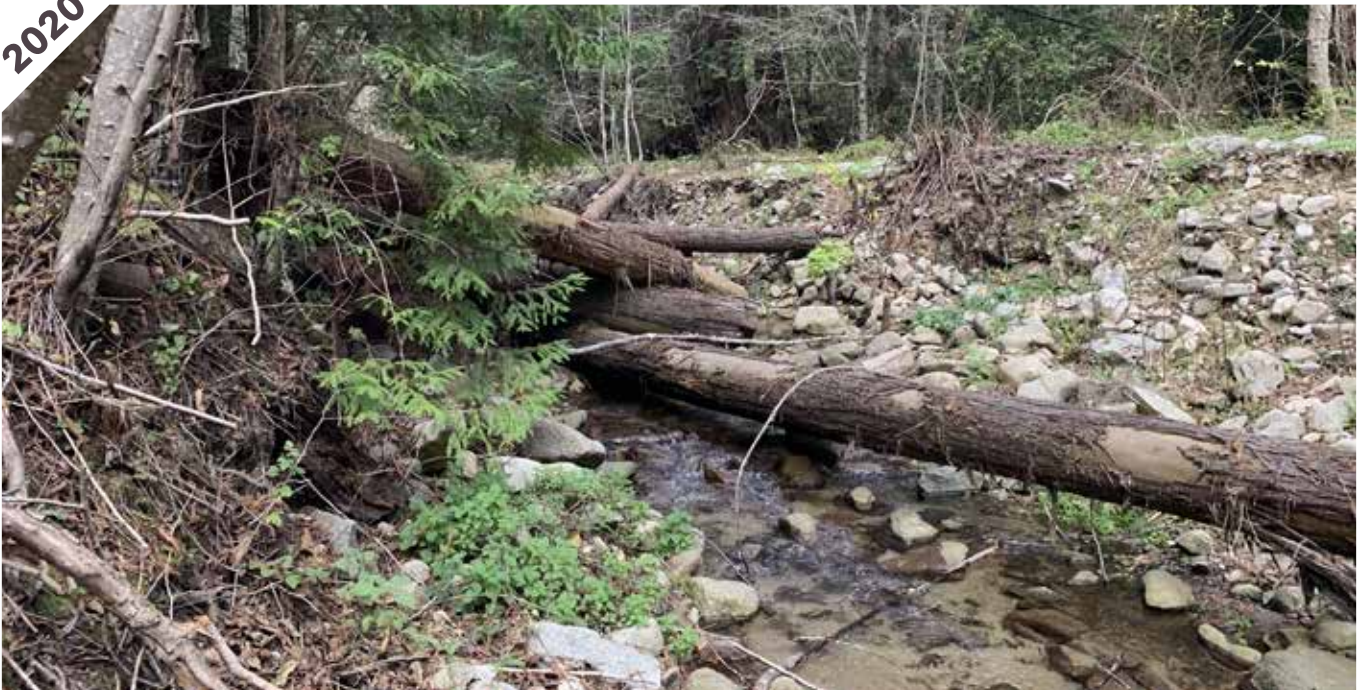
Photo point 5D: Large wood, placed just upstream of the confluence of San Vicente and Mill Creeks has racked up other woody debris, further amplifying its impact and creating additional habitat.

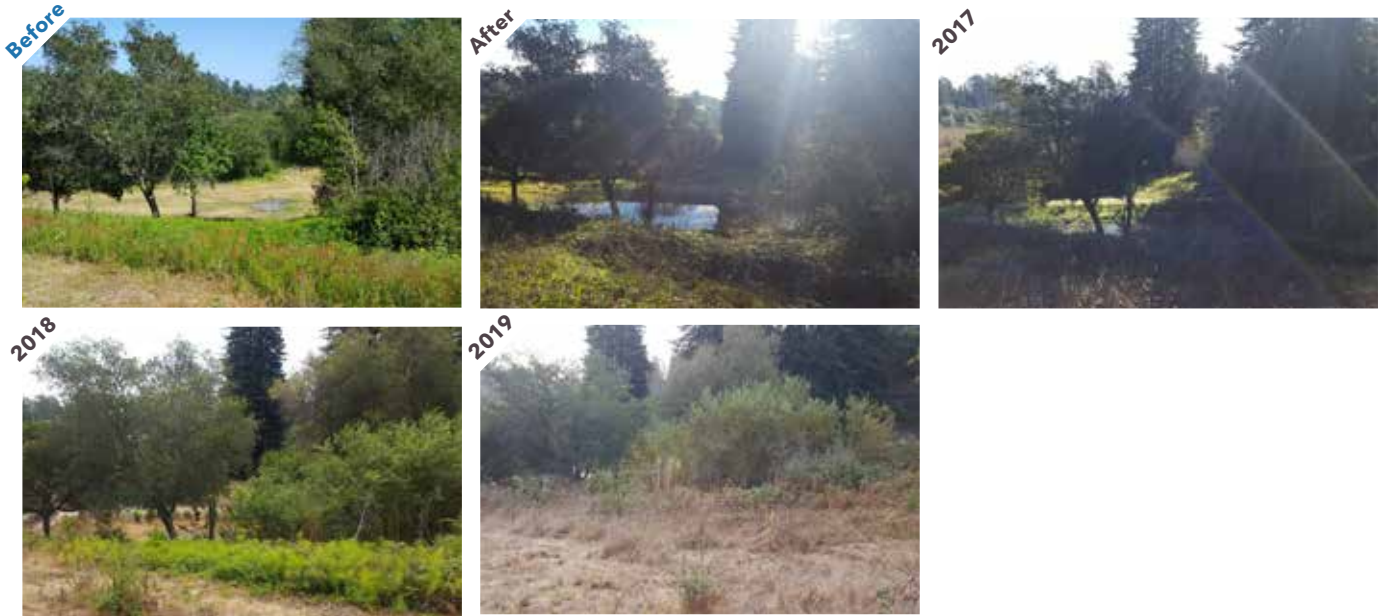
Photo point 1: In the before photo, the existing wetland habitat can be seen in the foreground. The habitat to be enhanced is in the background. The after photo shows the approximately 0.15 acres that were excavated to retain water and extend the inundation period to support amphibian breeding. In 2017, the enhanced wetland was providing for tree frogs, ducks, and other wildlife. In 2018, the enhanced wetland dried in May this year. Additional clay was applied to the pond to reduce leakage and increase the hydroperiod for amphibian breeding. In 2019 more clay was added to reduce leakage and reach the intended hydroperiod.

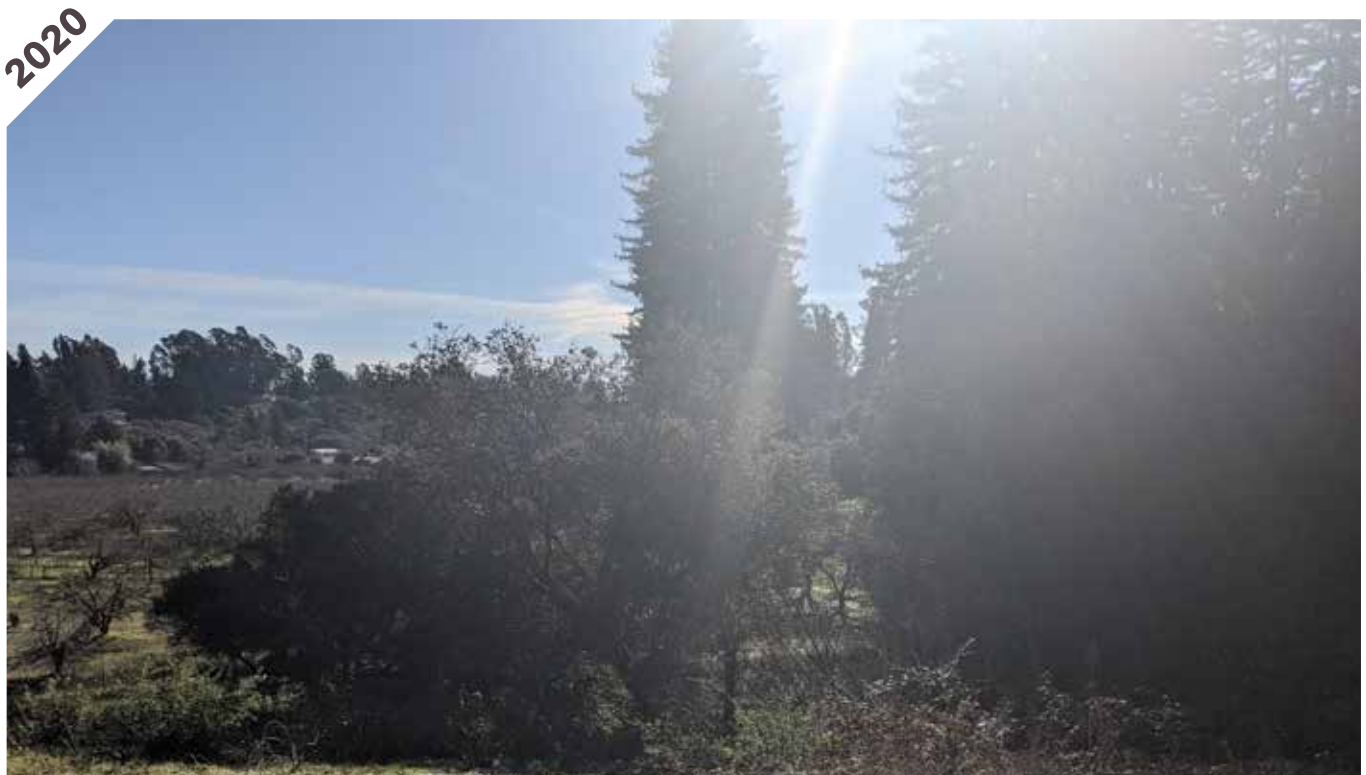
**Mitigation I. (E)** Vegetation within the wetland has achieved a success criterion of 90%. The hydroperiod and vegetation will continue to be monitored to ensure successful establishment and function. Adaptive management measures will be employed in 2022.

Photo point 1: The enhanced wetland does not currently have the intended hydroperiod. The site continues to be monitored.

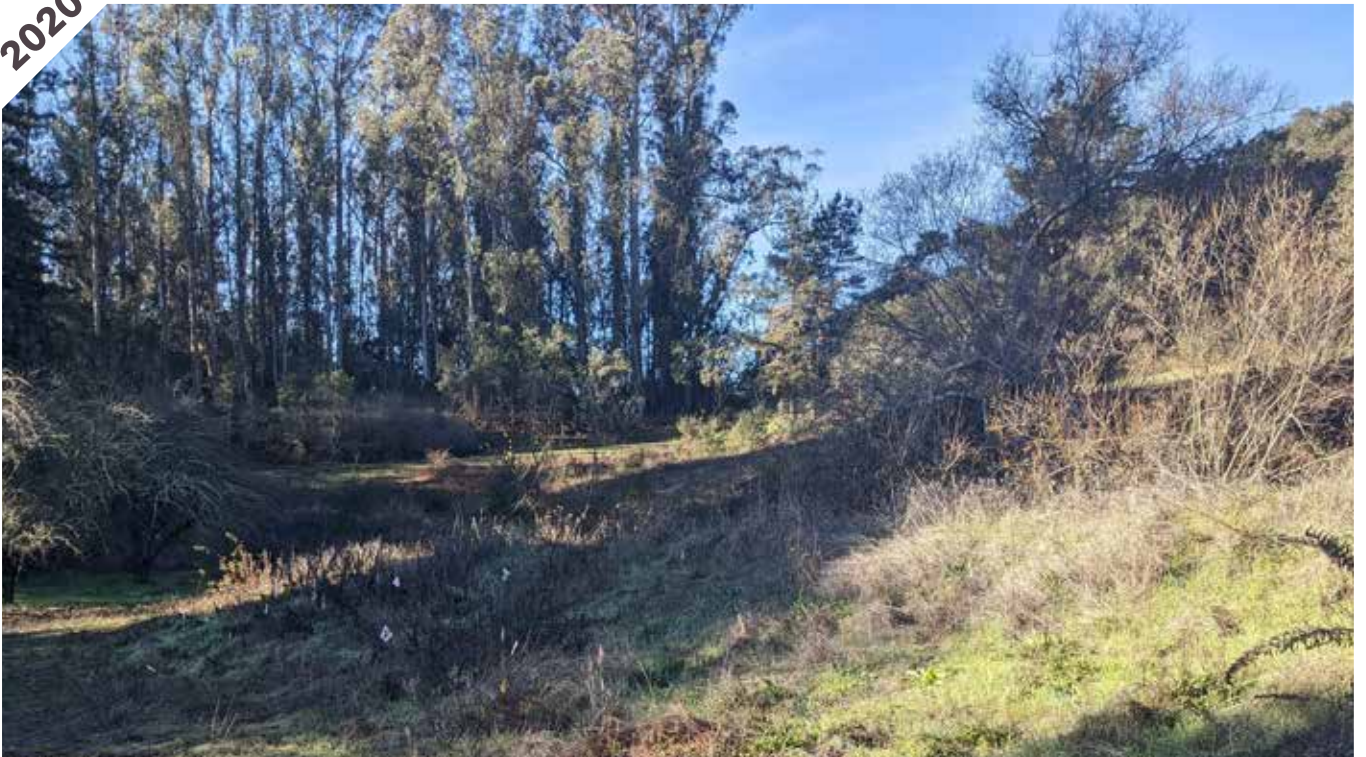
Photo point 4: The embankment is well vegetated and native vegetation, such as mugwort and willow, is visible.

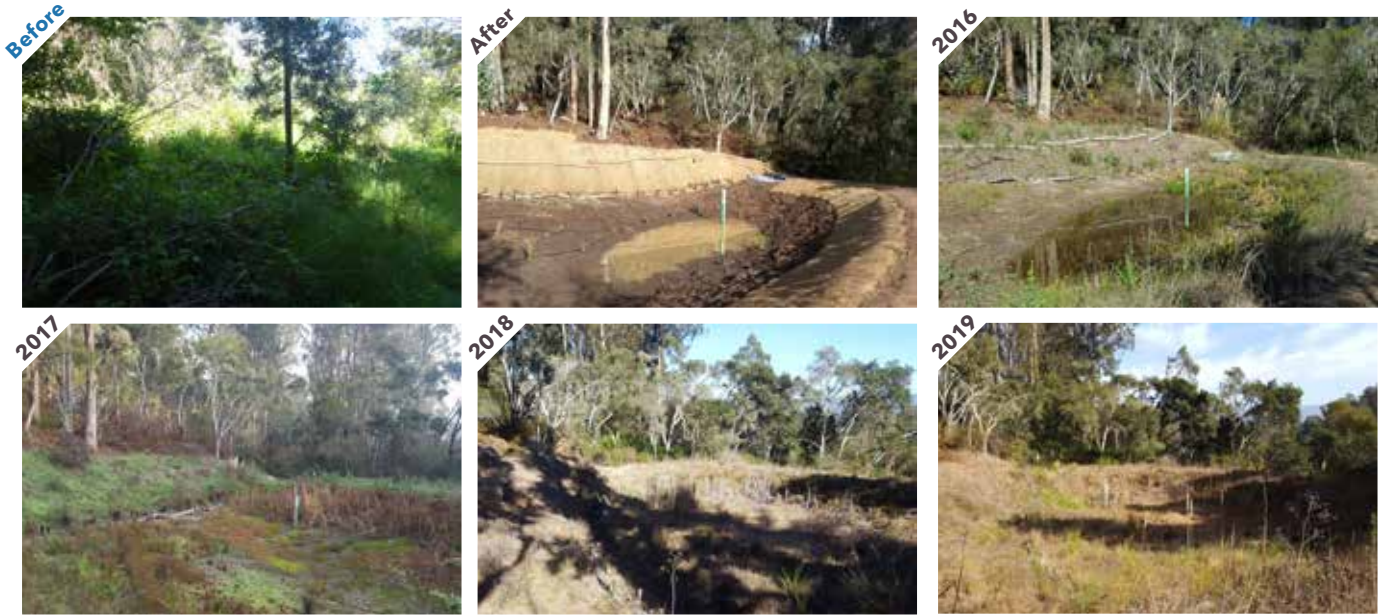
Photo point 3-2: The wetland was enhanced to increase the hydroperiod for amphibian breeding. A riser pipe to manage water levels can be seen. In 2016, the wetland did not hold water long enough to support amphibian breeding. Monitoring equipment was installed to monitor wetland hydroperiod and adaptive management measures are underway. In 2018-19 monitoring equipment was installed to monitor wetland hydroperiod and adaptive management measures were developed.

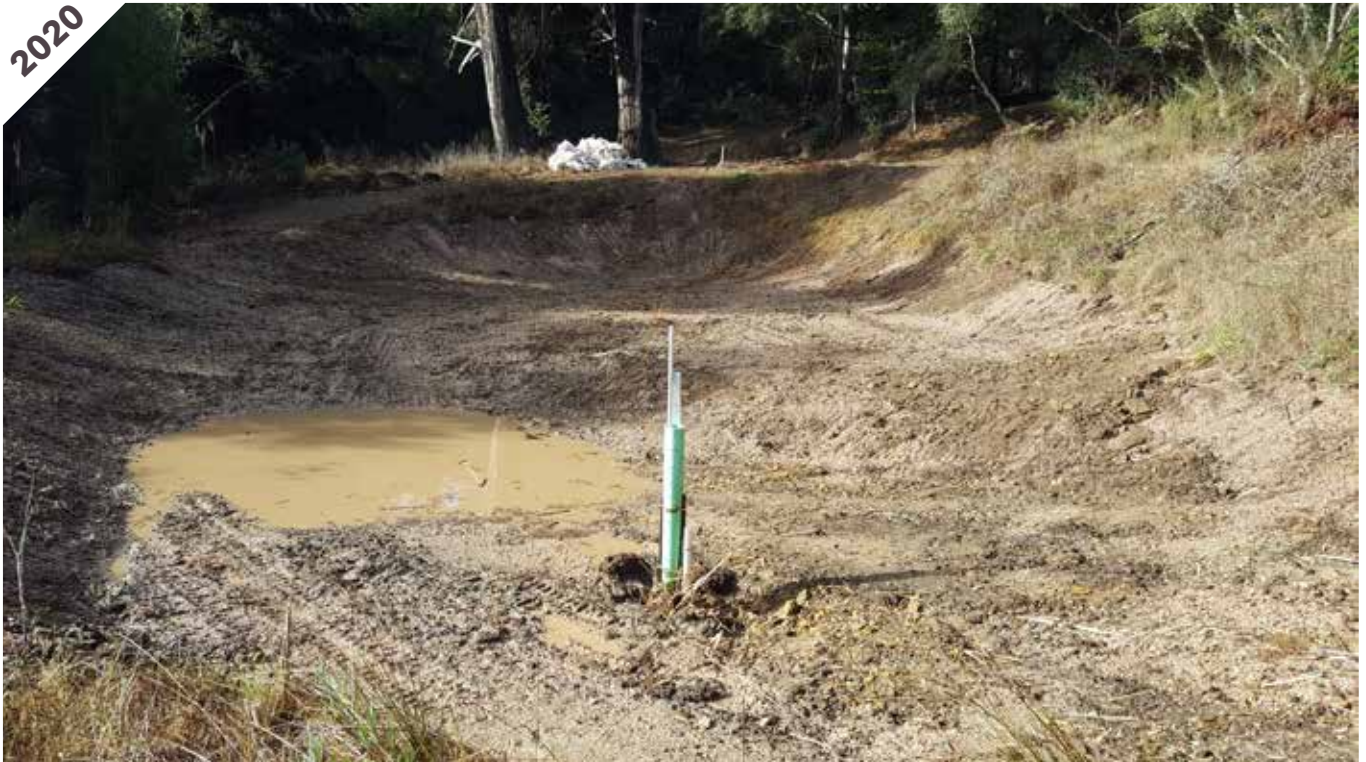
Photo point 4: The pond was lined with sodium bentonite to increase the hydroperiod for amphibian breeding.
