# COUNTY OF SANTA CRUZ

## PLANNING DEPARTMENT

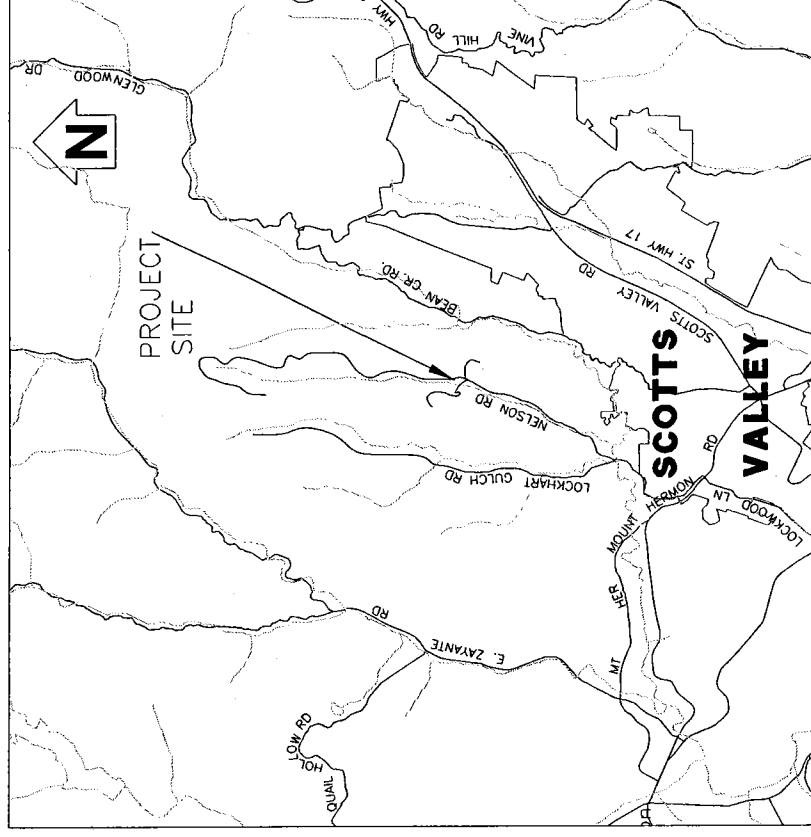
VICINITY MAP  
NO SCALE

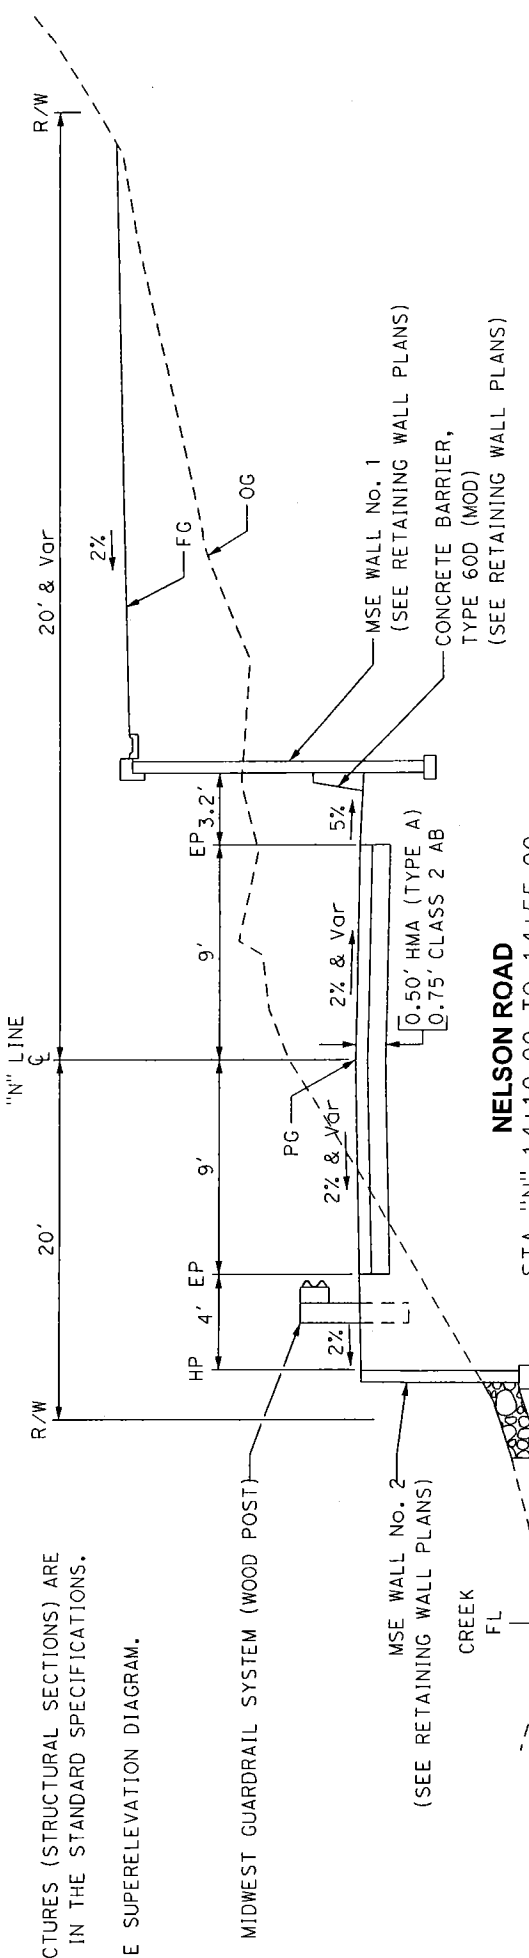
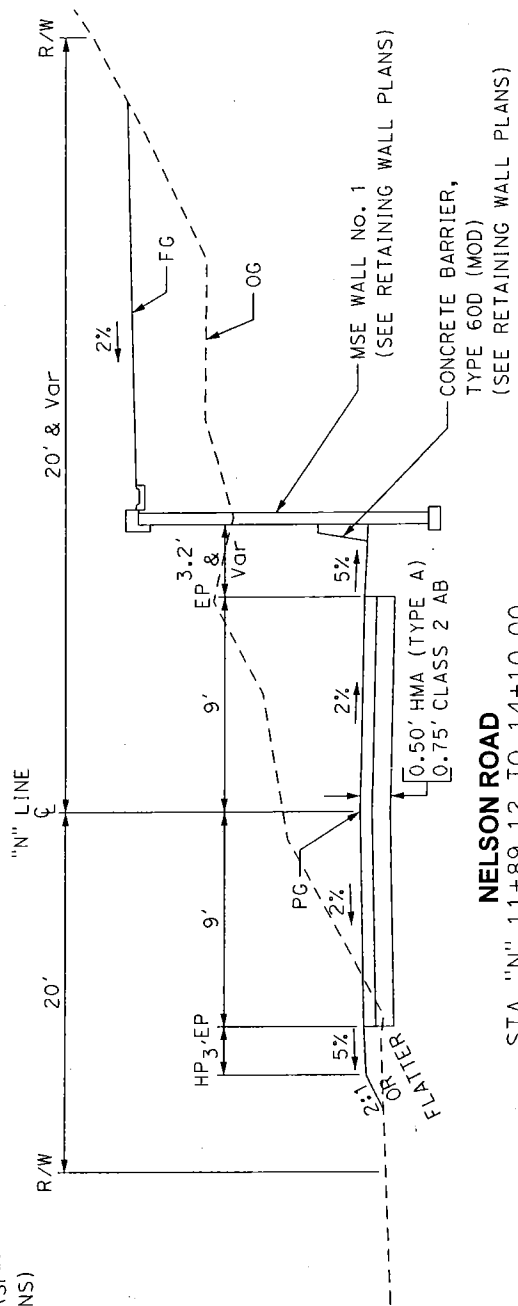
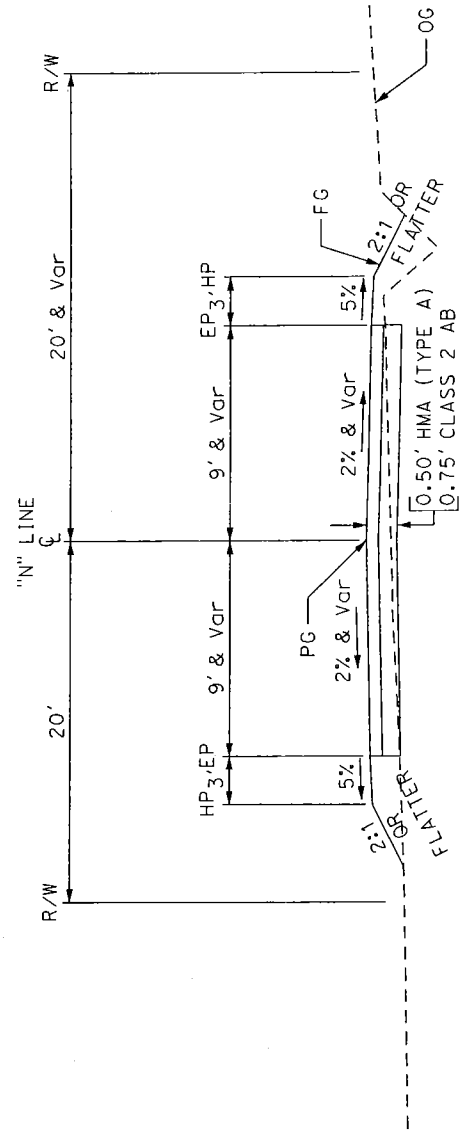
TYPICAL CROSS SECTIONS

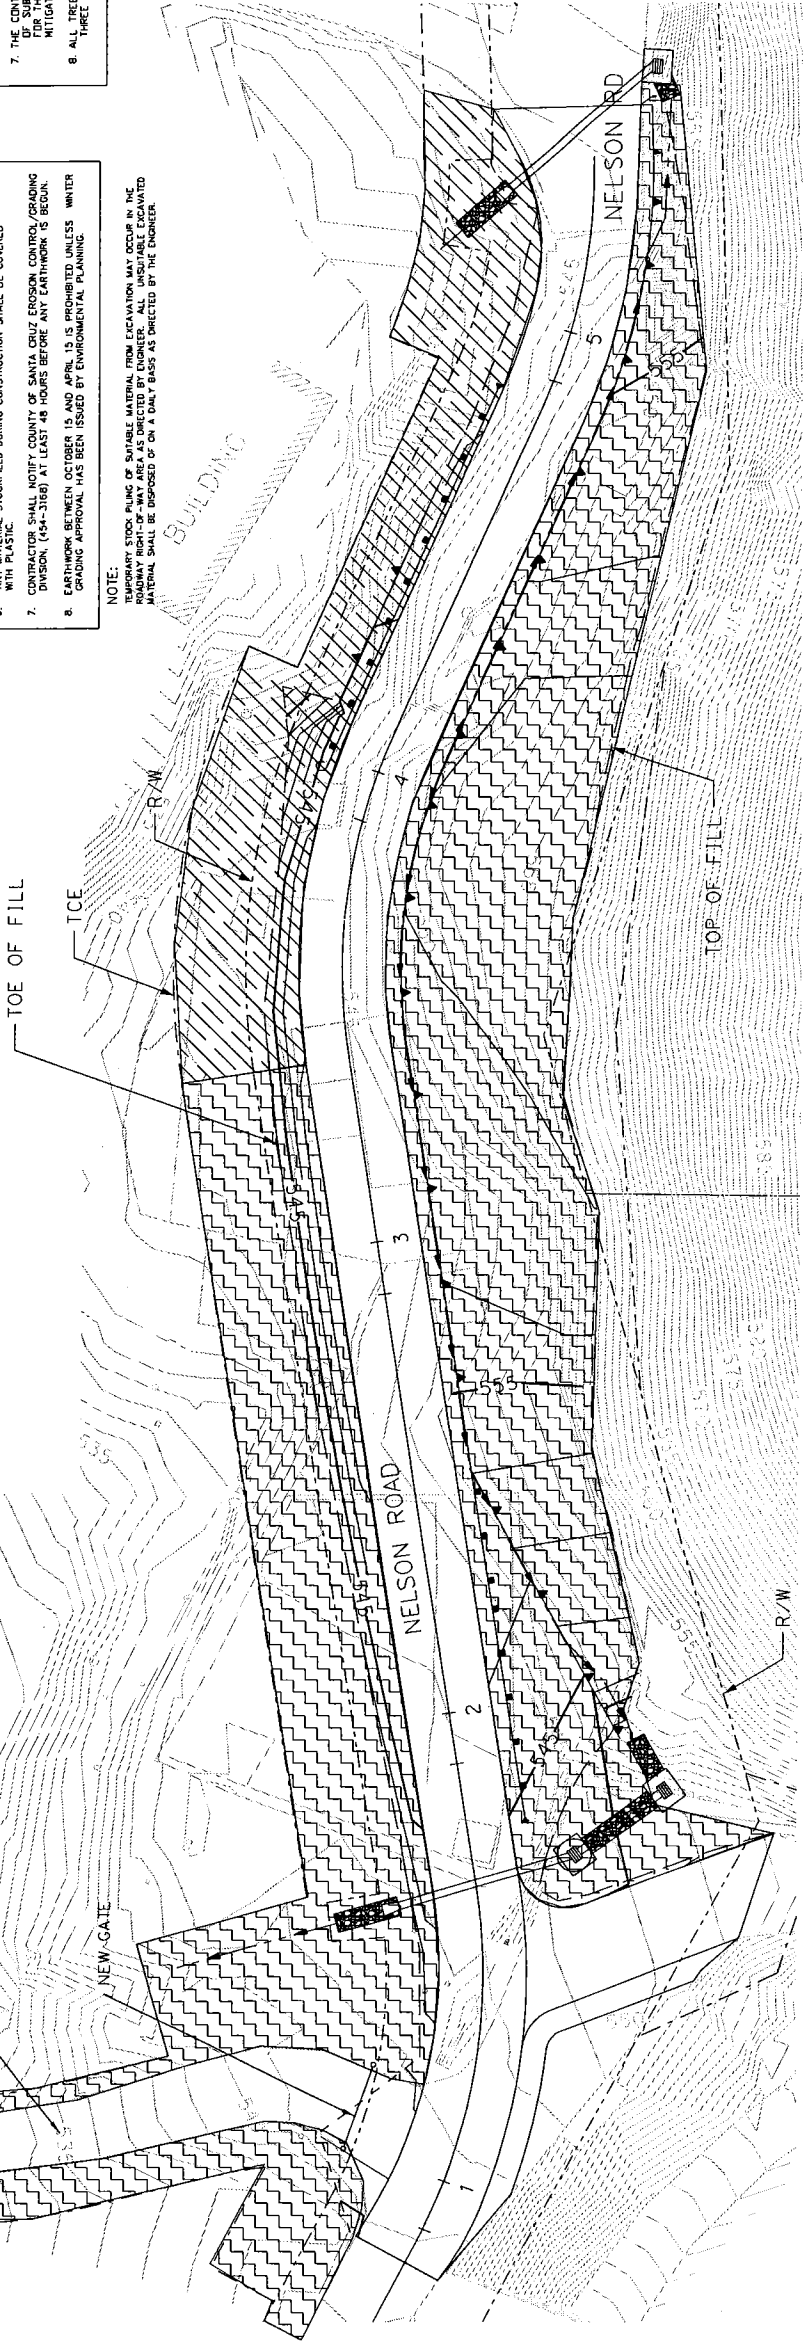
NOTE: TEMPORARY STOCK PILING OF SUITABLE MATERIAL FROM EXCAVATION MAY OCCUR IN THE ROADWAY RIGHT-OF-WAY AREA AS DIRECTED BY ENGINEER. ALL UNSUITABLE EXCAVATED MATERIAL SHALL BE DISPOSED OF ON A DAILY BASIS AS DIRECTED BY THE ENGINEER.

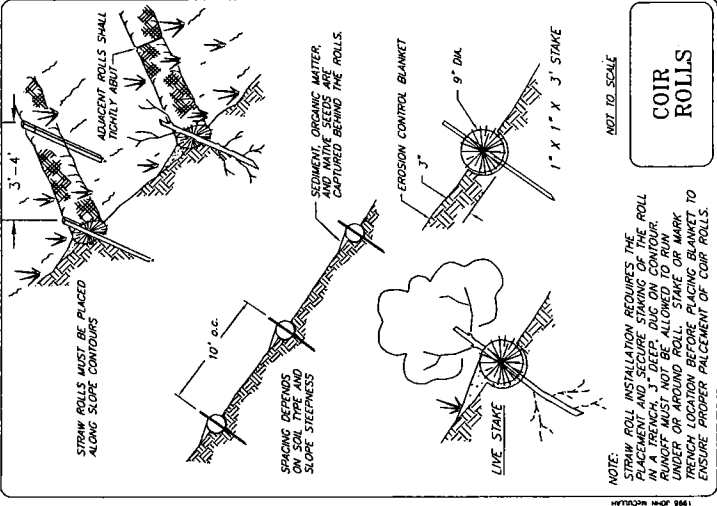
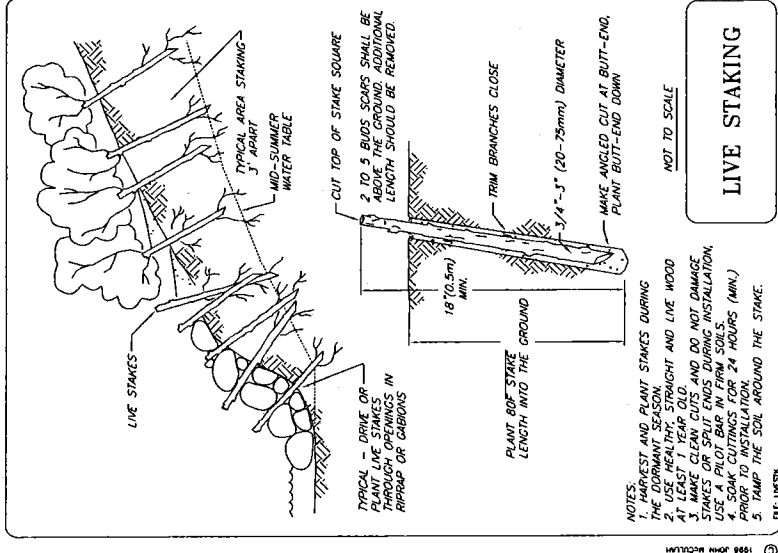
1100 BROADWAY  
NEW YORK, NY 10002  
PHONE: 212-693-1100  
FAX: 212-693-1100  
WWW.DEKORKEN.COM

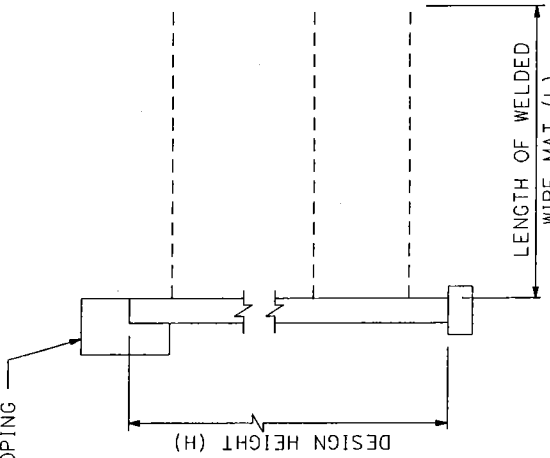
**TYPICAL SECTION**  
NO SCALE

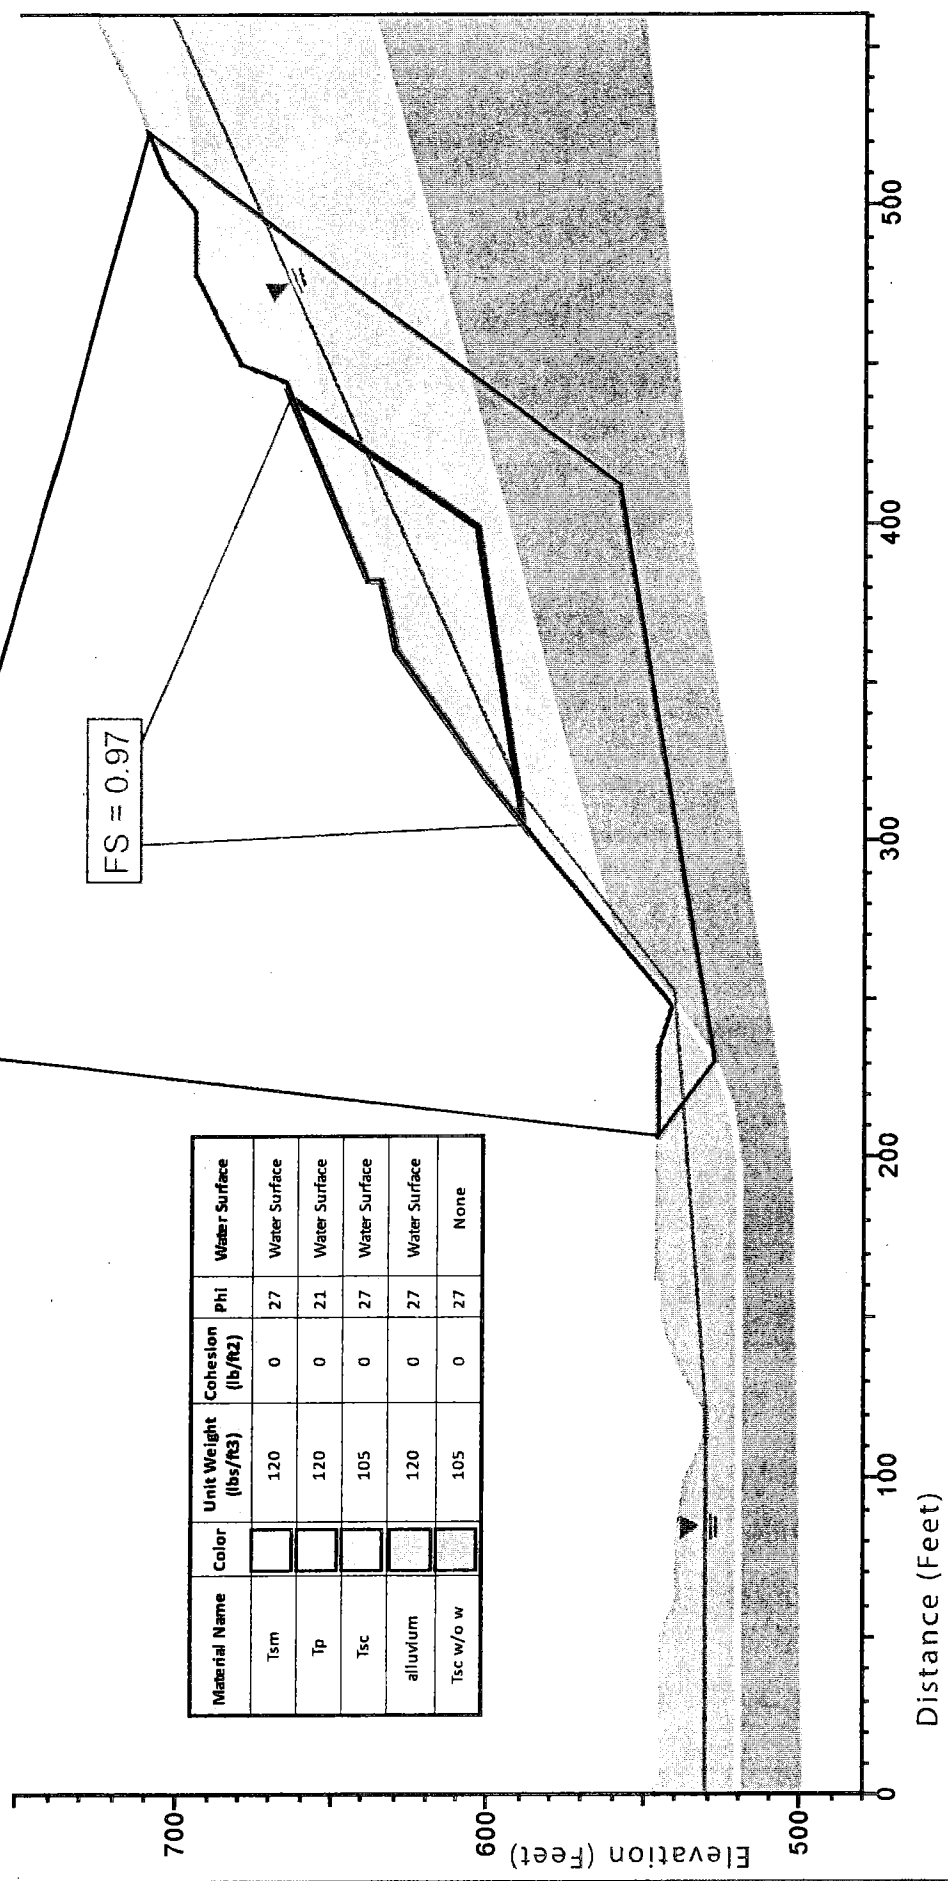
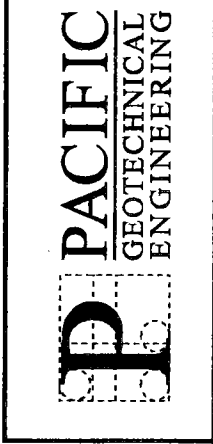
Material Name	Color	Unit Weight (lbs/ft <sup>3</sup> )	Cohesion (lb/ft <sup>2</sup> )	Phi	Water Surface
Tsm		120	0	27	Water Surface
Ip		120	0	21	Water Surface
Tsc		105	0	27	Water Surface
alluvium		120	0	27	Water Surface
Tsc w/o w		105	0	27	None

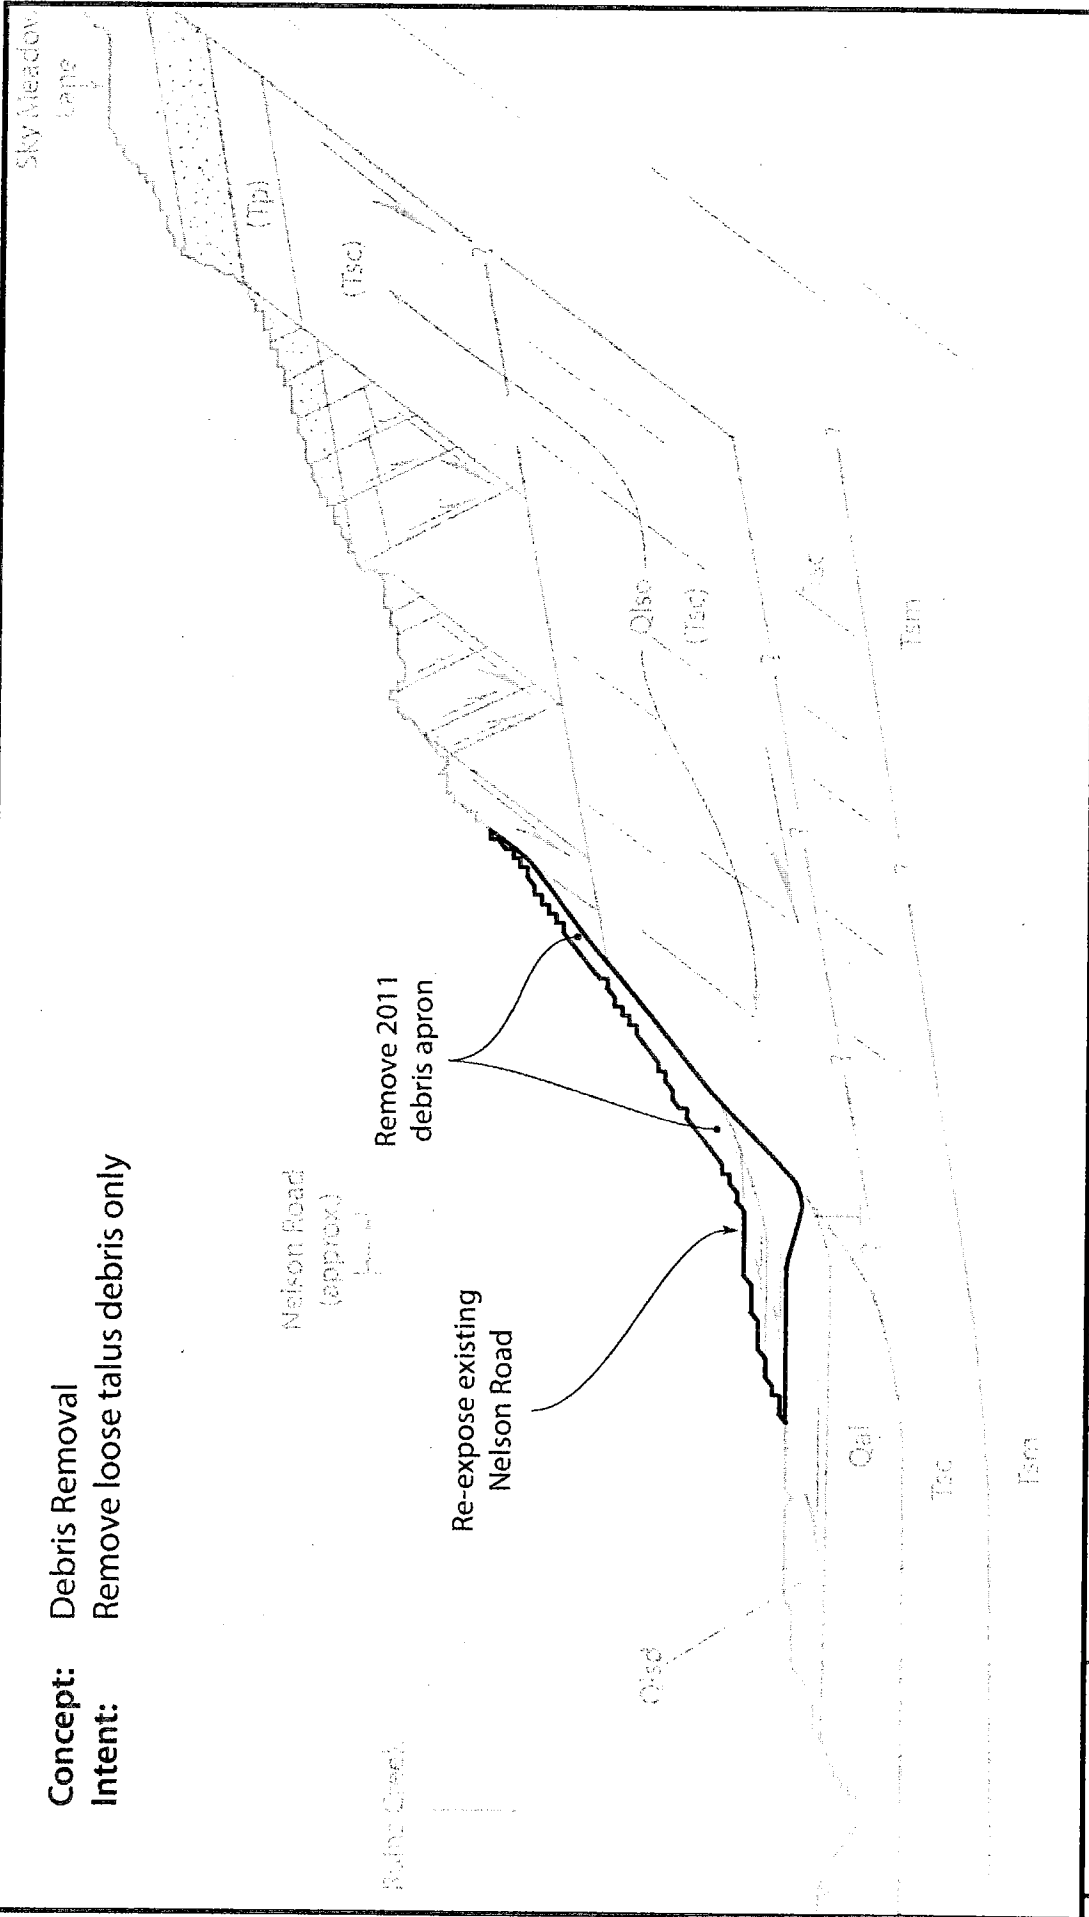
**DATE**  
 Draft  
 9/23/11

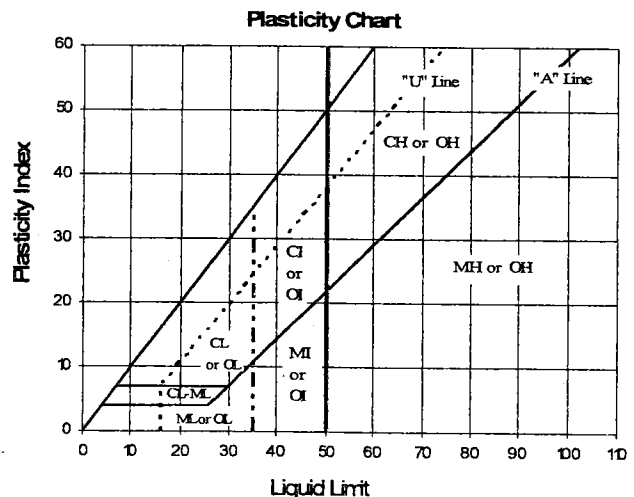
**KEY TO SOIL CLASSIFICATION – COARSE GRAINED SOILS**  
**(MORE THAN 50% IS LARGER THAN NO. 200 SIEVE SIZE)**  
(modified from ASTM D2487 to include fines with intermediate plasticity)

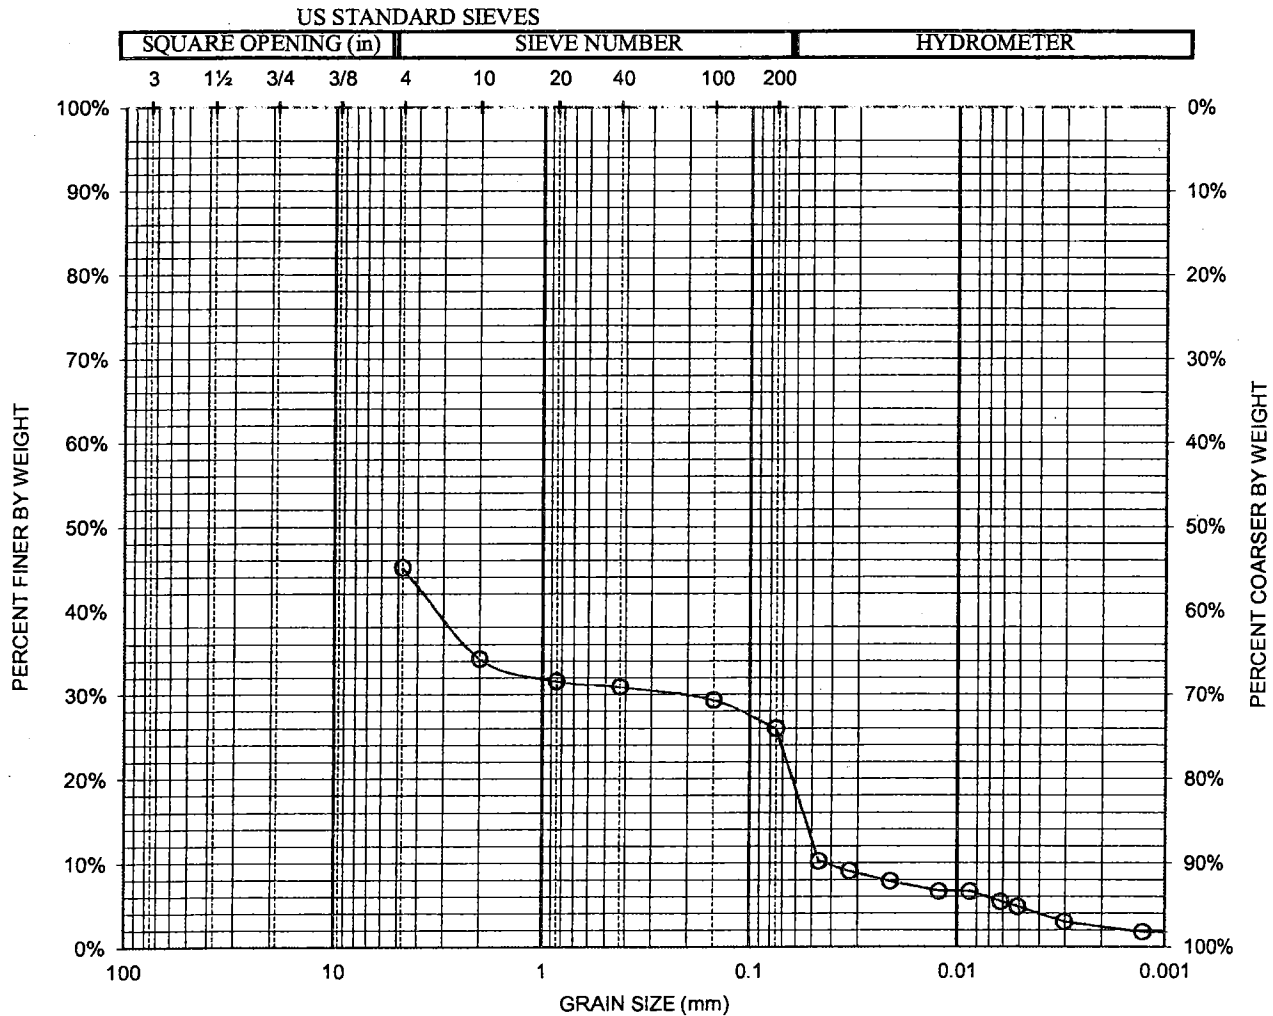
COARSE	FINE	COARSE	MEDIUM	FINE		
COBBLES	GRAVEL		SAND			SILT	CLAY
	54.8%		19.2%			23.6%	2.4%

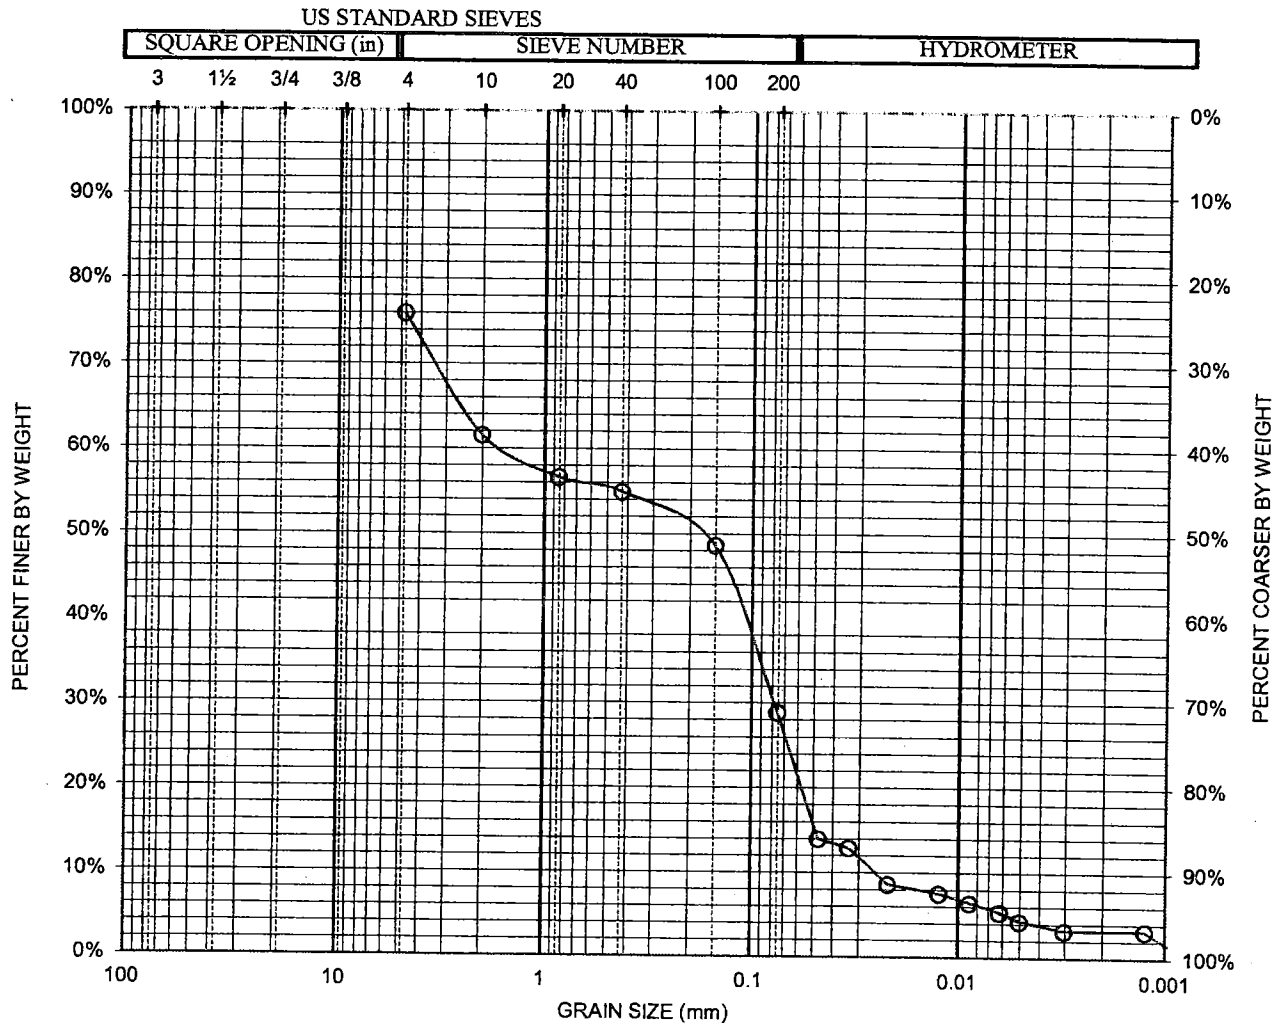
**REMARKS:** Sample soaked in water for two days and then mixed in a mechanical stirring device for one minute prior to washing and sieving.

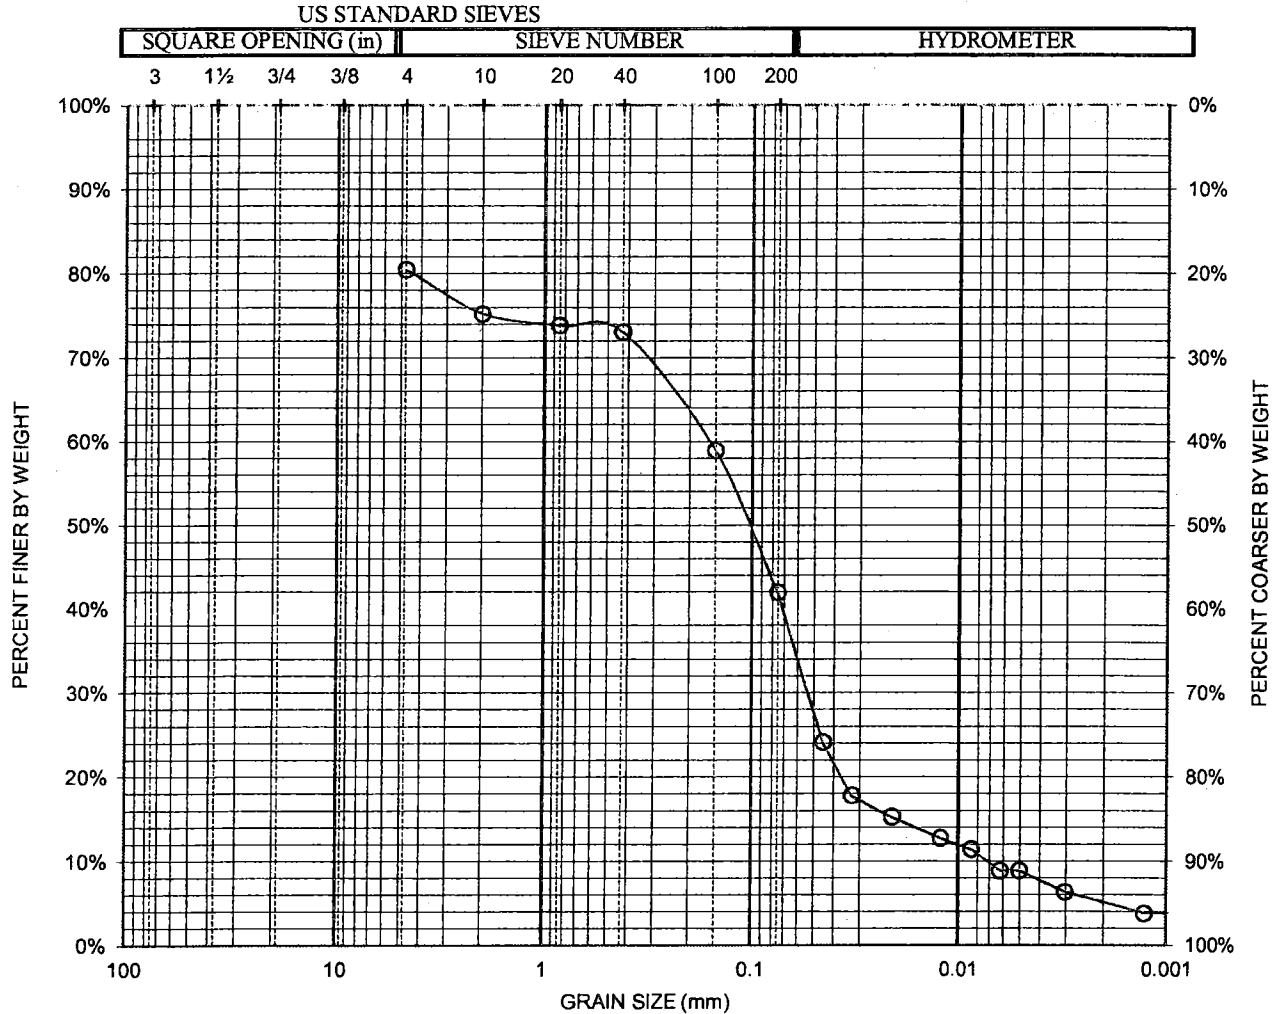
GRAVEL		SAND			SILT	CLAY
	COARSE	FINE	COARSE	MEDIUM	FINE		
	19.6%		38.5%			36.9%	5.1%

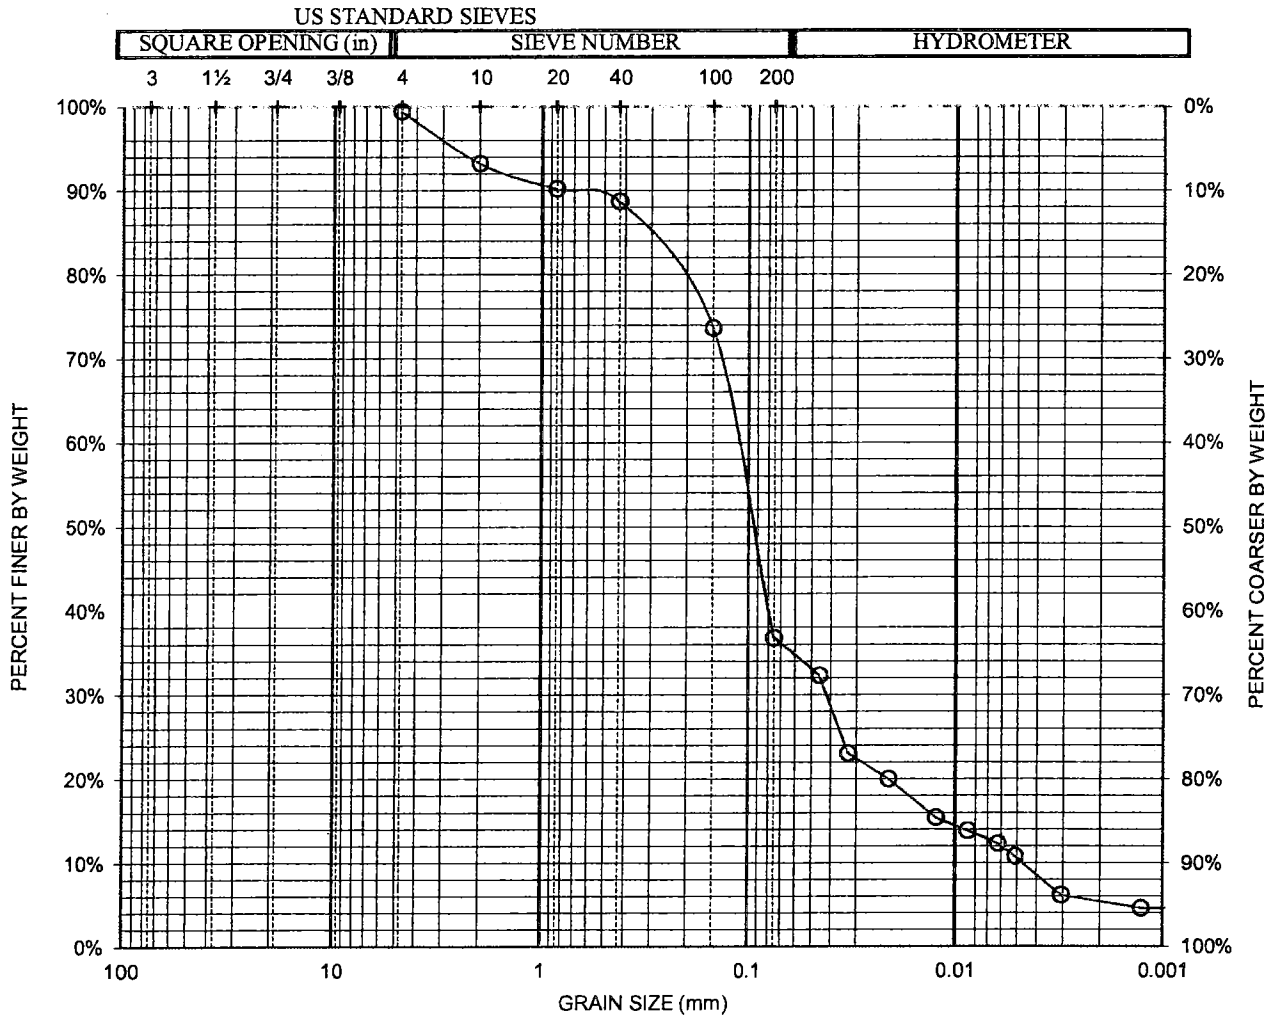
**REMARKS:** Sample soaked in water for two days and then mixed in a mechanical stirring device for one minute prior to washing and sieving.

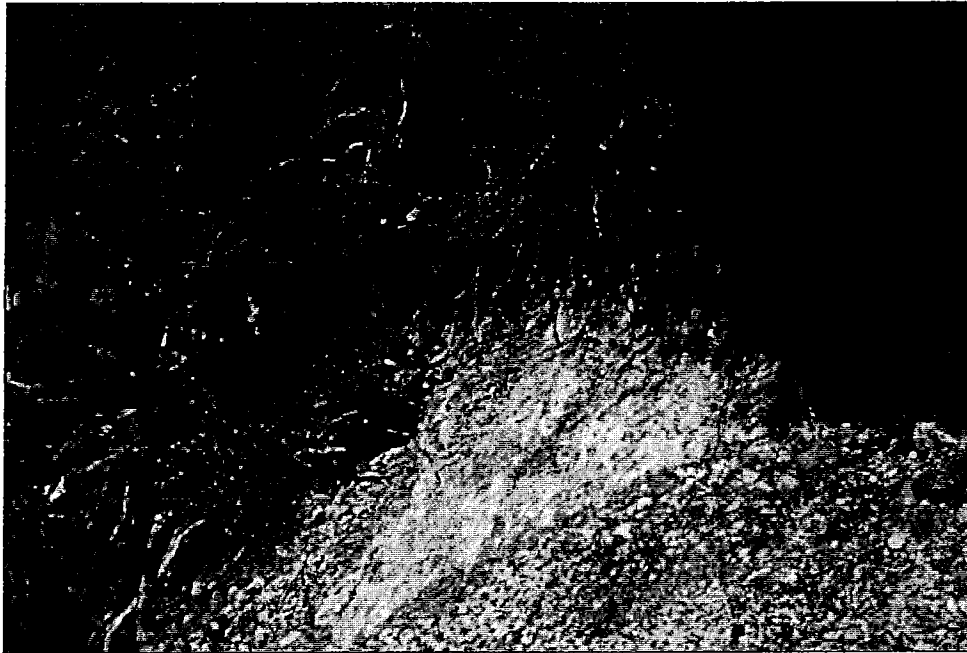
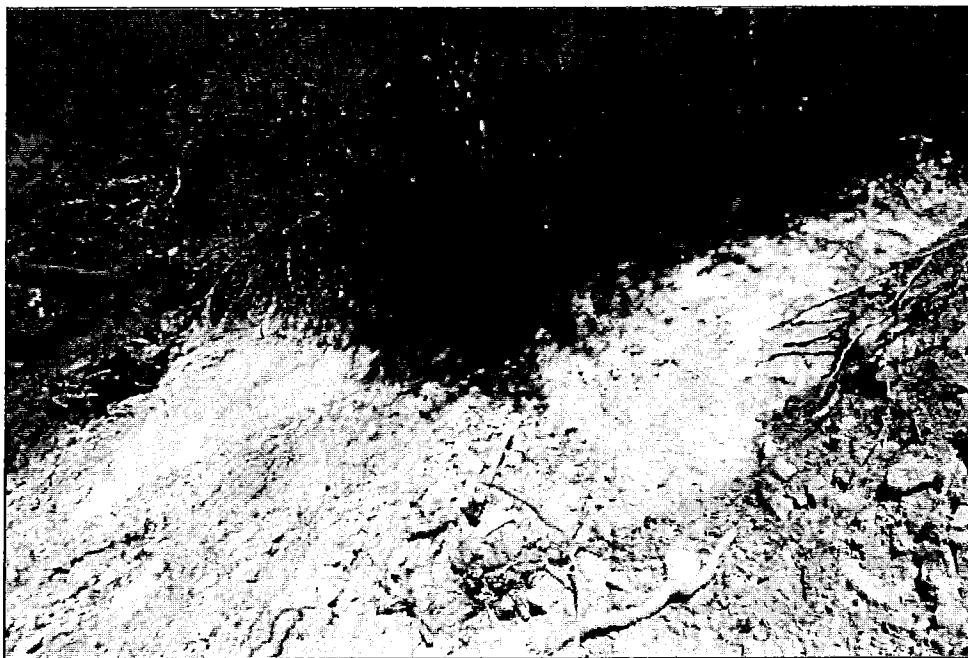
*Portion of 2011 landslide headscarp, illustrating strong control of rock joints on landslide geometry. The reflective bare face is nearly planar, and exposes rock along the upslope side of the joint. The exposed rock has a very light brown color. The remnants of material infilling the dilated joint (clay and iron oxides) tend to have a dark brown to rusty orange color.*

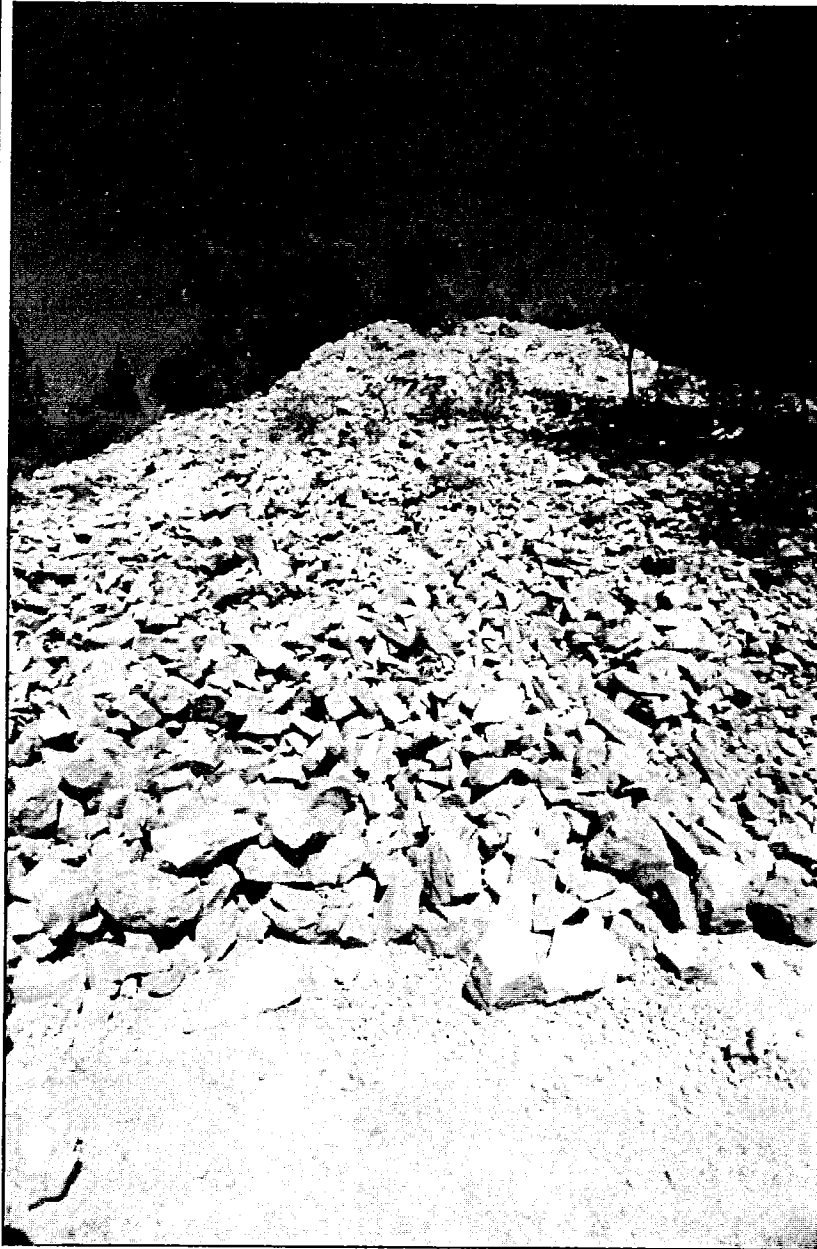
*View of 2011 landslide debris apron, taken shortly after March rains ceased. Note relatively consistent boulder size, and lack of visible internal fracturing of boulders; this contrasts with boulder appearance after 3 months of exposure (following photos).*

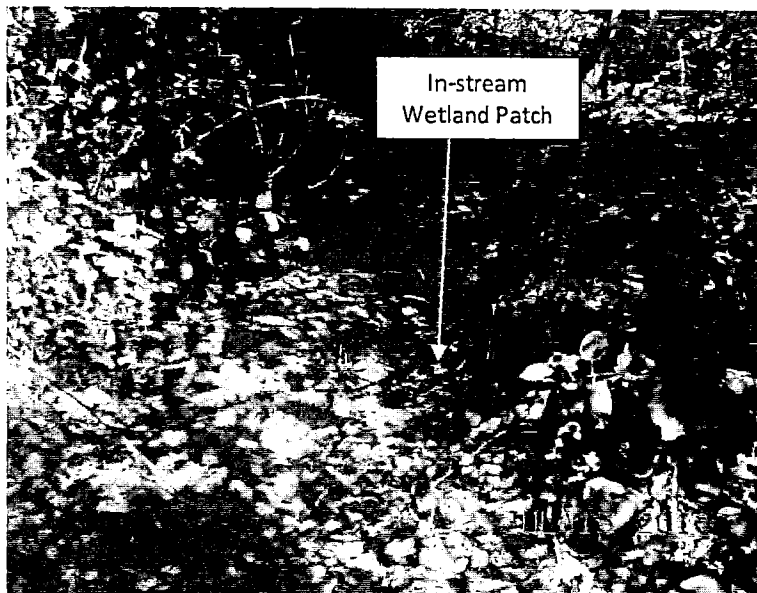
**Figure 3. Looking upstream from ford across Ruins Creek, showing patch of in-channel wetlands, measuring 1 square foot, July 2013**

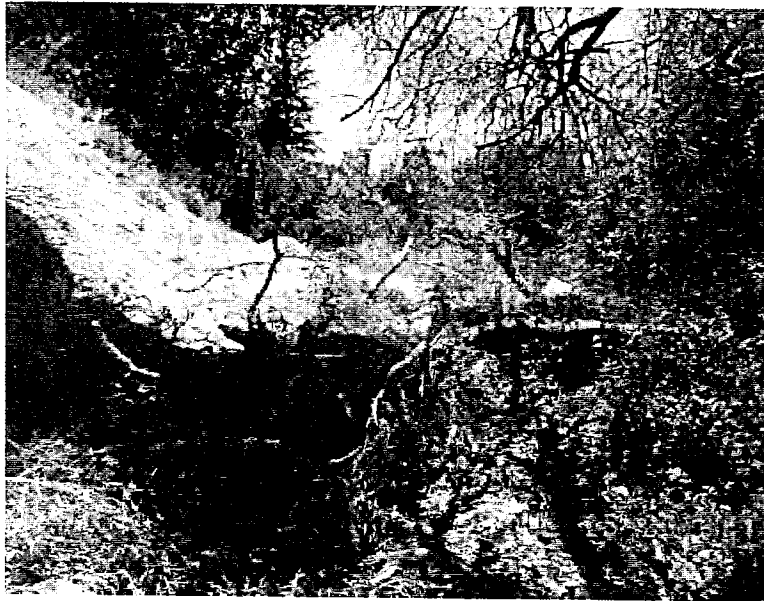
Figure 6. Vegetation within road bypass area, showing scrub and talus slope, July 2013

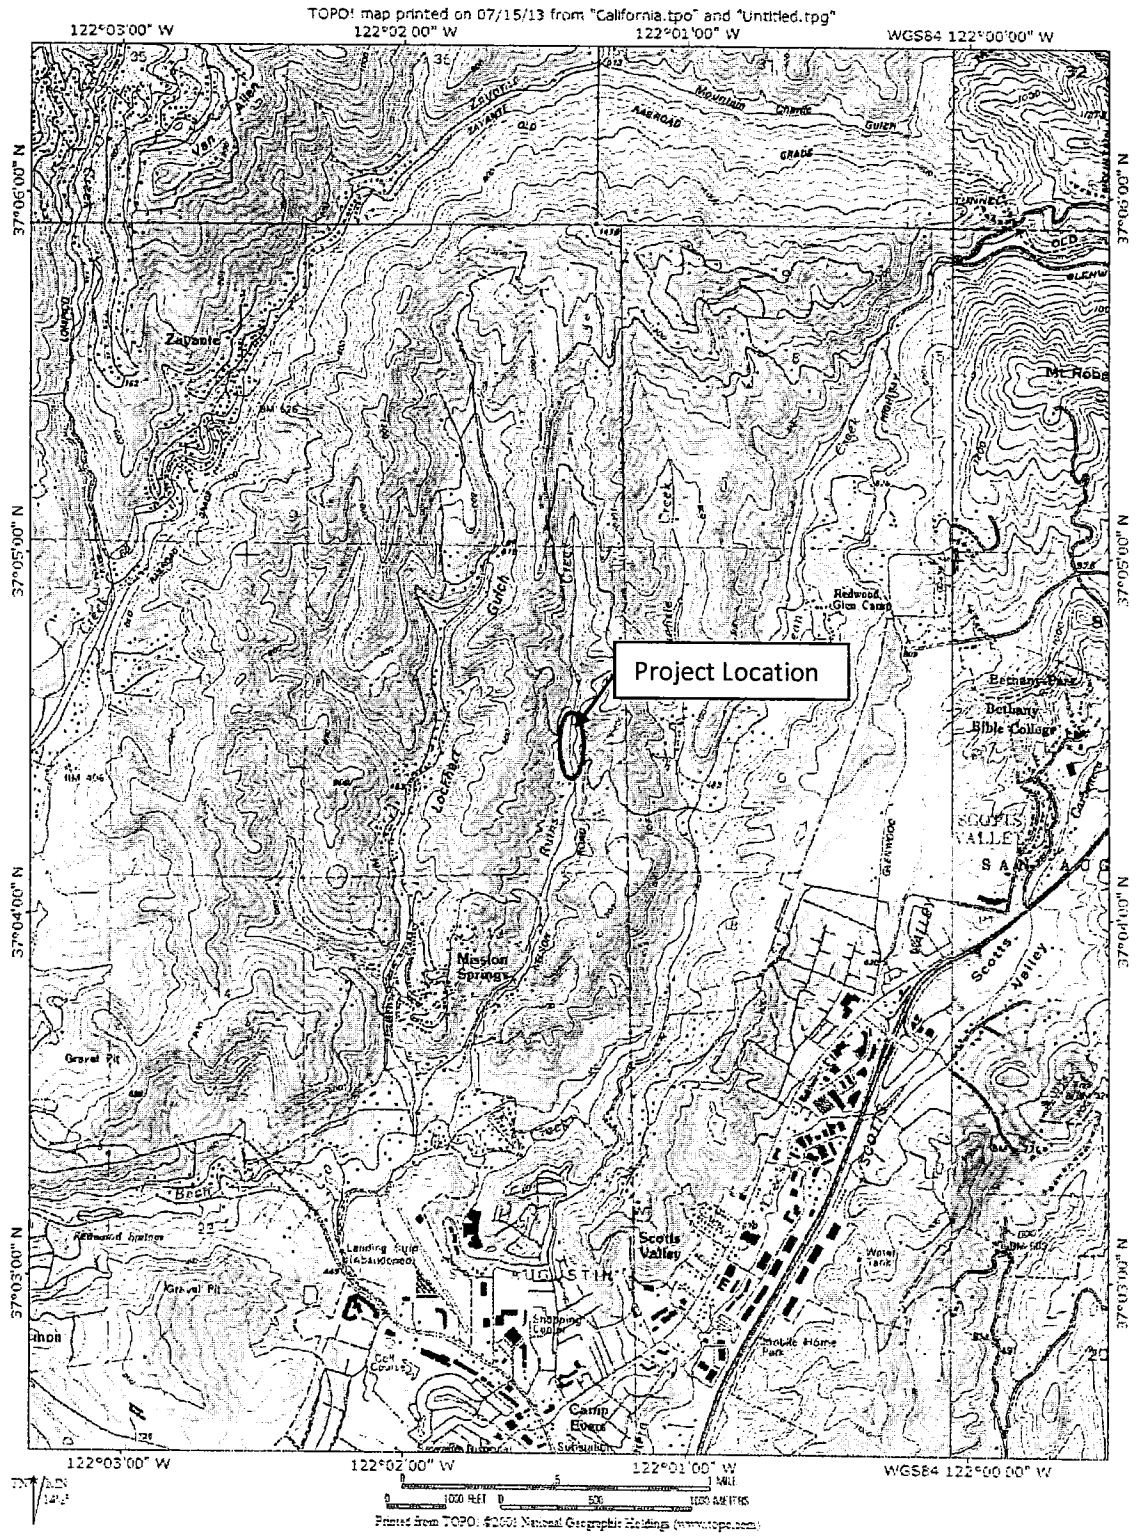
**Figure 1. Proposed Project Location**  
(USGS Felton USGS Topographic Map)

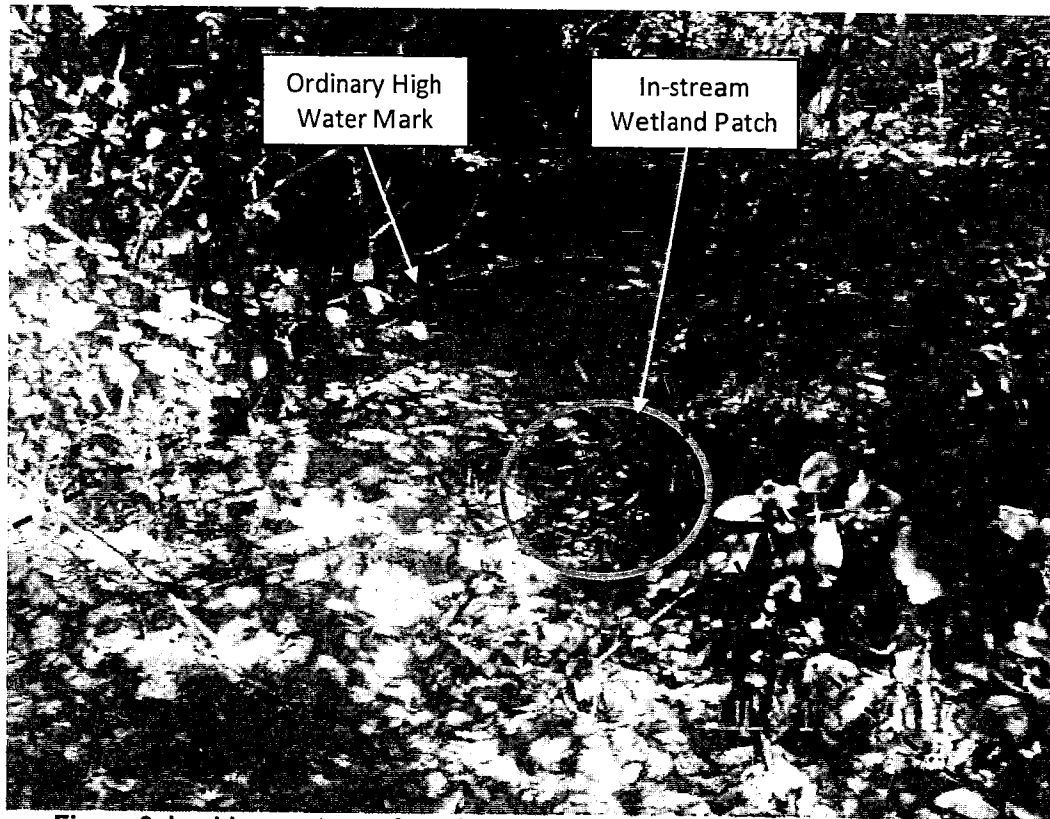
Figure 3. Looking upstream from ford across Ruins Creek, showing patch of in-channel wetlands, measuring 1 square foot, July 2013
