Existing Conditions, Ocean View
Santa Cruz, California

Figure 5-1b

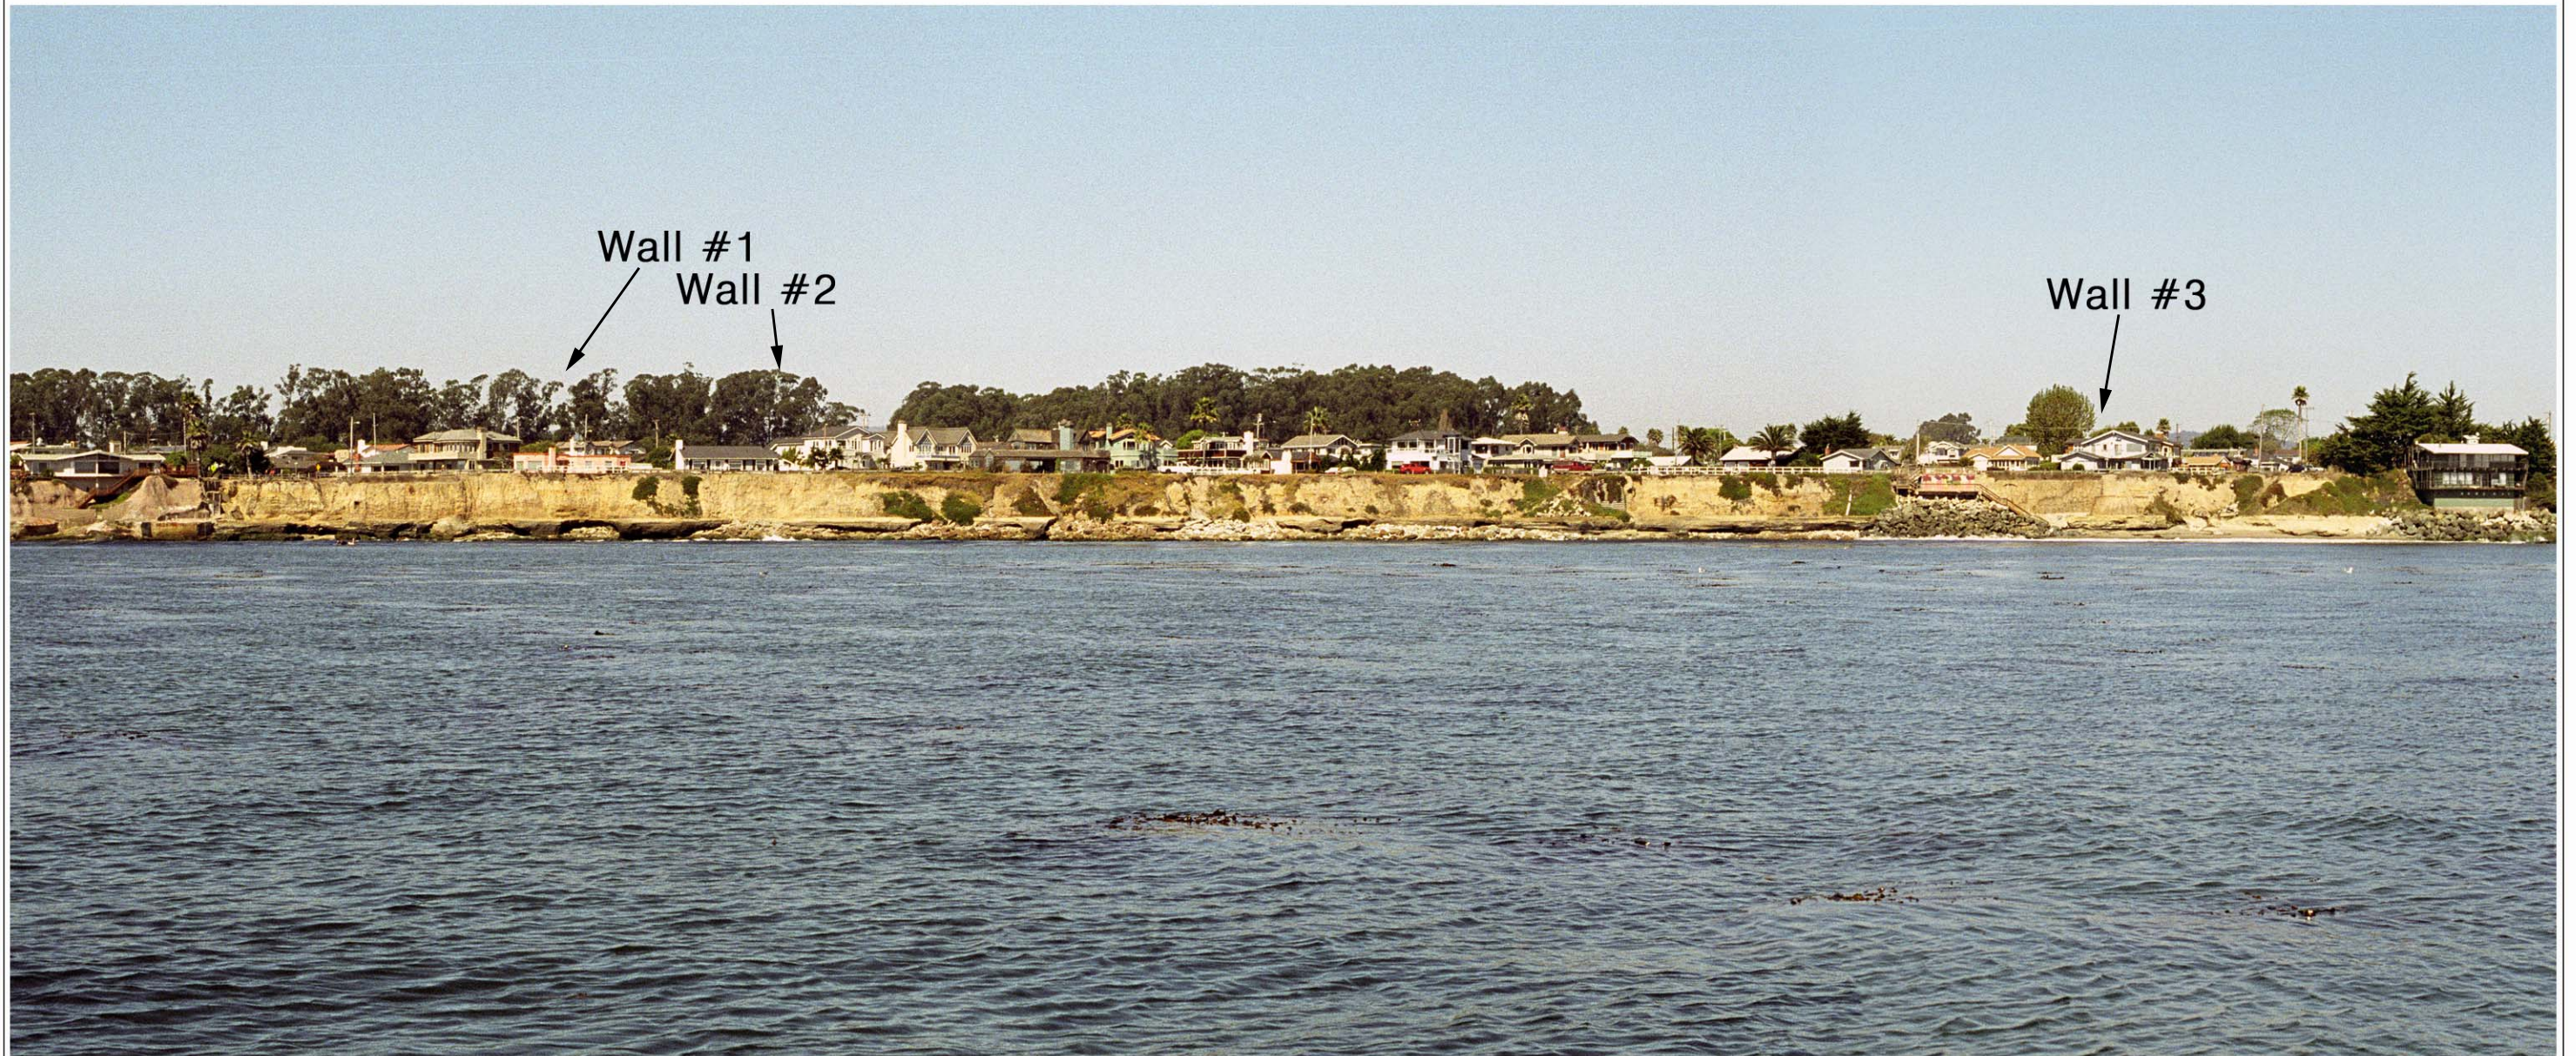
A view of the existing conditions at the project site including emergency soil nail walls constructed in 2004.
