**49 Shearwater Lane (APN 052-291-12)
Residential Development**

Biotic Report

Updated June 29, 2021

49 Shearwater Lane (APN 052-291-12) Residential Development

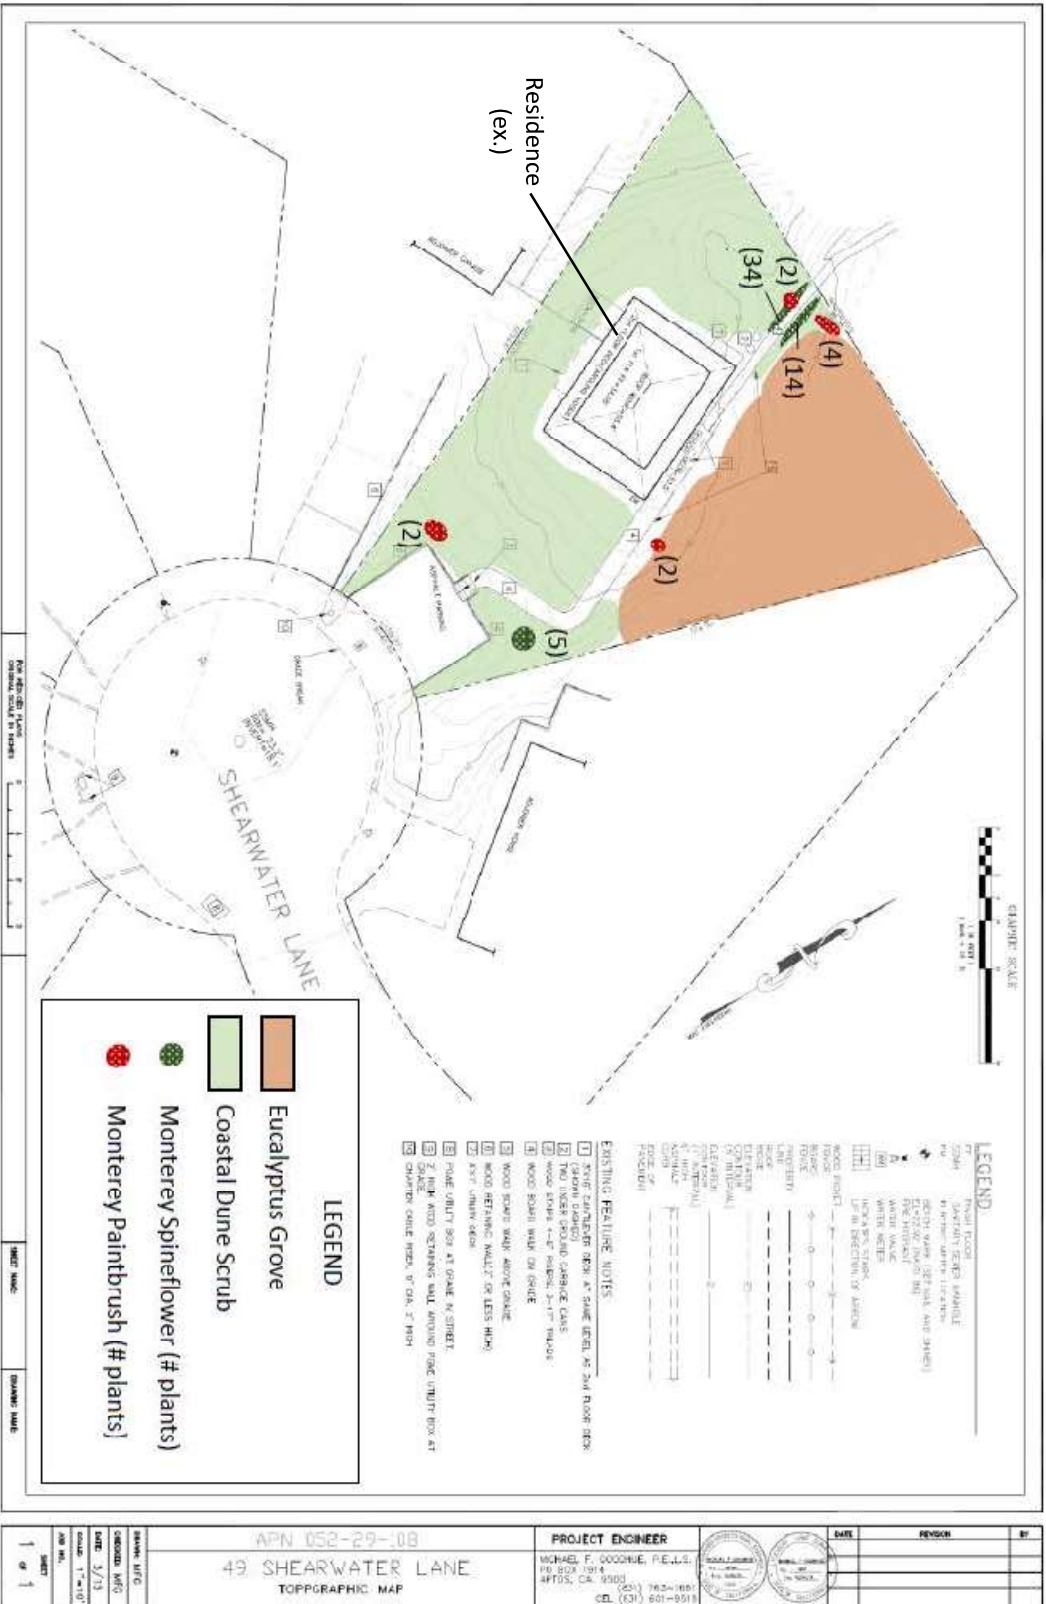
Figure 2. Distribution of vegetation types and special status plant species

The project site supports two vegetation types: coastal dune scrub (degraded) and non-native eucalyptus grove. The distribution of these vegetation types is presented on Figure 2.

The spineflower is characterized by its whitish to pinkish flowers, low-growing habit and spiny bracts surrounding the flowers. Individuals of Monterey spineflower were observed on the parcel during the April 2020 field survey. A colony was observed along both sides of the wooden pathway in the northwestern portion of the parcel. A second colony was observed north of the existing asphalt parking area. A total of 53 plants were found on site. The location (and number of plants) of this species is depicted on Figure 2. Figure 8 depicts this species.

The location of this species is depicted on Figure 2. Figure 9 depicts this species.

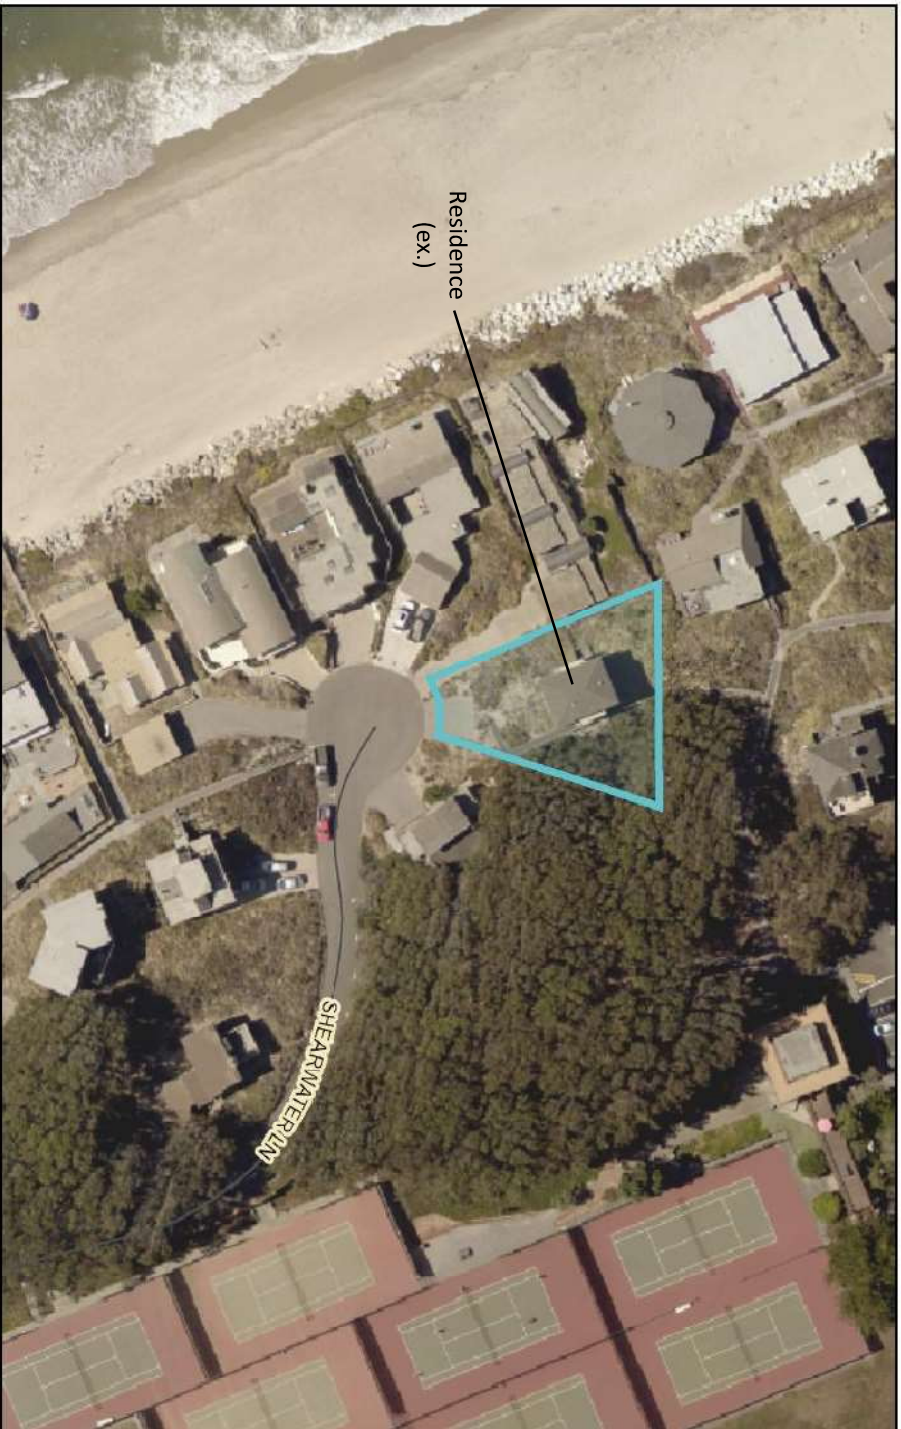
November 17, 2020

Figure 3. Location of parcel on aerial photo (Source: Santa Cruz County GIS)

Despite the degraded site conditions, two special status plant species were observed on the parcel: Monterey spineflower (*Chorizanthe pungens* var. *pungens*) and Monterey paintbrush (*Castilleja latifolia*). These plant species were found in small patches, as depicted in Figure 2. Figure 3 is an aerial image of the parcel and surroundings. The character of the scrub is depicted in Figures 4 and 5.

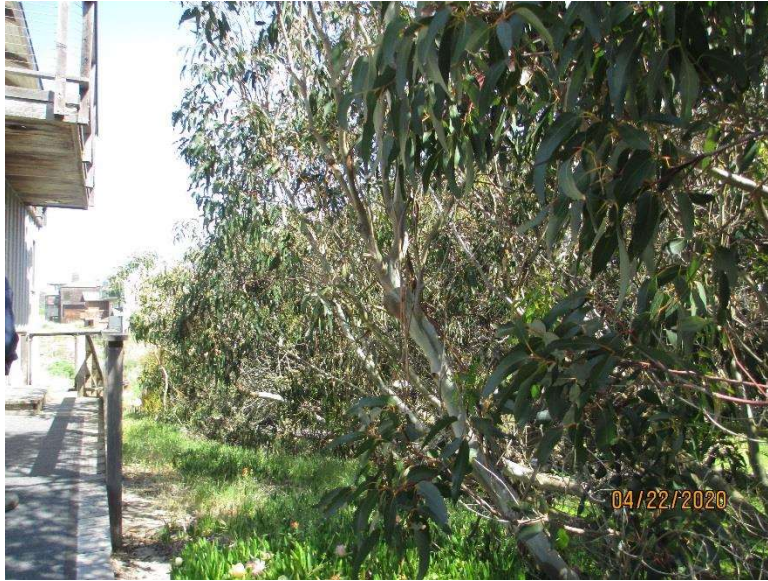
Figure 6. Character of eucalyptus tree limbs immediately east of existing residence

plant species were limited to small patches of Monterey paintbrush and wild cucumber (*Marah fabacean*). Figures 6 and 7 depict the character of this vegetation type.

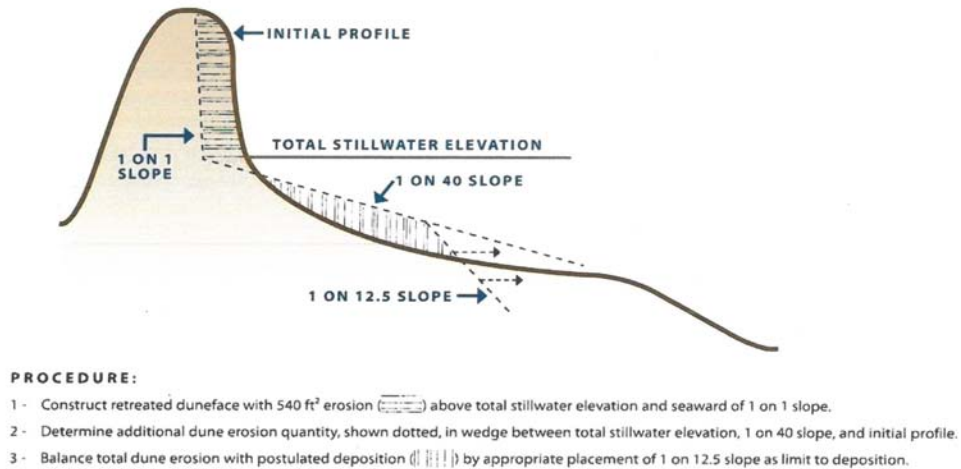
Figure 3: Procedure Giving Eroded Profile in Case of Duneface Retreat Sketch

- f. Once the area of 1,100 square foot sand reservoir was determined, a 1:1 (H:V) slope was projected up, landward, from the intersection of the vertical line and the SWEL horizontal line until it intersected with the top of the dune, as shown below in **Figure 3**.

- g. To complete the eroded dune profile a 1:40 (H:V) slope was projected seaward, from the intersection of the vertical line and the SWEL horizontal line, as shown below in Figure 3.
