Initial Study Attachment 1

County of Santa Cruz

MITIGATION MONITORING AND REPORTING PROGRAM for Application No. 181586

TENTATIVE IMPROVEMENT PLANS

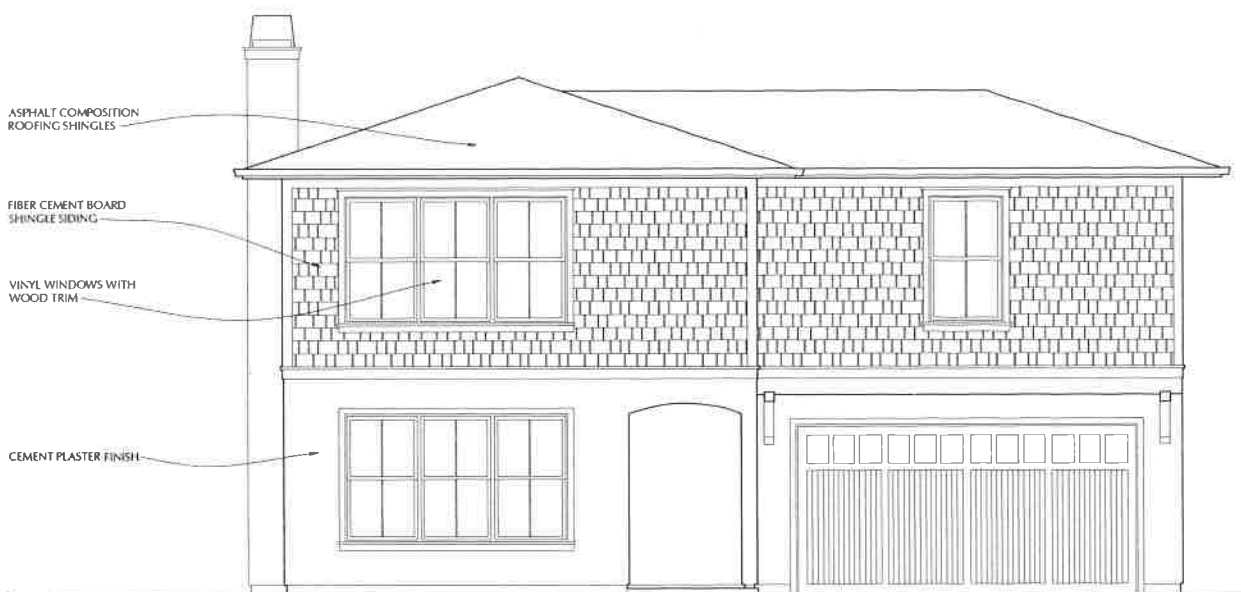
① FRONT ELEVATION
SCALE: 1/4"=1'-0"

ASPHALT COMPOSITION ROOFING SHINGLES
FIBER CEMENT BOARD SHINGLE SIDING
VINYL WINDOWS WITH WOOD TRIM
CEMENT PLASTER FINISH

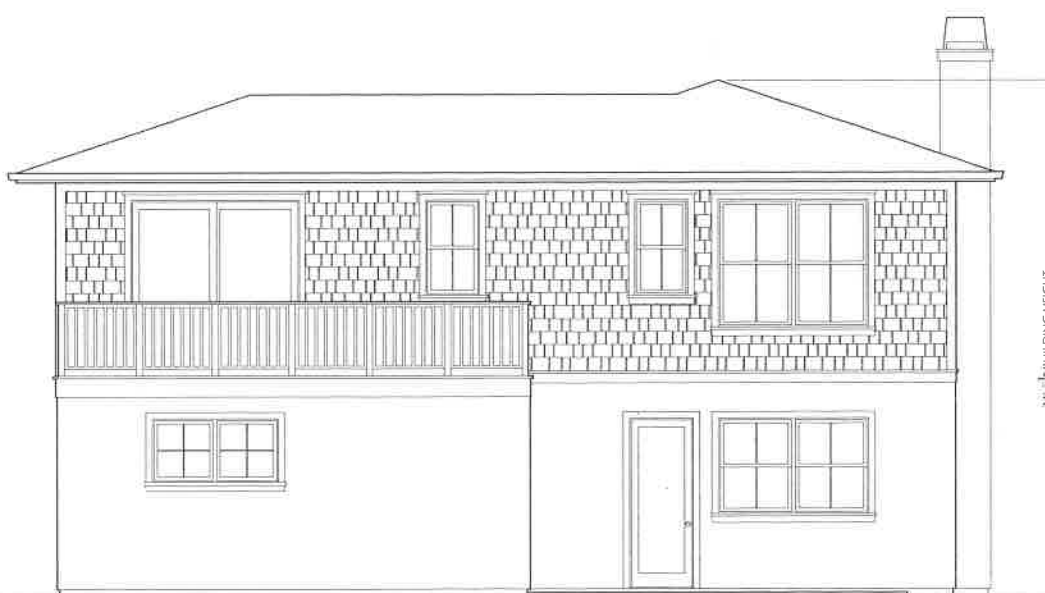
③ BACK ELEVATION
SCALE: 1/4"=1'-0"

24'-0" BUILDING HEIGHT

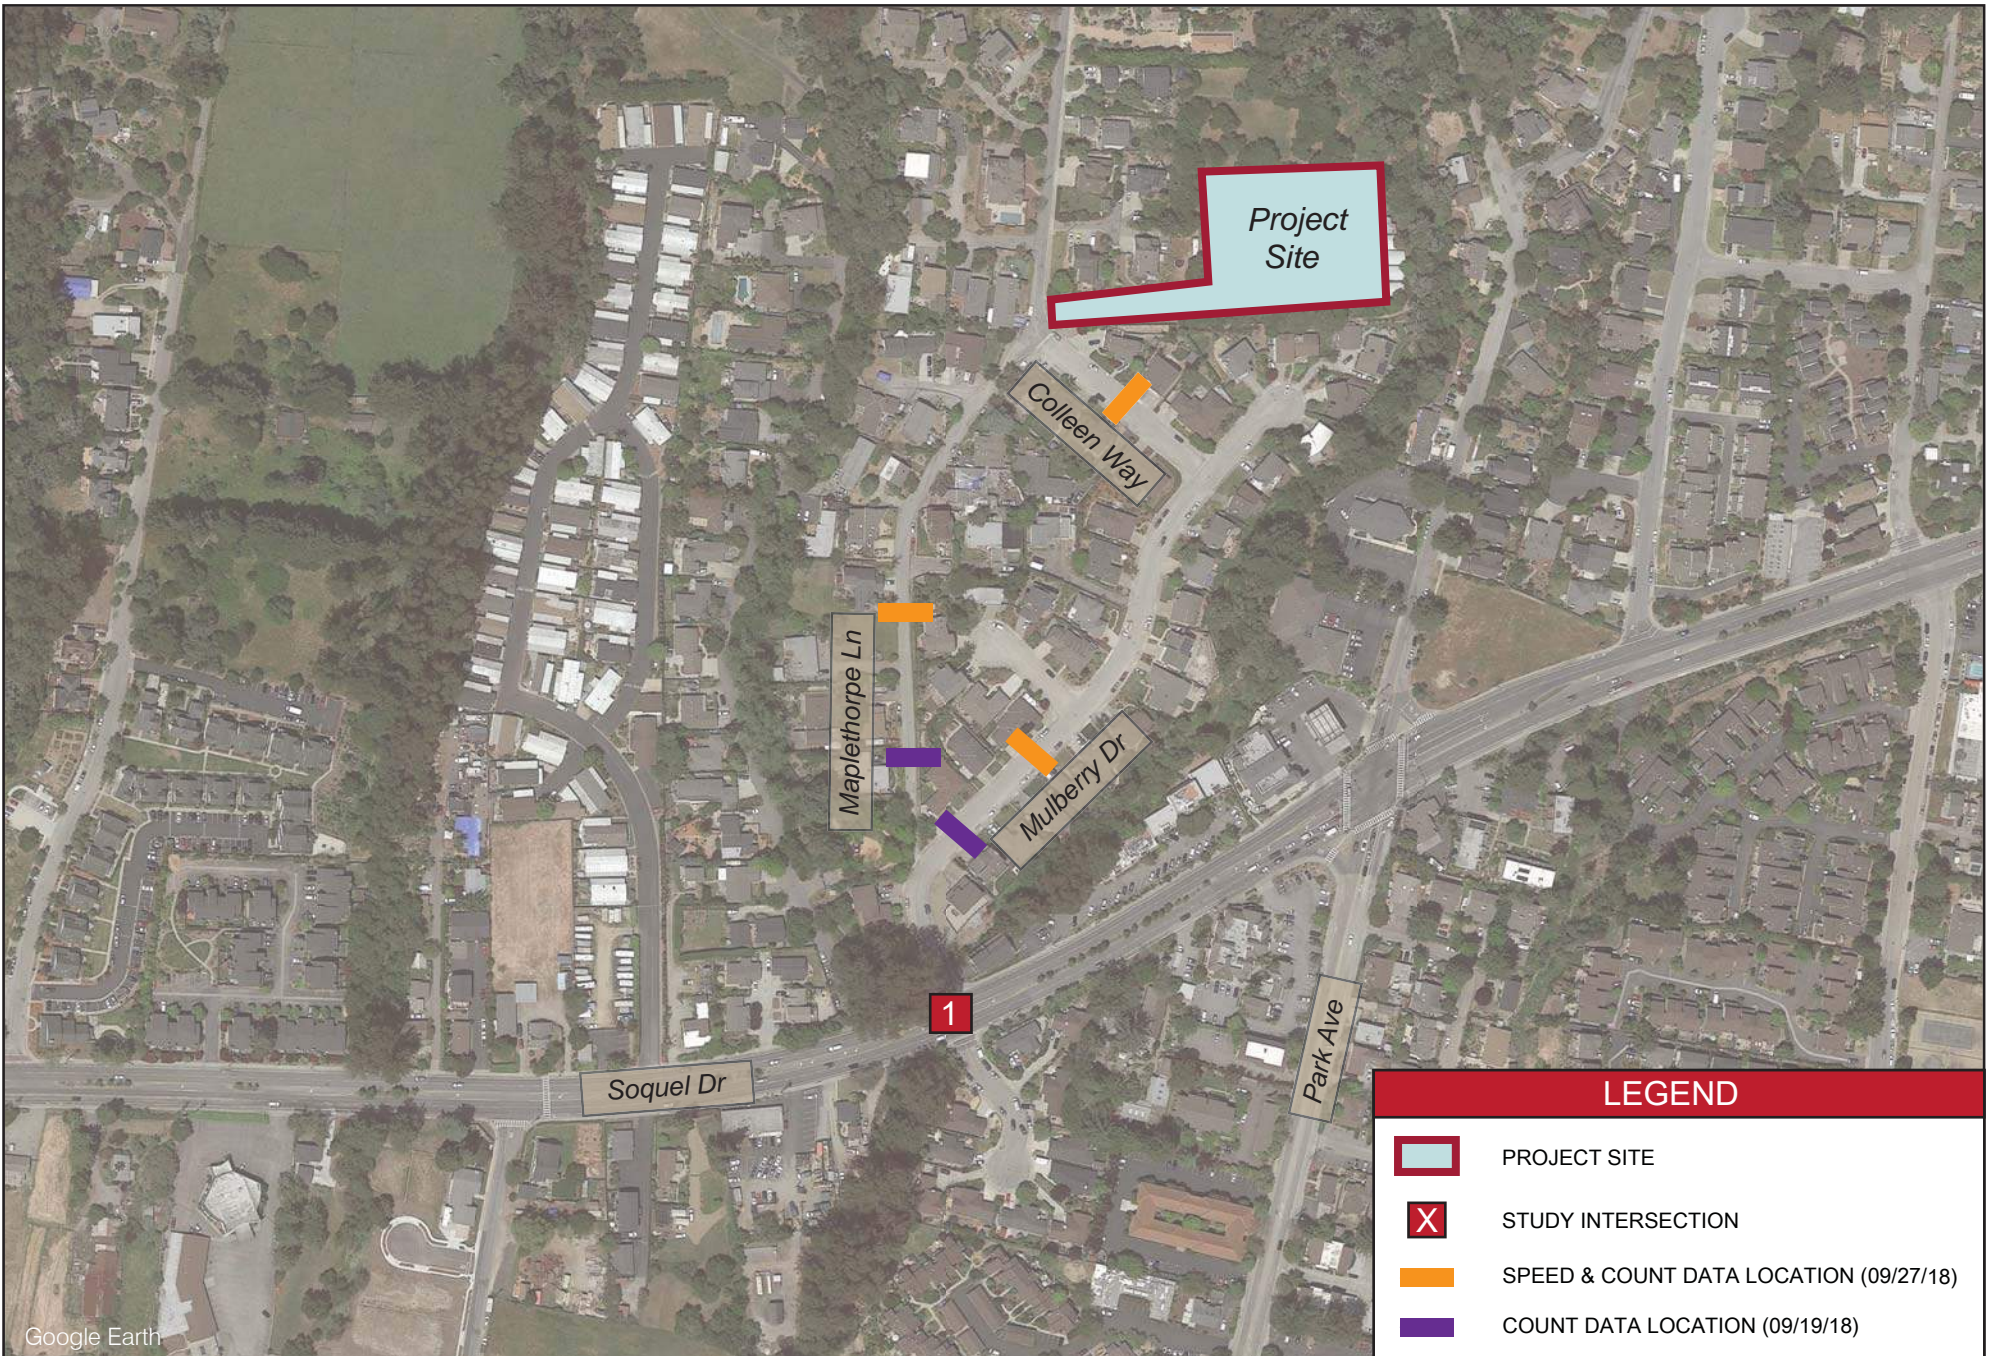
Figure 1 shows the Project Location Map, which includes the study intersection and roadways. The Project site plan is shown in **Figure 2**.

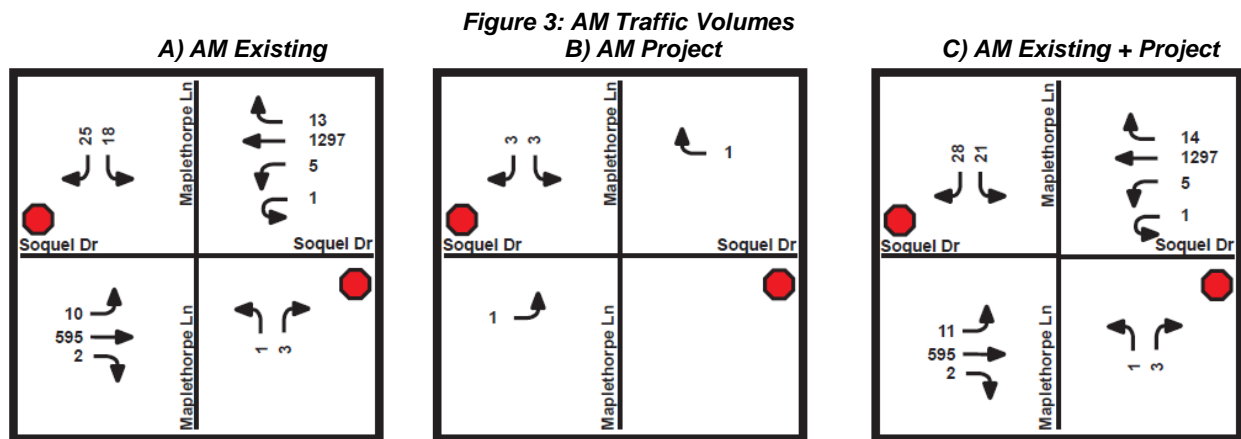
The analysis indicates that the AM peak demand at the study intersection occurs from 7:45am to 8:45am. During this peak, the intersection operates at an overall LOS A. The southbound side-street approach operates at an LOS D under existing conditions. Under existing plus project conditions, the overall intersection is LOS A and the side-street operates at a LOS D. This peak’s side-street delay and LOS is better than the City’s minimum requirements; therefore, the intersection operates at acceptable conditions. **Figure 3** below shows the AM traffic volumes for all analysis conditions. **Table 5** shows the existing analysis results and existing plus project analysis results with SSSC.

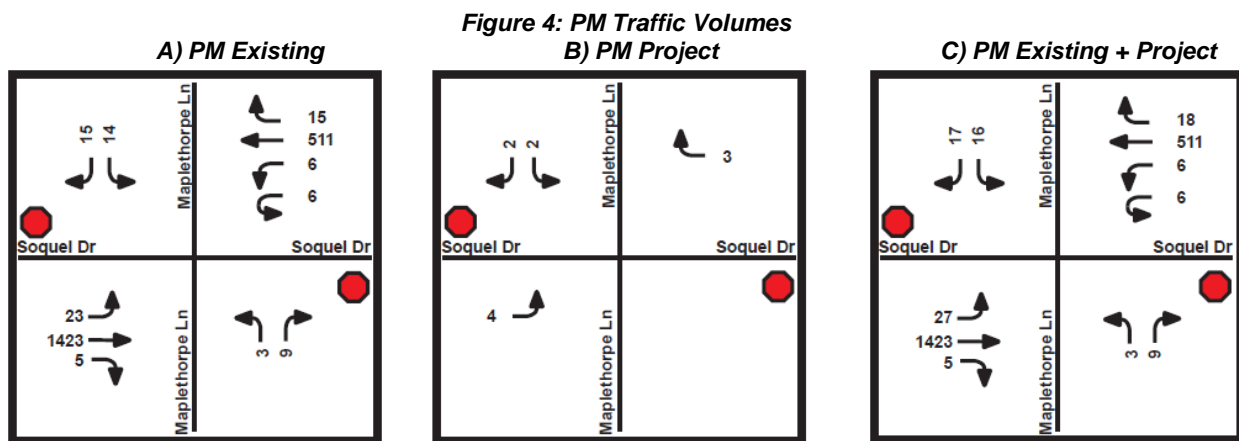
The analysis indicates that the PM peak demand at the study intersection occurs from 4:15pm to 5:15pm. During this peak, the intersection operates at an overall LOS A. The southbound side-street approach operates at an LOS D under existing conditions. Under existing plus project conditions, the overall intersection is LOS A and the side-street operates at a LOS D. This peak's side-street delay and LOS is better than the City's minimum requirements; therefore, the intersection operates at acceptable conditions. **Figure 4** below shows the PM traffic volumes for all analysis conditions. **Table 5** shows the existing analysis results and existing plus project analysis results with SSSC.

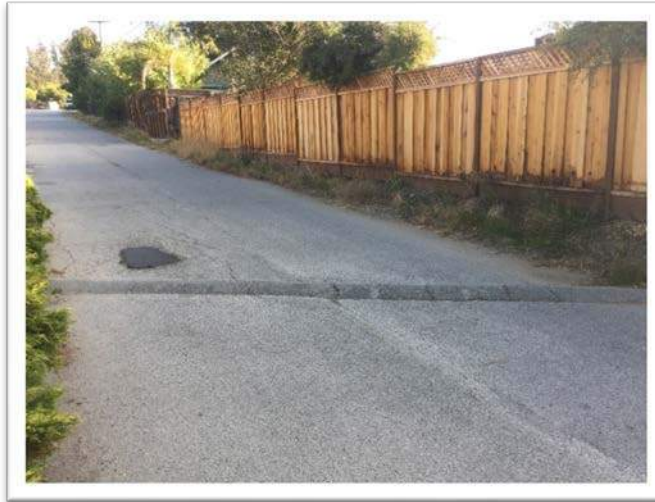
Figure 7: Existing Maplethorpe Lane Speed Bumps

As discussed previously, speed data shows that operating speeds of drivers are close to the speed limits along the study roadways. Additionally, Maplethorpe Lane has speed bumps as shown in **Figure 7**.

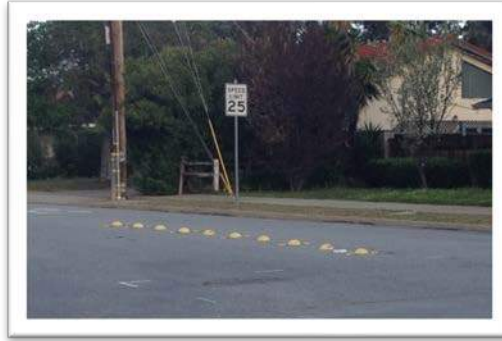
Figure 9: "Armadillo" Raised Pavement Markers (Cupertino, CA)

One alternative that could accomplish this improvement is “armadillo” raised pavement markers along the centerline of both Mulberry Drive and Colleen Way. See **Figure 9** and **Figure 10** examples for

application. This treatment could be implemented at a low-cost and without a reduction in on-street parking.

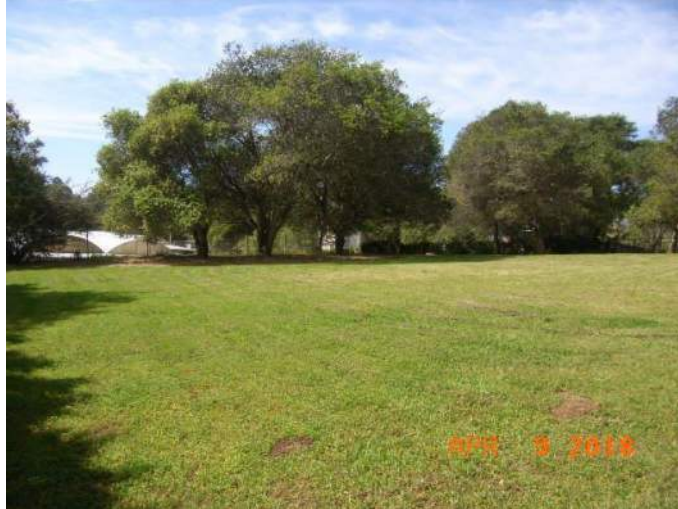
Wildlife Resources. The non-native grassland habitat provides little value to native wildlife, due to its fragmented nature at this site, mowing, and the predominance of non-native vegetation. The weedy, grassy areas do provide some forage for wildlife that can tolerate the high human presence in and around the site such as rock dove (*Columba livia*), California towhee (*Pipilo crissalis*), and Botta's pocket gopher (*Thomomys bottae*).

Figure 3. Non-native Grassland in North-Central Portion of Property

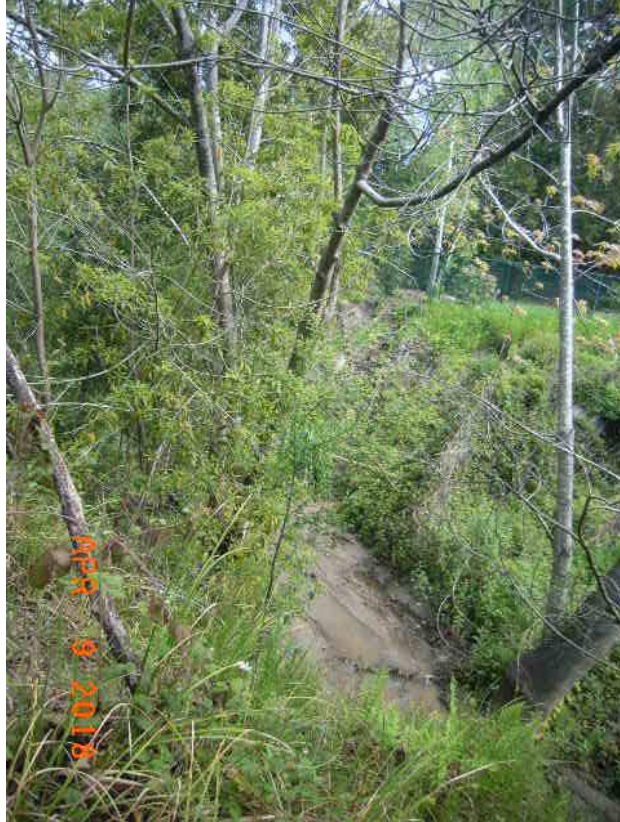
Wildlife Resources. The riparian habitat on the property provides the cover, forage, nesting opportunities for some birds and mammals, seasonal source of drinking water, and moist microclimate along the creek and embankments in the understory. The value of this riparian is moderated by the proximity to residential uses and high human activity. Common wildlife species expected to occur in riparian habitat on the property include California slender salamander (*Batrachoseps attenuatus*), scrub jay (*Aphelocoma californica*), acorn woodpecker (*Melanerpes formicivorus*), black phoebe (*Sayornis nigricans*), western gray squirrel (*Sciurus griseus*), and raccoon (*Procyon lotor*). This intermittent creek does not support any fish.

Figure 4. Riparian Woodland along Intermittent Creek

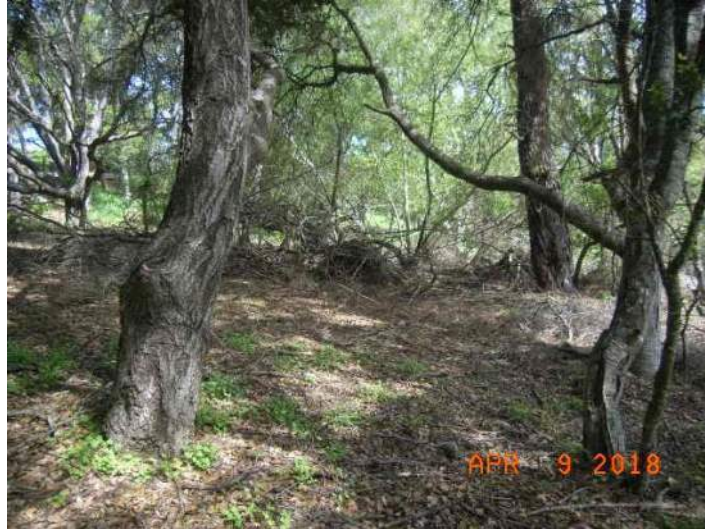
Wildlife Resources. The use of the oak woodland habitat by wildlife is expected to be similar to that described above for the riparian woodland. The value of the oak woodland in the area of proposed Unit #9 lacks any understory vegetation or downed woody debris, and thus has less diversity of niches for wildlife, such as found in the oak woodland areas just to the north of Unit #9 which will not be disturbed by the project. A large San Francisco dusky-footed woodrat (*Neotoma fuscipes annectens*) house was observed in the more intact oak woodland and is located approximately 70 feet north of proposed Unit #9.

Figure 5. Oak Woodland, prime

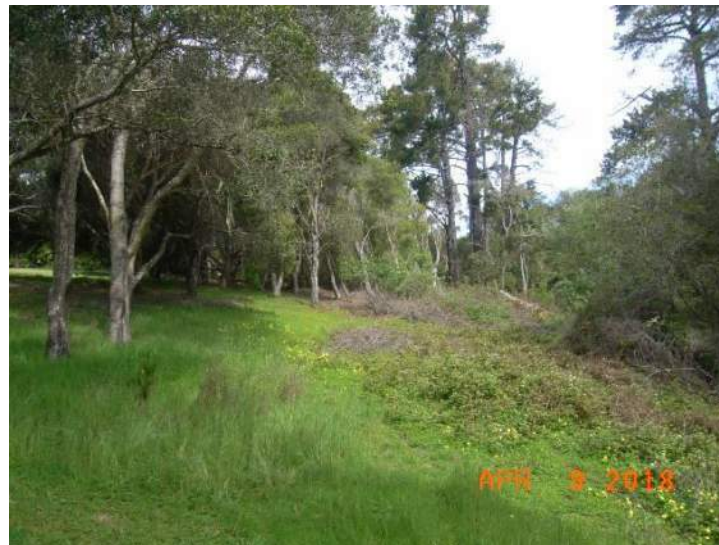
Figure 6. Blackberry Scrub

A small area of blackberry scrub grows westward of the riparian woodland. This scrub is dominated by California blackberry and poison oak. Figure 6 shows the blackberry scrub.

Wildlife Resources. This habitat type is expected to be similar to that described above for riparian woodland for use by wildlife. The berries provide forage and the thicket provides cover and nesting opportunities for several native wildlife species.

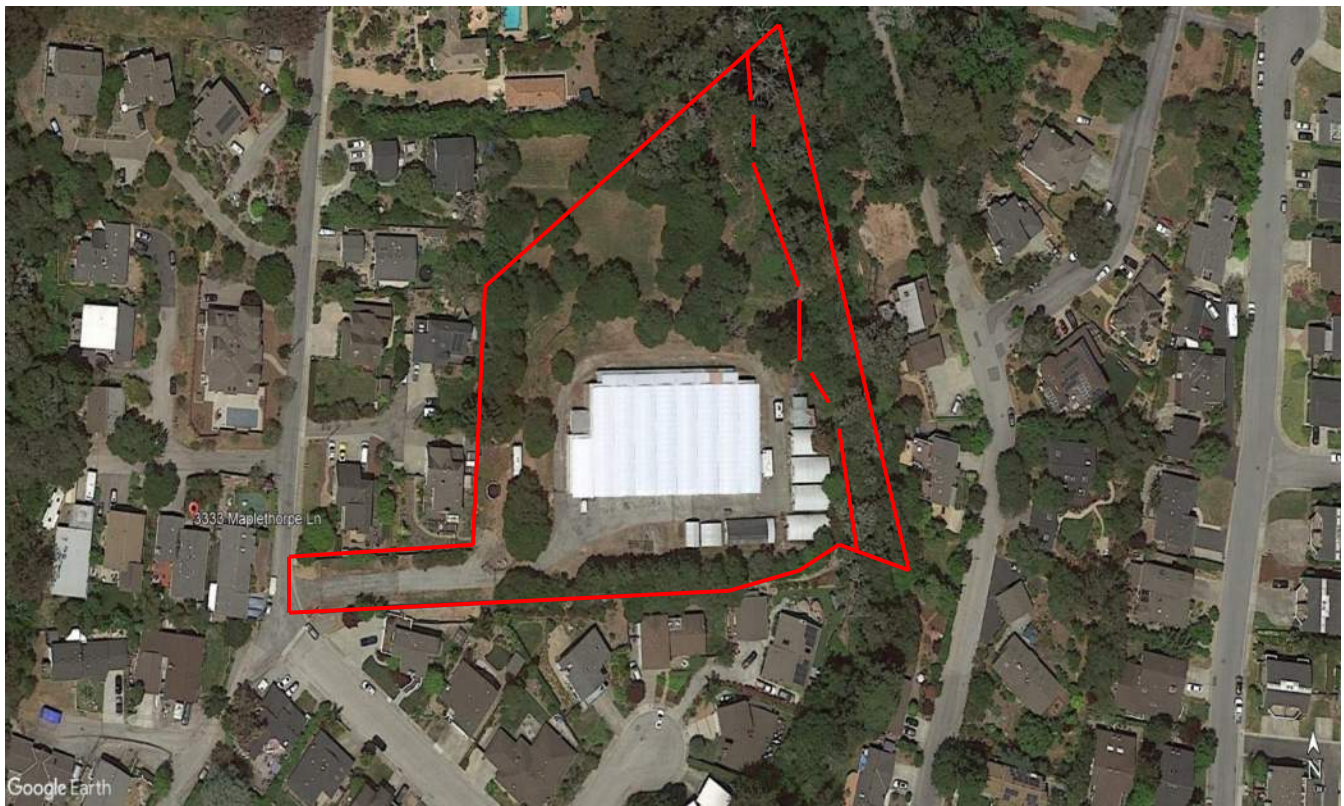
The property is located at 3333 Maplethorpe Lane, Soquel. Much of the project site has been graded and is currently occupied by a series of greenhouses that served a commercial nursery production (Image #1, below). The land surrounding the green houses is ungraded. The terrain ranges from sloping to level and is bordered on the east perimeter by a seasonal creek. This creek and a riparian setback are located outside the project limits.

Image #1 – Approximate property boundaries. Approximate area of riparian setback, (to right of dashed line), is outside project limits.

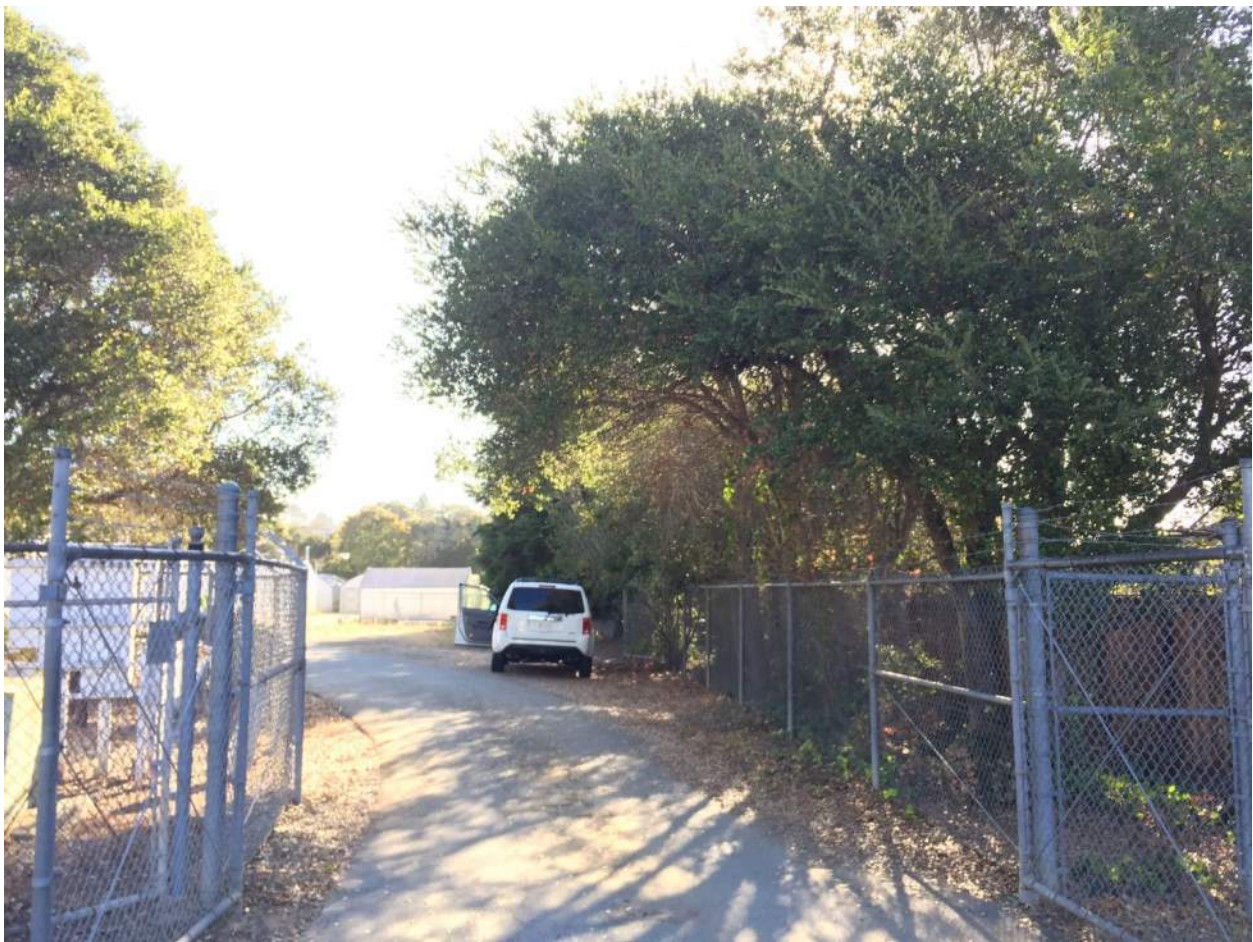
Image #2 – A long row of oaks (right side of image), along southern perimeter.

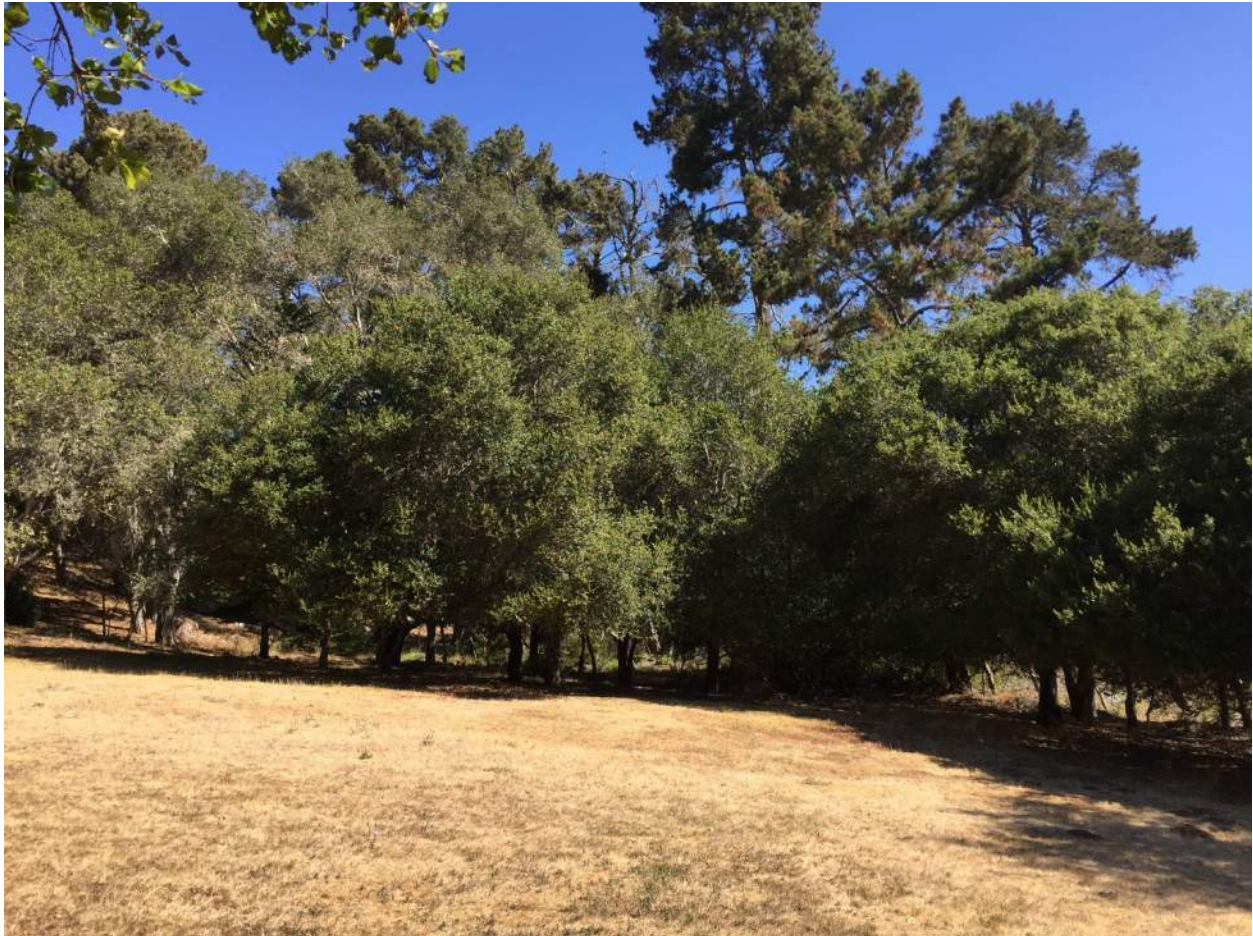
There is a very dense grove of coast live oaks on the upper eastern edge of the project limits (Image #3), and many of these trees have unbalanced (one-sided) canopies, due to their closely spaced arrangement.

Image #3 – Grove of coast live oak on north east side of project boundaries.

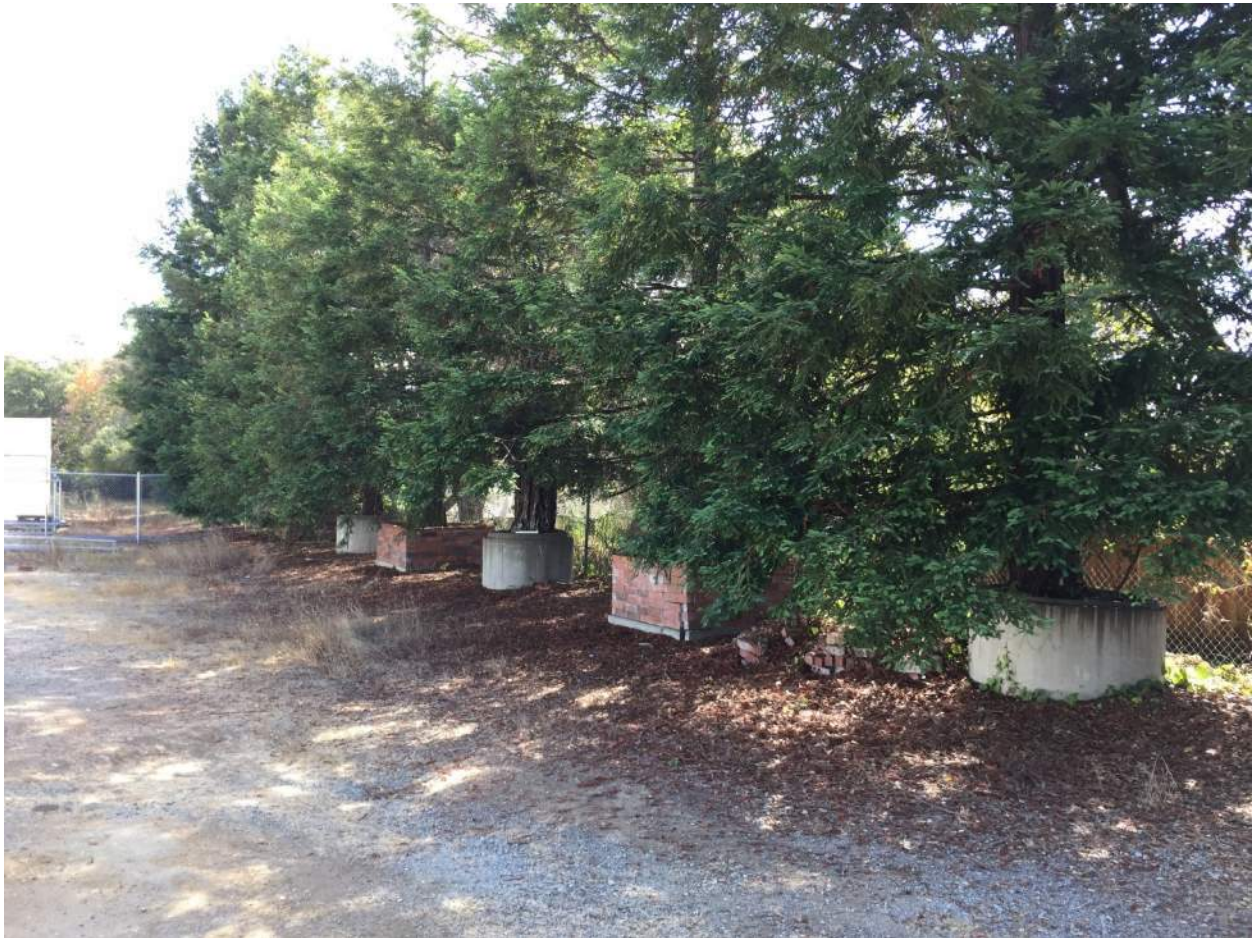
There are seven young coast redwoods (*Sequoia sempervirens*), growing in large concrete planter boxes near the south perimeter (Image #4). Finally, one young cypress tree (*Hesperocyparis sp.*) was inventoried.

Image #4 – Row of coast redwoods located in planter boxes along southern perimeter. These trees compete for available light and space and suppress the canopy development of the coast live oaks located behind them.

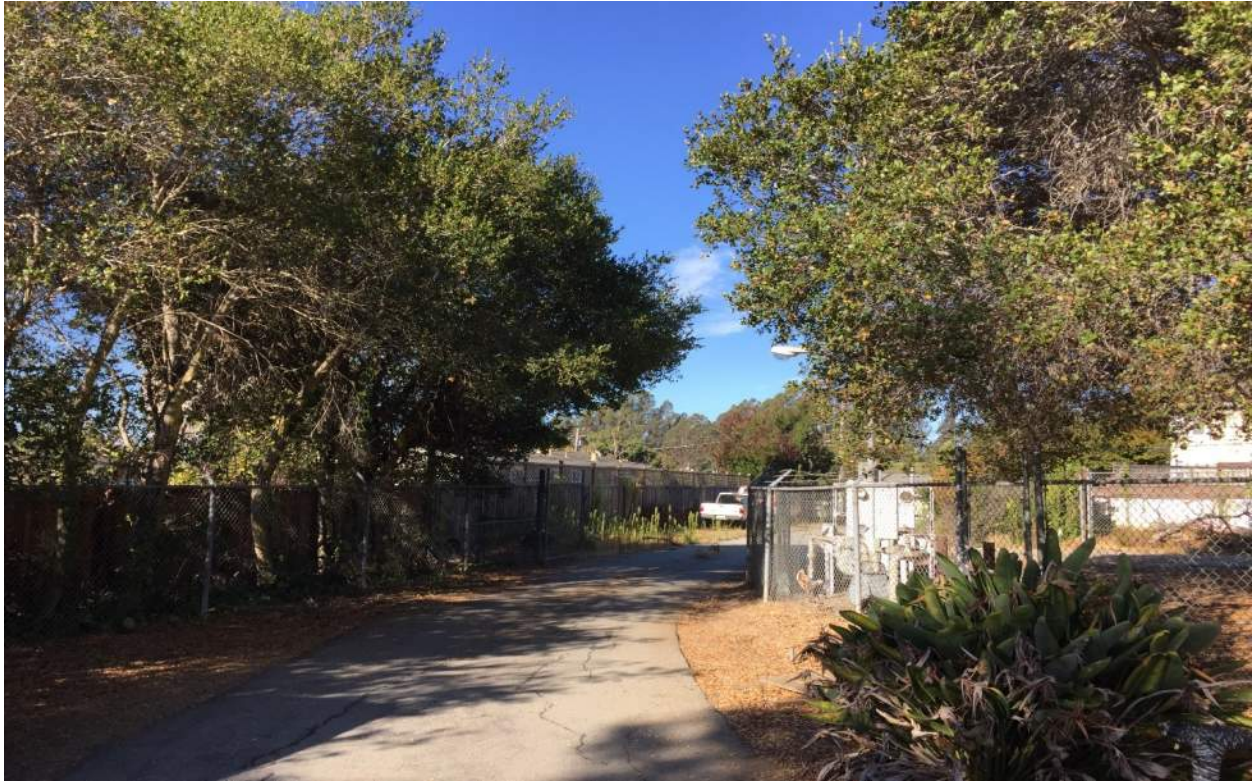
Image #5 - Entry Area. Trees T1 – T6 on left, canopy of tree T83, on right.

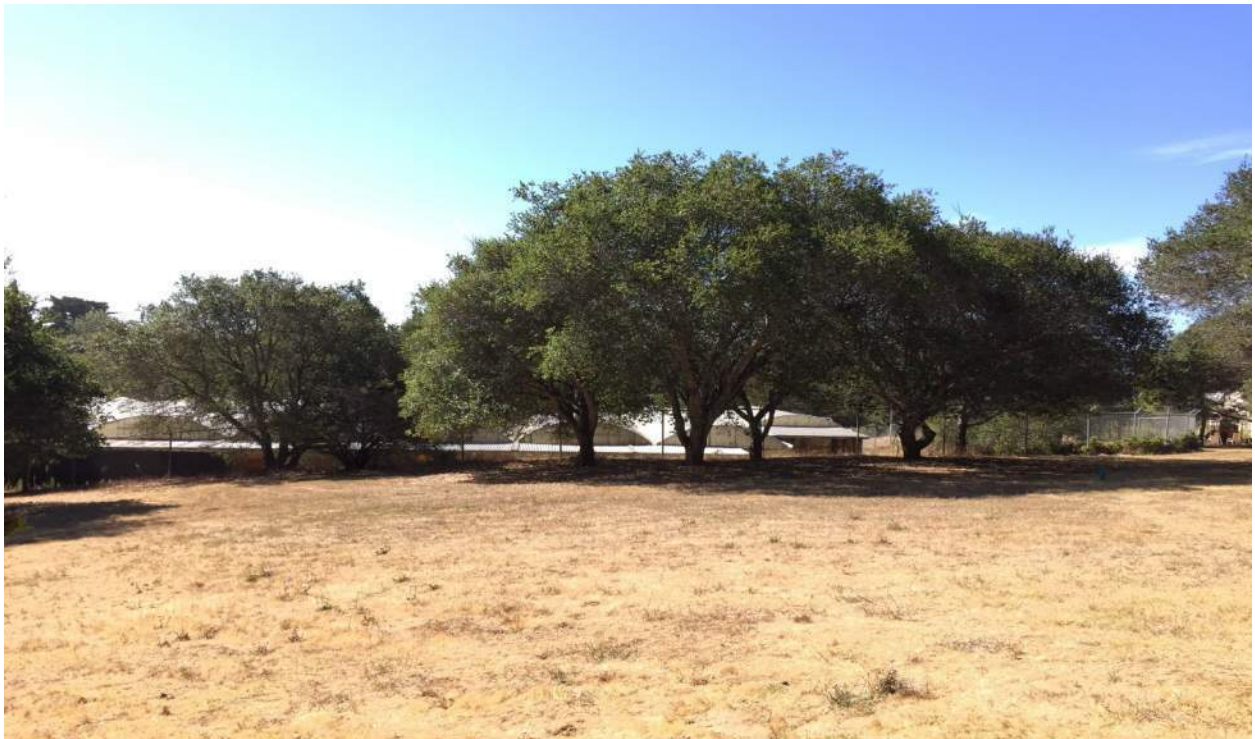
Image #6 – Looking south. Trees T58 -62 & T25, to be retained. Unit #9 proposed for open area (foreground), of trees.

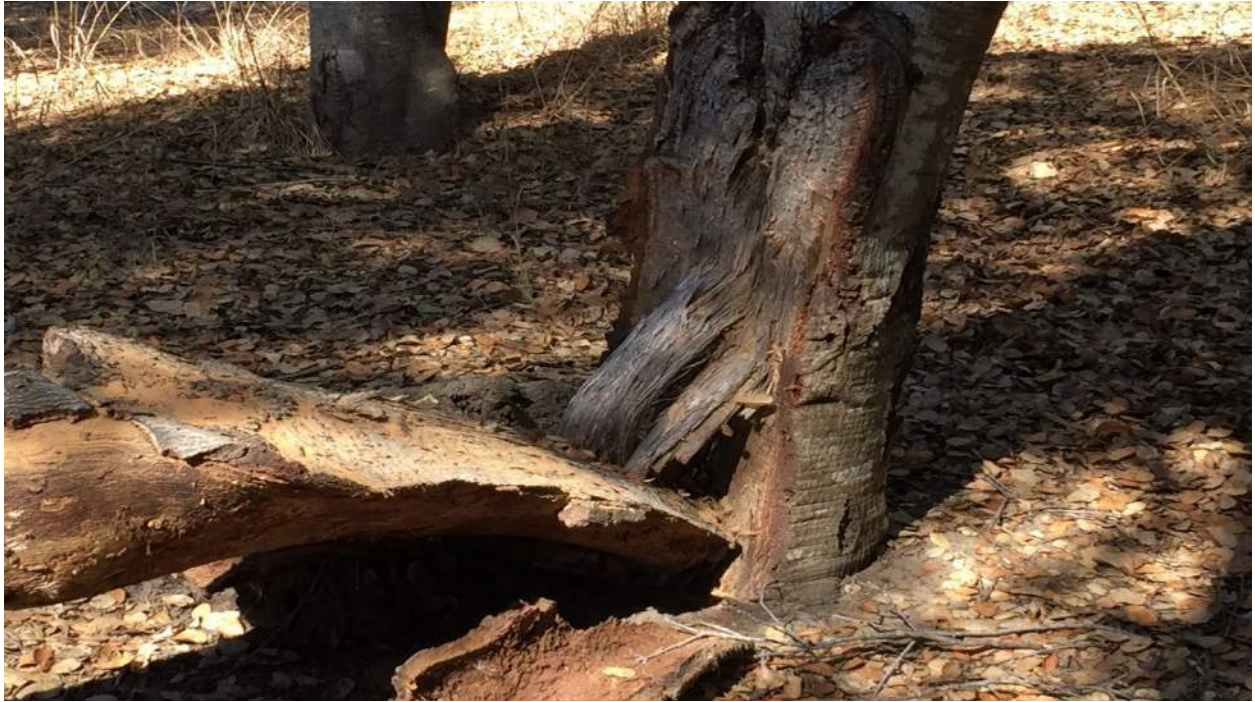
Image #7 - Example of a tree in poor condition. Tree T37 with portion of trunk missing from previous trunk failure.

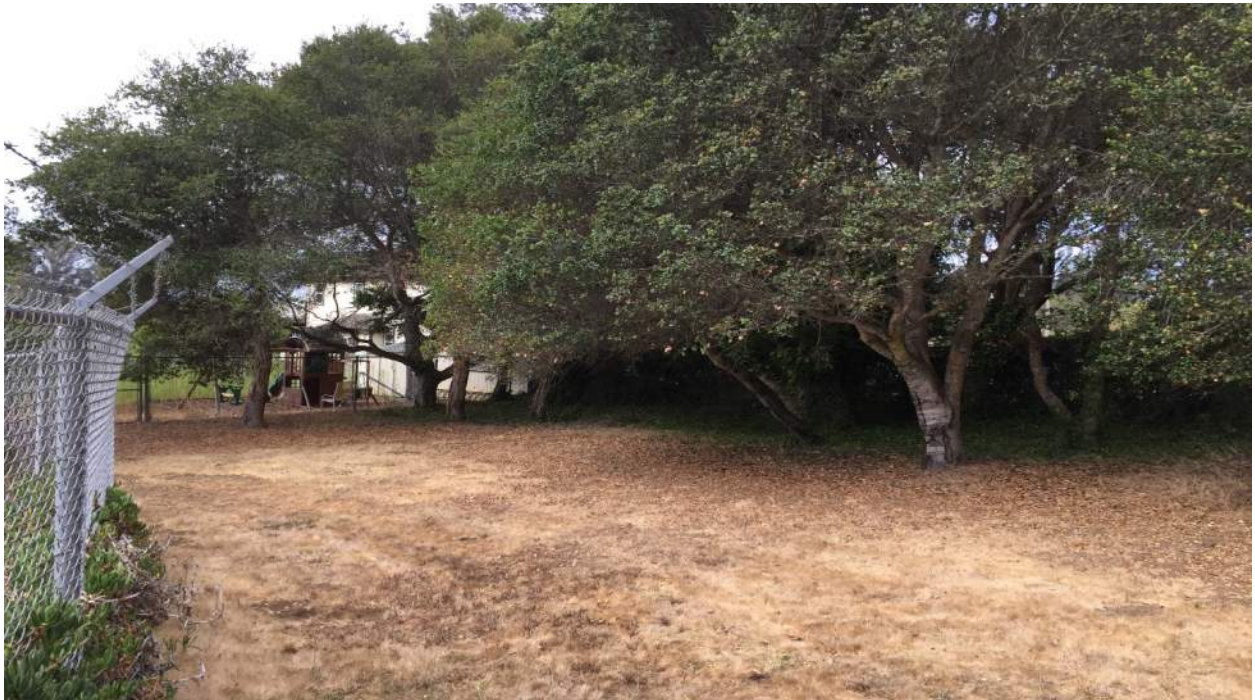
Image #8 – Looking southwest. Trees T71,73 & 77, upper right, to be retained. Trees T78 – 81 lower left will require removal (in foot print of Unit #1).

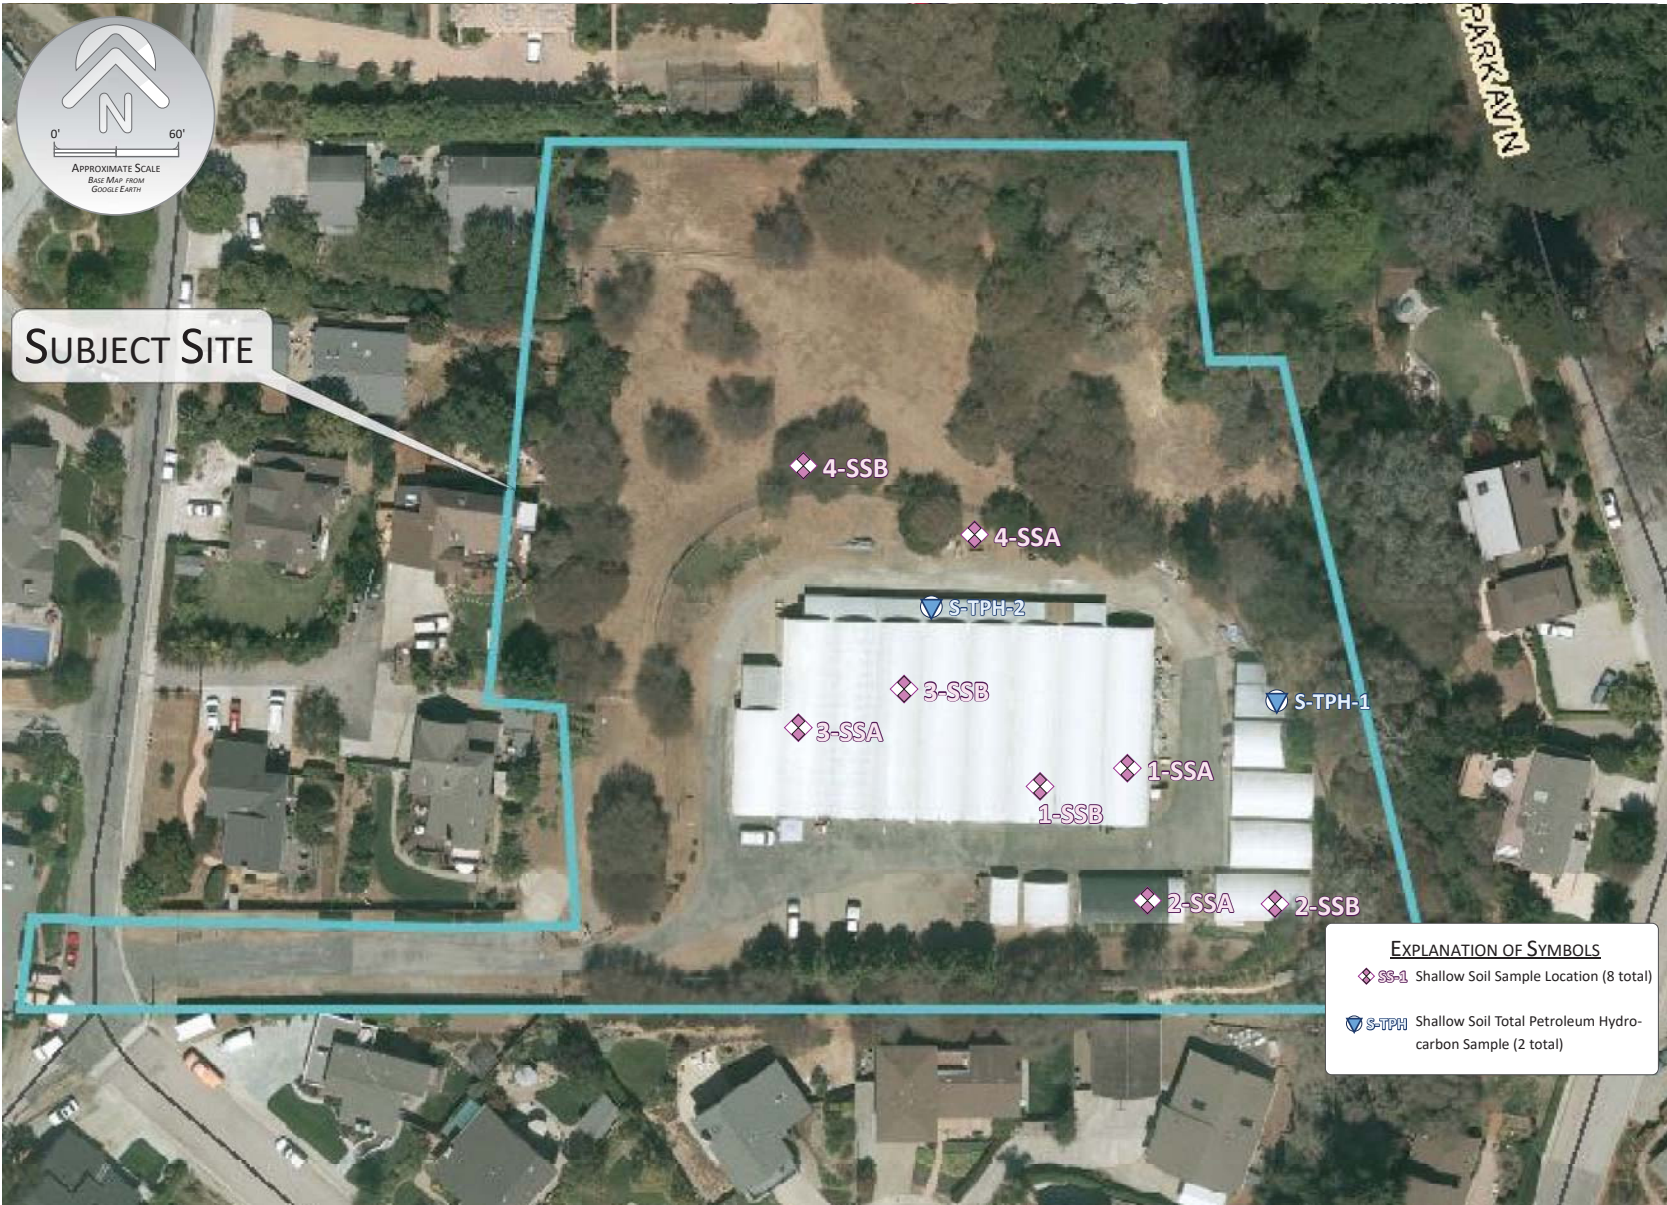
- ◆ SS-1 Shallow Soil Sample Location (8 total)
- ◆ S-TPH Shallow Soil Total Petroleum Hydrocarbon Sample (2 total)

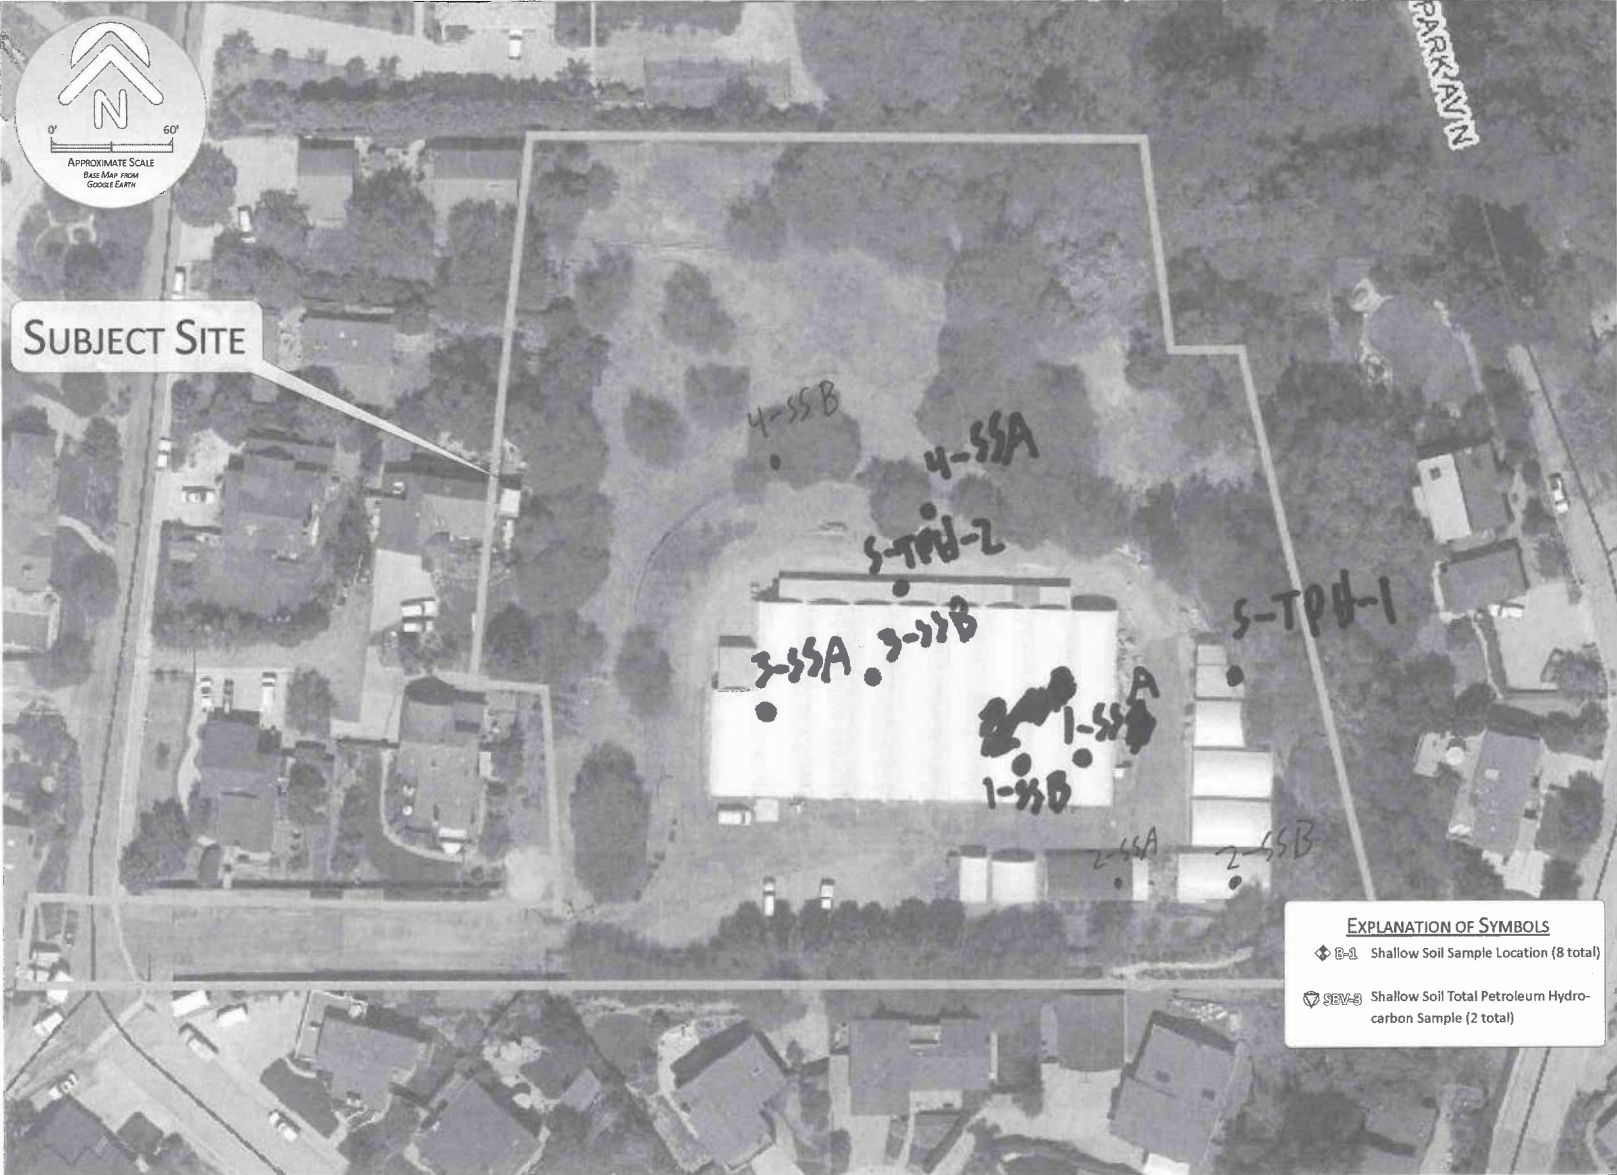
FIGURE 1
Project
2X/16

EXPLANATION OF SYMBOLS
 ◆ S-1 Shallow Soil Sample Location (8 total)
 ◆ SEV-8 Shallow Soil Total Petroleum Hydrocarbon Sample (2 total)

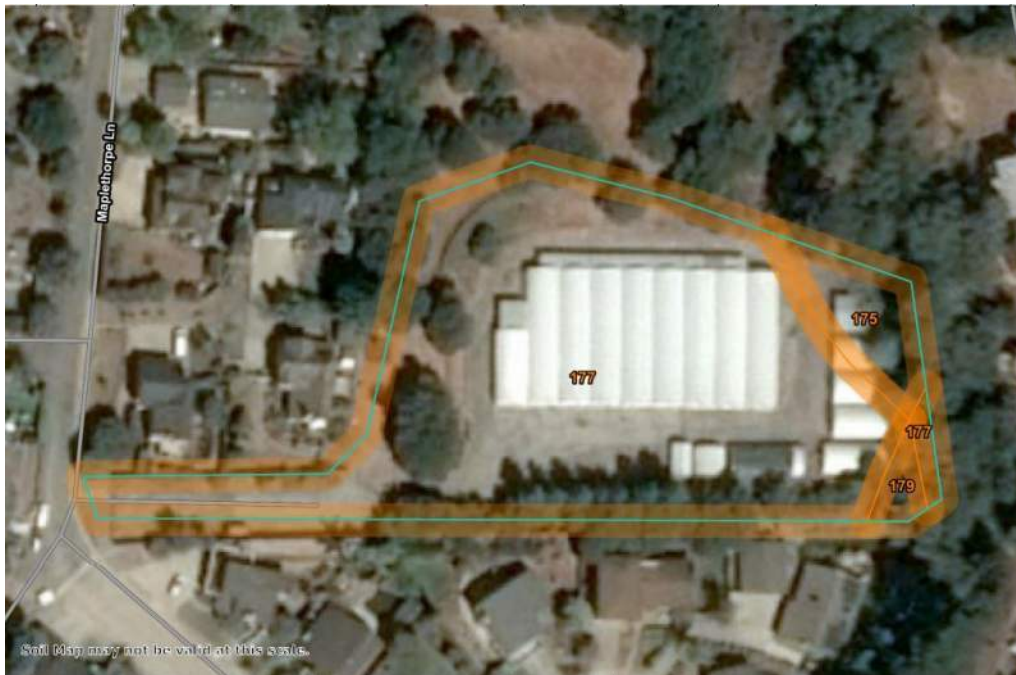
FIGURE 2: SOILS MAP

The soil at the site consists primarily of Tierra-Watsonville Complex (Soil Type 175), with small areas of Watsonville Loam (Soil Type 177 and 179) per NCS Web Soil Survey Website. These three soil types are poorly drained, with average infiltration rates ranging from 0.00 in/hr to 0.06 in/hr. See the site location on the map shown in Figure 2, below, and NRCS Soils Data in Attachment A.
