Initial Study Attachment 1

County of Santa Cruz

MITIGATION MONITORING AND REPORTING PROGRAM for Application No. 181586

TENTATIVE IMPROVEMENT PLANS

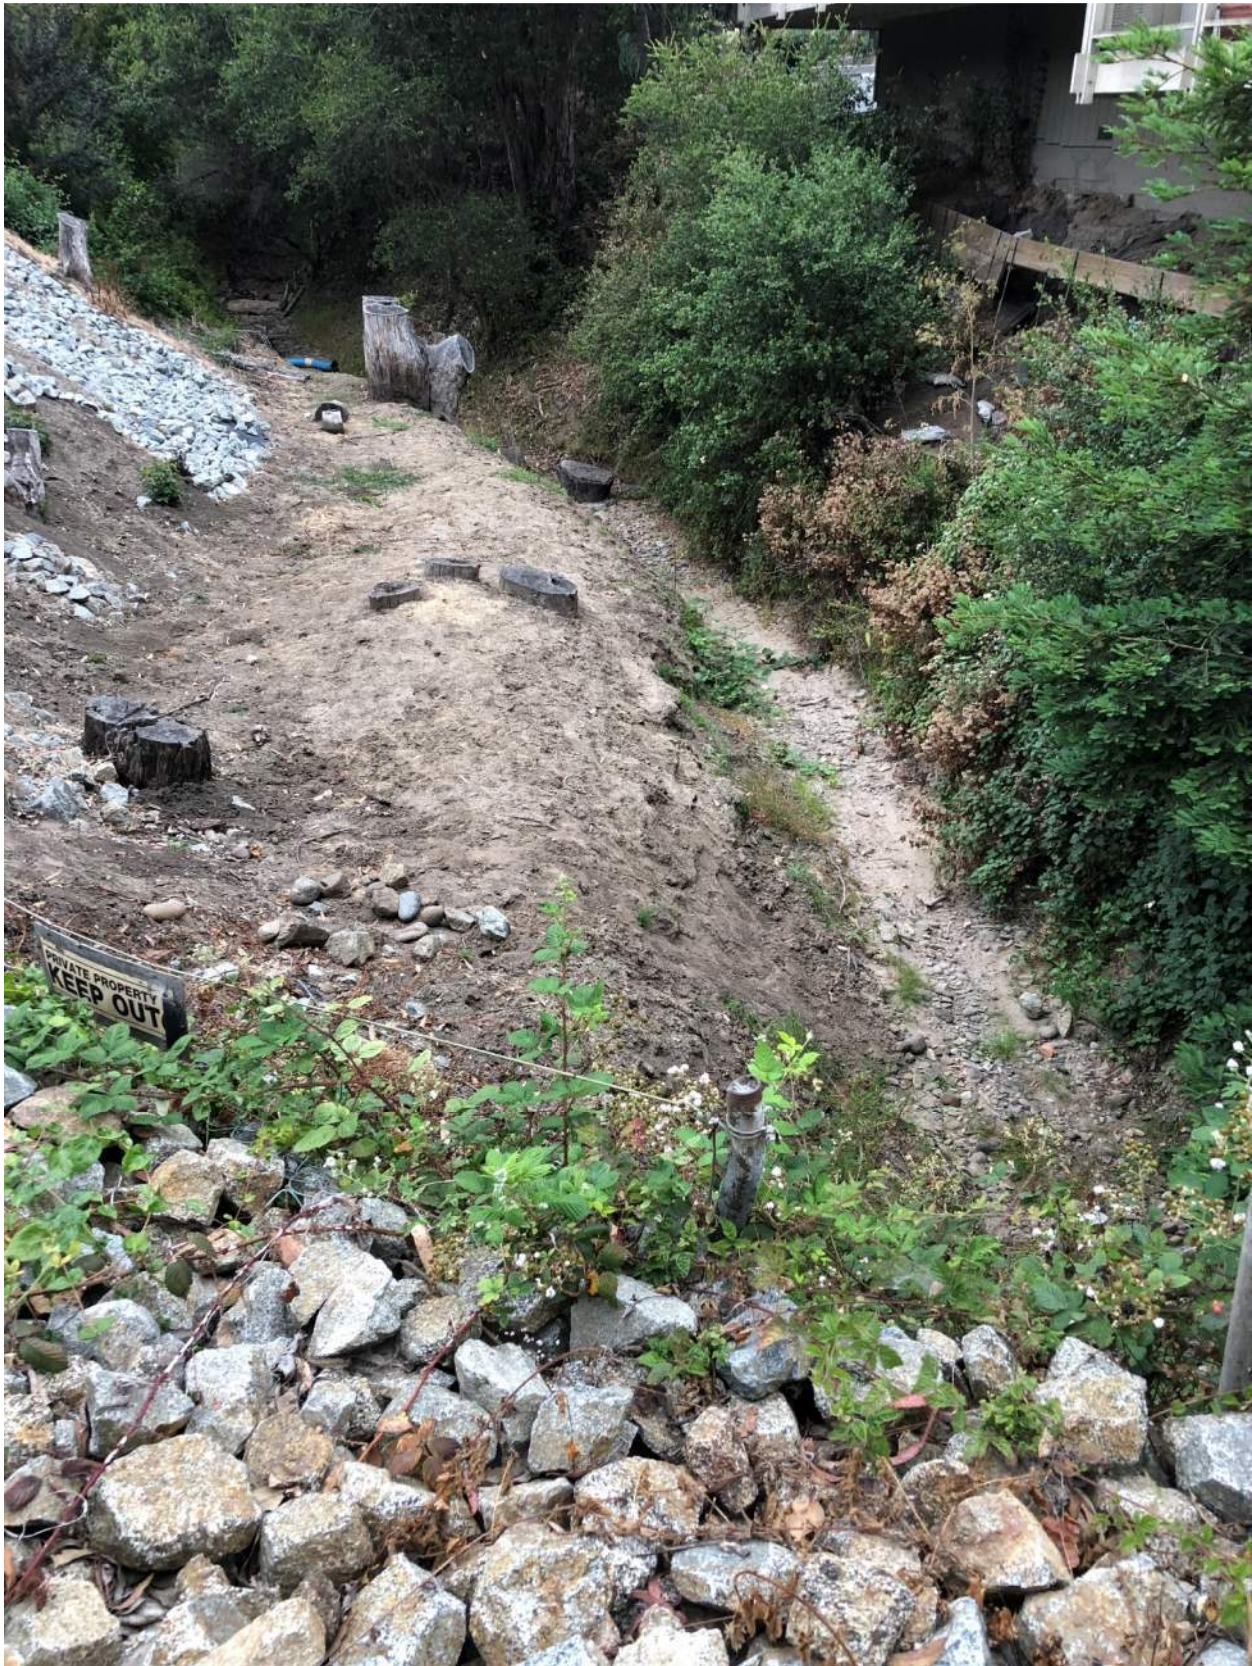
Figure 3- Existing Channel

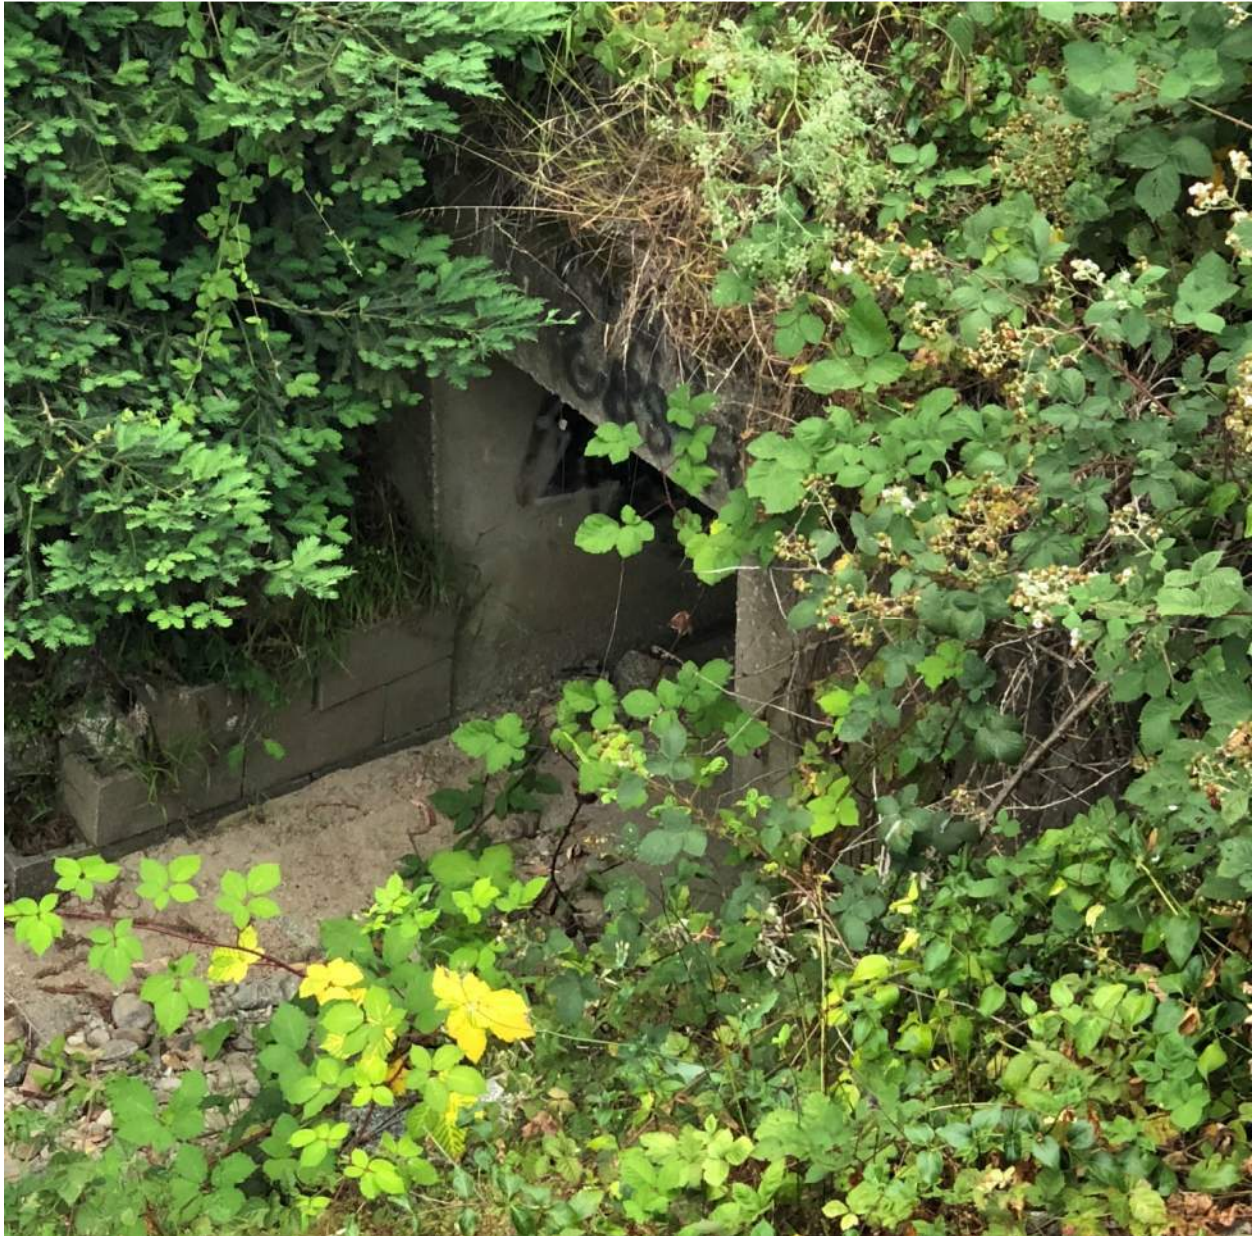
Figure 4- Existing Culvert

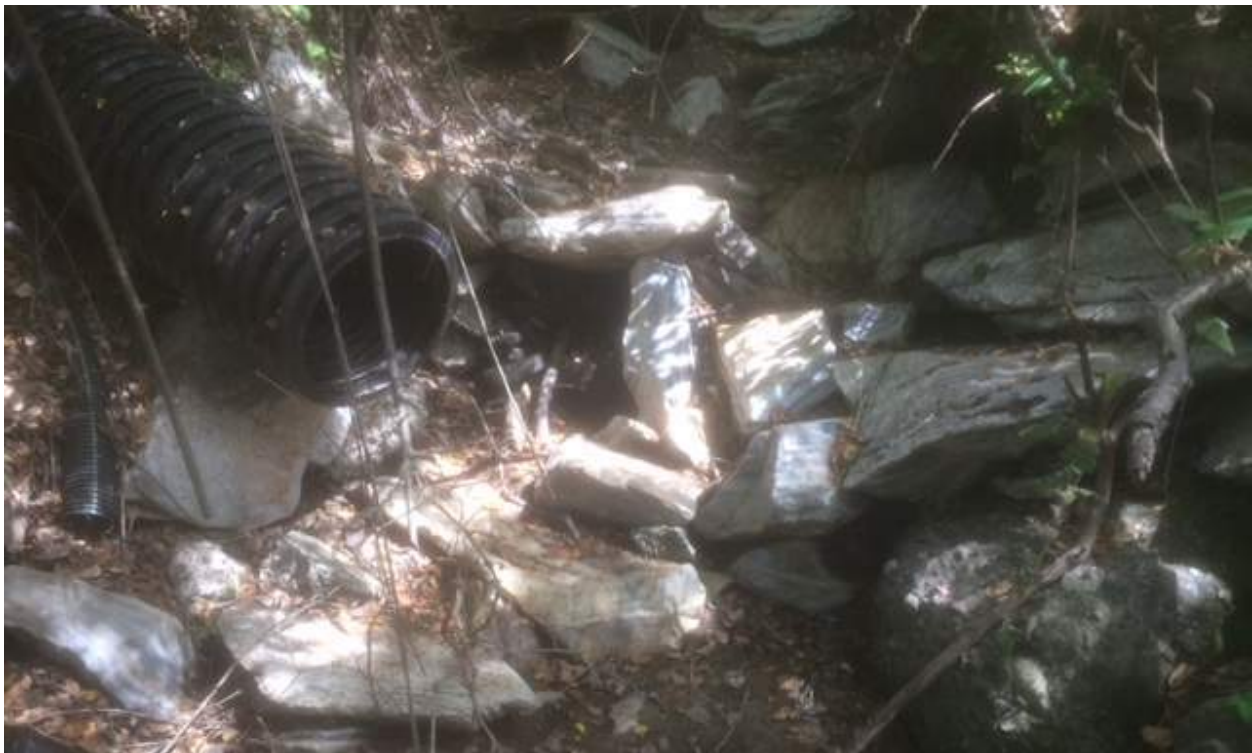
Figure 5- 15" CPP Culvert Discharge Point

The discharge point (invert) of the CPP culvert is approximately 1.39-feet above the flowline of the ravine. The discharge is protected by a rip-rap energy dissipater (see figure 5, below)

The 10-year design storm flow rate of approximately 105.84 cfs results in a flow depth at the CPP discharge point of approximately 1.36-feet, leaving approximately 0.03-feet of freeboard below the CPP culvert invert. As the CPP culvert represents the highest point at which flow from the proposed improvements enters the ravine, flow depth upgradient of this location will remain unchanged by the proposed work. Calculation of flow through the ravine (channel) at the CPP discharge point is shown in Figure 6, below (Note that all channel and culvert flow calculation were performed using AutoDesk's Hydraflow Extension for AutoCAD Civil 3D):

Flowline length of the existing ravine in the area of interest is approximately 135 linear feet, sloped at approximately 6.3%. The bottom of the ravine averages 1.5-feet in width, with side slopes varying from 6:1 to 1:1. The ravine includes one significant point of interest, where a 15-inch corrugated plastic pipe (CPP) culvert discharges into the ravine.

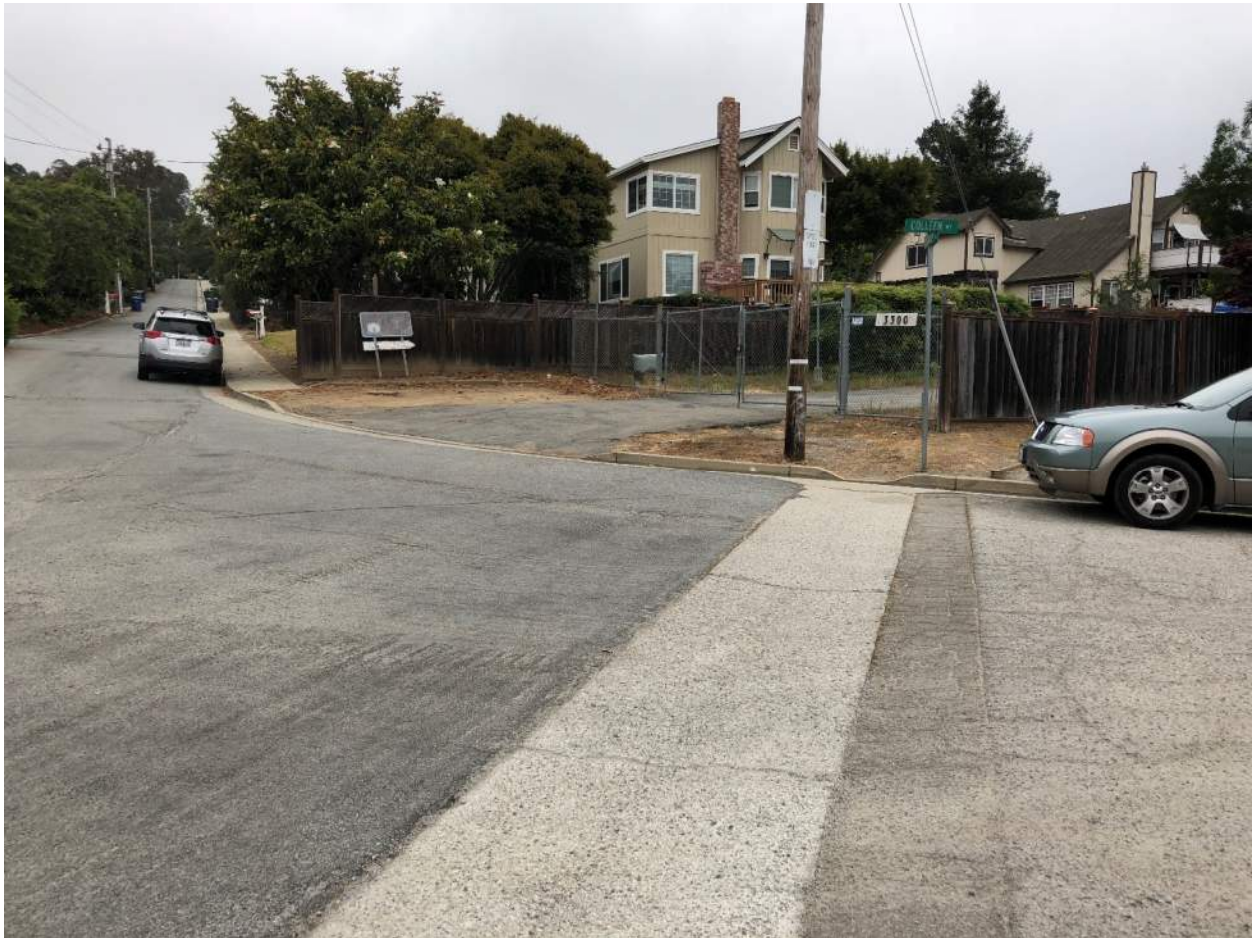
Figure 8- Existing Conditions at Site Entrance

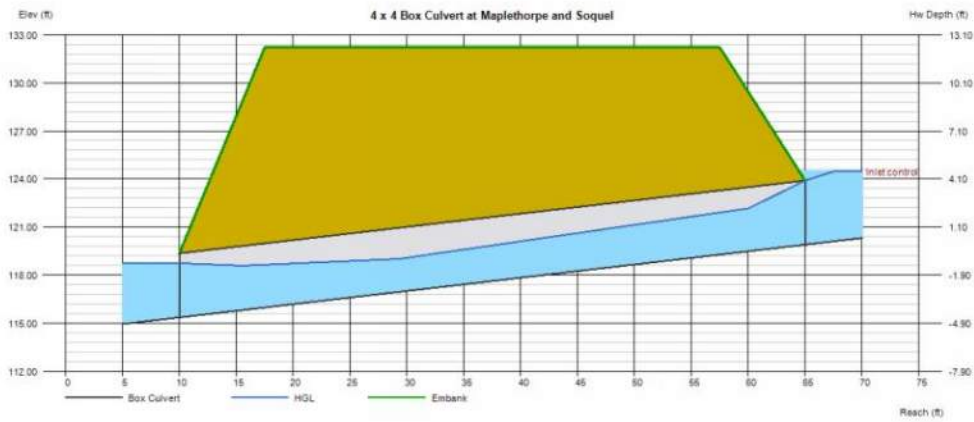
Figure 10- Culvert flow

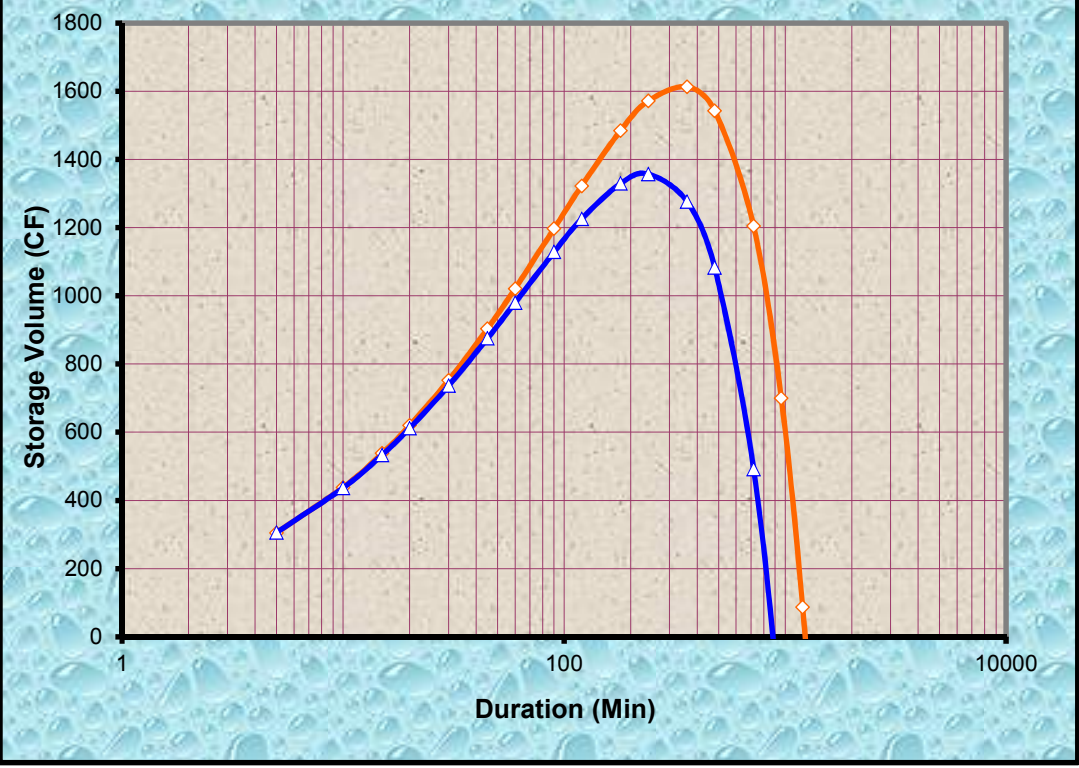
Chamber Model HS180
 Number of Chambers 12
 Number of Endcaps 6
 Stone Voids (porosity) 40%
 Base of Stone Elevation 171 ft
 Recommended Stone Below Chambers* 12 in.
 Recommended Stone Above Chambers* 12 in.
