HISTORIC RESOURCE EVALUATION

Mission Springs Camps and Conference Center
1050 Lockhart Gulch Road
Scotts Valley, CA 95066

September 6, 2016

Zinn Geology, Preliminary Geological Feasibility Report,
December 2016

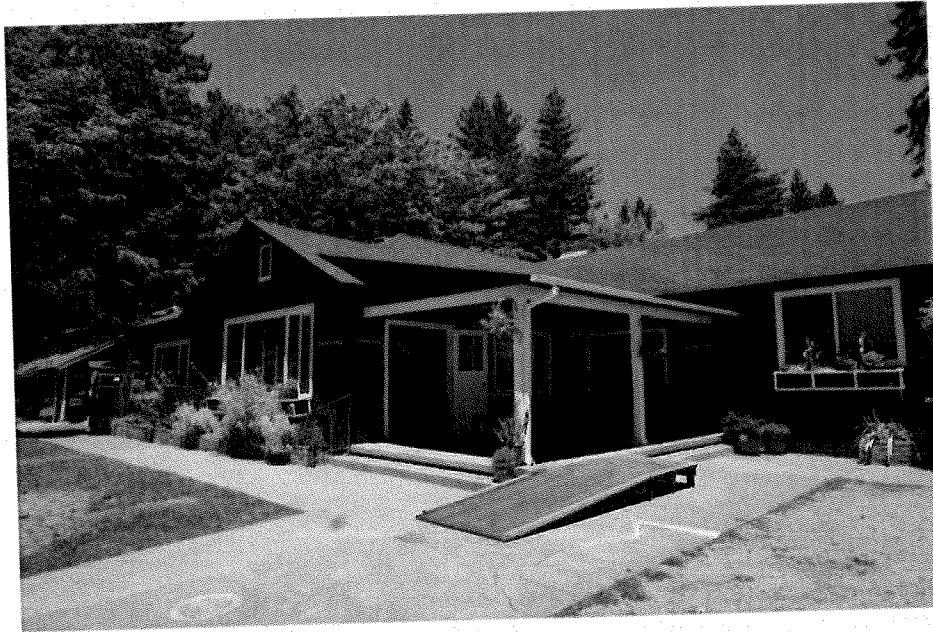
Figure 8: The main entrance at Fireside Hall, 2016.

Fireside Hall stands directly across from the vehicular bridge at the Mission Springs' southern entrance and just south of the central lawn. West of the building is the dining hall, and the basketball courts are located to the east. The single-story, wood-frame building is generally L-shaped in plan, covers 4,210 square-feet and features an asphalt shingle-clad combination gable, hipped and shed roof with exposed rafter tails at several eaves. Wide, horizontal shiplap siding clads the building's exterior, and sliding vinyl windows with flat wood surrounds are typical throughout. The foundation appears to be poured concrete with sections of decorative brickwork at the base extending into low planters at the south side. Paved concrete pathways surround the building and a raised concrete porch covered by a shed roof extension protects the primary entrance at the center of the south façade. Two pairs of double single-lite doors open off of the entry porch: one in the east façade and one in the south façade. A plywood-clad chimney stands centered at the east gable end wall and a brick chimney extends from the roof near the junction of the hip and the gable.

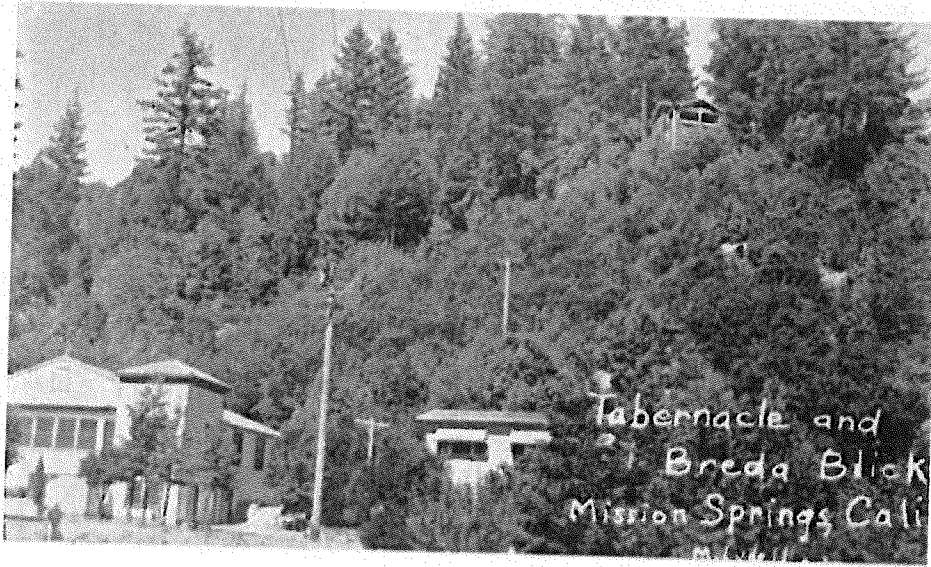
*Figure 10: View of the Tabernacle from the approximate location of the present day Maintenance Office.
Source: Mission Springs, 1944.*

No documentation has been found to confirm the construction dates of the Maintenance Office and three cabins at the RV Park. A thorough inspection of historic photographs in combination with the on-site analysis indicates that the Maintenance Office was likely constructed in the 1960s or later. At this time there is no definitive proof that the building is fifty years old. In regards to the cabins at the RV Park, there also is no definitive proof as to the exact age of the buildings. Most likely they were constructed post-1962, when several existing cabins were demolished and a use permit for a trailer park was issued. Given the type of construction and the lack of any similar detailing to any other buildings at the Mission Springs grounds it is unlikely that these cabins are meet the minimum age requirement.

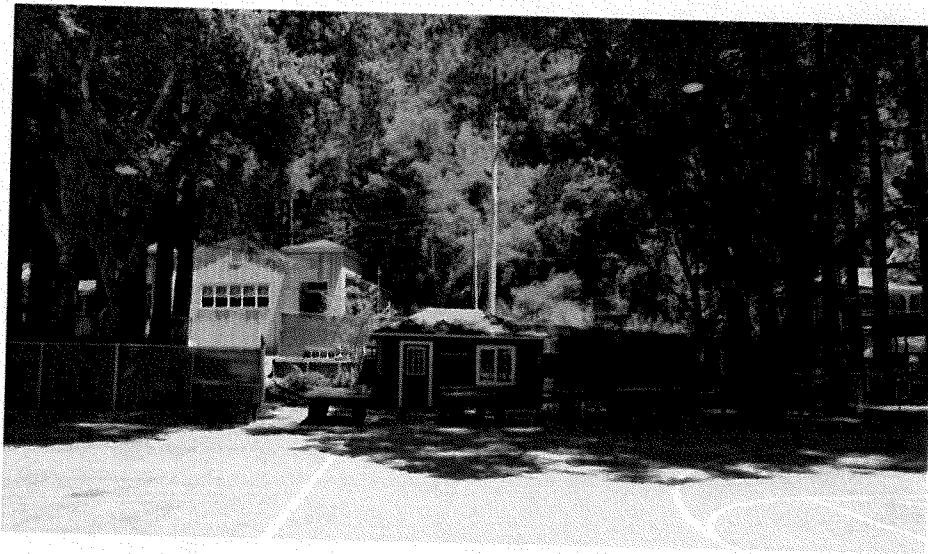
Figure 11: Maintenance Office front façade, 2016.

The small, single-story, hipped-roof maintenance office stands at the eastern edge of the paved basketball court, just below the Old Tabernacle. The rear, eastern wall of the structure is built into the retaining wall located along the western edge of Tabernacle Drive. The building is rectangular in plan and covers a footprint of approximately 150 square-feet. A poured concrete foundation, which steps up to the eastern retaining wall, supports the exterior walls clad in painted shiplap siding with flat corner boards. Asphalt shingles cover the roof. Wood rafter tails extend under the eave at all four sides and a gutter stretches across the eave at the front, west façade. The west façade features the only openings with one, flush door penetrated by a nine-lite window and one sliding vinyl window with false muntins. Both opening maintain flat wood surrounds.

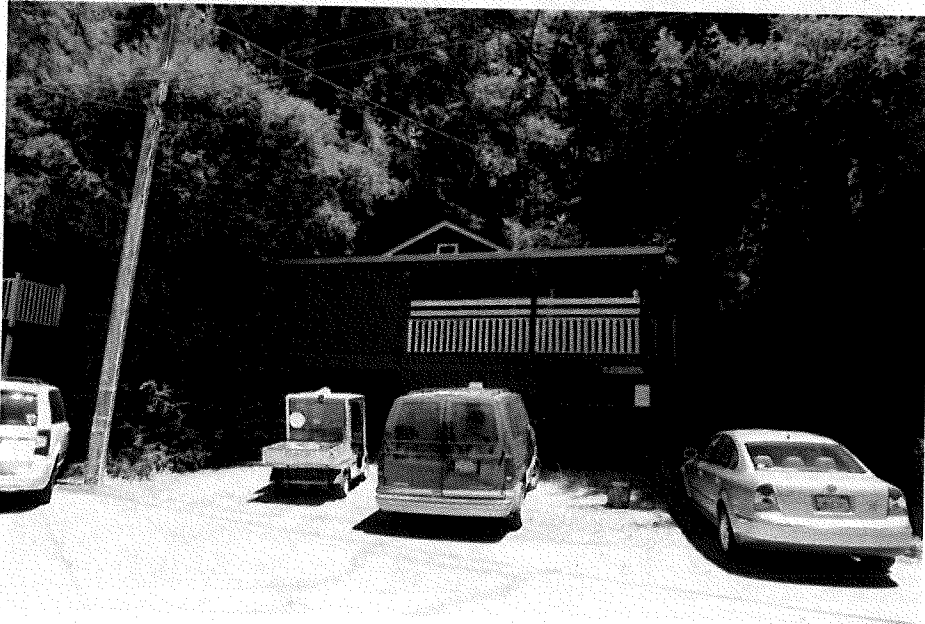
Figure 19: 316 Tabernacle Drive front façade, 2016.

carport and storage room addition to the southwest. Concrete steps lead from the Tabernacle Drive up to the deck and front entrance. The house maintains a variety of siding types including: vertical T-111 board, vertical board and batten, shiplap with a half round profile and V-groove shiplap. The majority of the fenestration consists of replacement sliding vinyl window units with flat wood surrounds. However, the north façade is punctuated by three wood windows: one six-lite and two nine-lite units. Additionally, three skylights have been installed at the roof. Concrete footings are visible beneath posts at the deck and a segment of a poured concrete foundation is extant under the main house. One flush door provides access from the deck at the west side and a modern fiberglass door serves as the main entrance in the south façade.

The building's design presents numerous alterations. A large, two-story, flat-roofed deck, carport and storage area addition extends out from the front of the cabin obscuring the original design features. Further, much of the original siding material has been replaced, as have most of the windows and exterior doors. Only a few character defining features remaining including some of the wood siding and potentially two original windows. Due to the significant alterations, the building does not retain integrity of design.

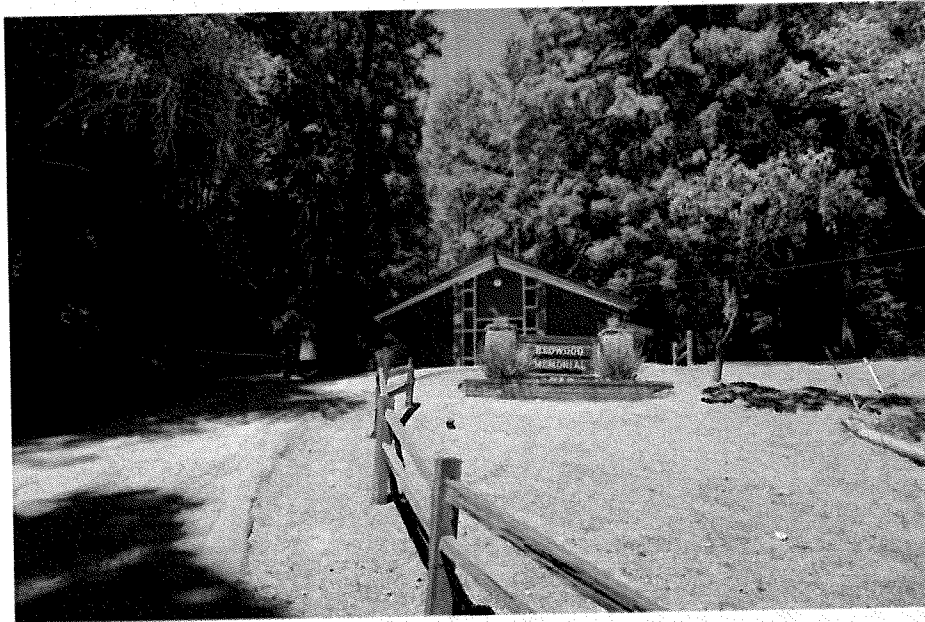
Figure 24: Redwood Memorial Chapel, 2016.

Standing alone at the top of a steep driveway just west of and downhill from the pool facility is the 1,240 square-foot Redwood Chapel. The single-story building is rectangular in plan with an asphalt shingle-clad gable roof and a poured concrete slab foundation. The roof features wide overhanging eaves with exposed rafters, a plain wood fascia and an extension supported by wood posts at the northeast corner to provide a cover over an exterior concrete patio. The building is clad in vertical board and batten siding, except at the front entry configuration. The main entrance is centered on the south, front façade beneath a wide eave and pronounced wood beam, and consists of a center bay with a pair of flush doors topped by a fixed single-lite transom and an expanse of natural-finished horizontal siding above. Flanking the center bay are two five-lite fixed wood-framed windows spanning from the floor to the ceiling and infilled with glass of alternating colors. Two stone-clad piers extending out from the face of the wall complete the chapel entrance which is lit at the exterior by a hanging globe light fixture.
