**Williams Tree Service Property
Plan for Riparian Habitat Restoration Buffer and Visual
Buffer Planting**

Williams Tree Service Riparian and Visual Buffers

October 6, 2016

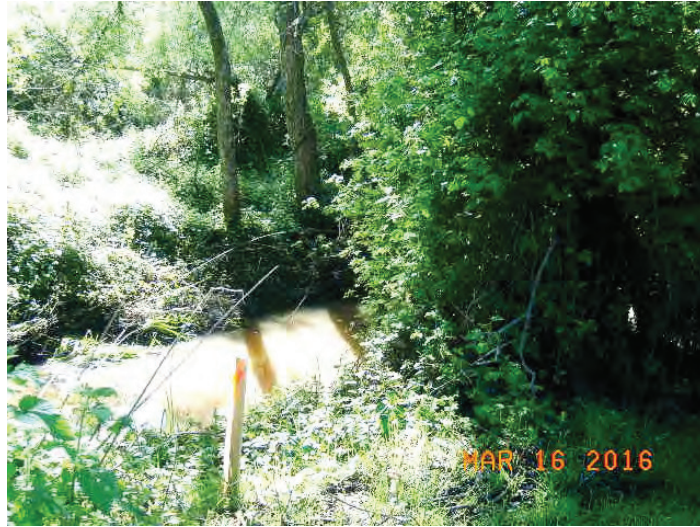
Figure 3. Willow riparian woodland along Harkins Slough on APN 052-511-08

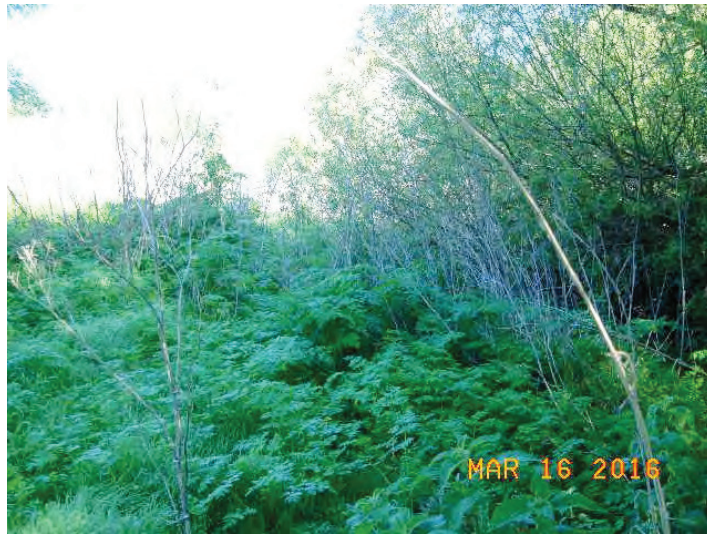
Figure 4. Willow riparian woodland along west bank of Harkins Slough on APN 052-511-08

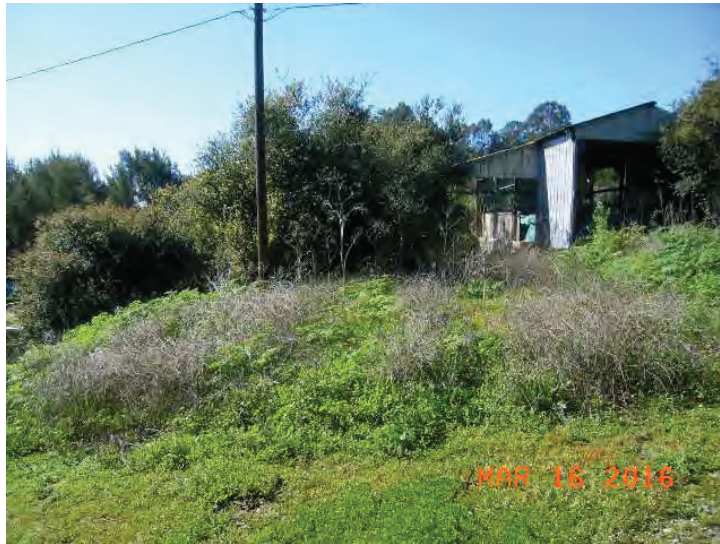
Ruderal (weedy) areas occur on the upper parcel and in some areas on the lower parcel. The areas are dominated by annual, non-native grasses and forbs typical of previously disturbed areas. The most commonly observed plant species is poison hemlock. Other species include wild oat (*Avena fatua*), ripgut brome (*Bromus diandrus*), Italian ryegrass (*Lolium multiflorum*), rattail fescue (*Festuca myuros*), Bermuda grass (*Cynodon dactylon*), soft chess (*Bromus hordeaceus*), wild radish (*Raphanus sativa*), narrow-leaved clover (*Trifolium angustifolium*), bur clover (*Medicago polymorpha*), mallow (*Malva sp.*), wild mustard (*Brassica sp.*), and ice plant (*Carpobrotus edulis*). Native plant species are limited; deerweed (*Acmispon glaber*), bracken fern (*Pteridium aquilinum*), coyote brush (*Baccharis pilularis*), and young coast live oak (*Quercus agrifolia*) were observed. Figure 5 shows a typical ruderal area on APN 052-511-06.

Figure 5. Ruderal vegetation on slope on APN 052-511-06

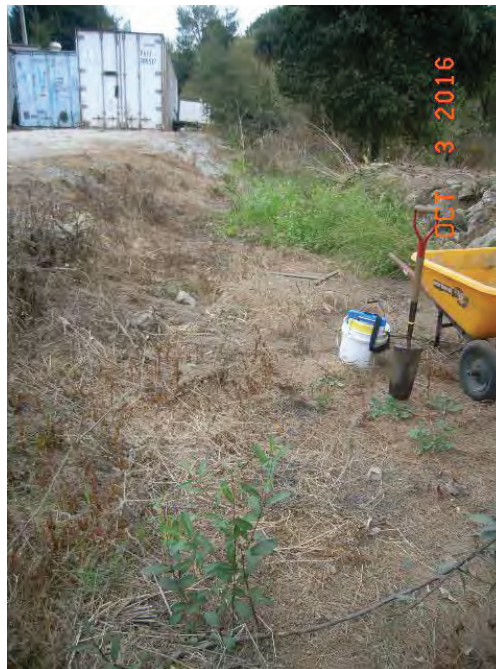
A drainage swale travels along the boundary of APN 052-511-08 and empties into a drainage ditch within the CalTrans Highway 1 right-of-way. This swale supports ruderal vegetation, such as poison hemlock and Italian thistle (*Carduus sp.*) A wetland delineation was conducted in October 2016, wherein a portion of the swale was found to support an herbaceous component of a riparian corridor. Most of the corridor exhibits intermittent flow; however, a short section (20 feet) in the central portion has perennial flow. Saturated soil and shallow water (0.5 inch) was observed in October 2016. Wetland plant species were observed in this area, such as pennyroyal (*Mentha pulegium*), rabbitsfoot grass (*Polypogon monspeliensis*), and nutsedge (*Cyperus eragrostis*). The condition of the swale is depicted in Figures 6 and 7. The wetland delineation is on file with the County of Santa Cruz Planning Department.

Figure 6. Condition of drainage swale, October 2016

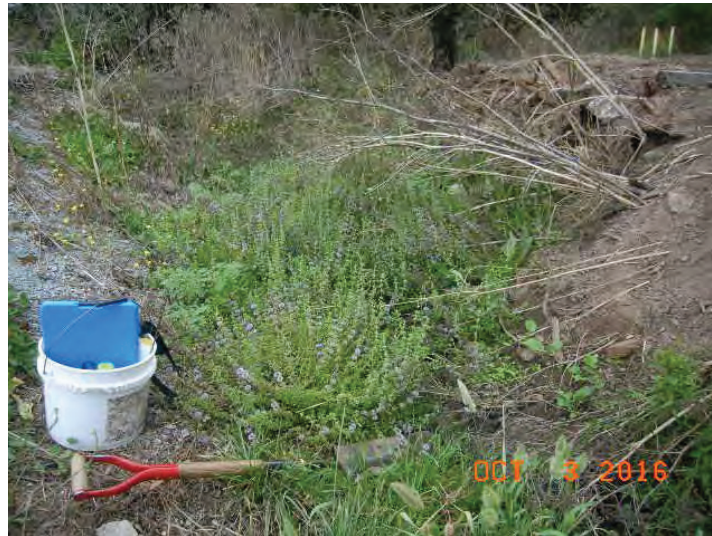
Figure 7. Character of area with perennial flow and wetland vegetation in drainage swale

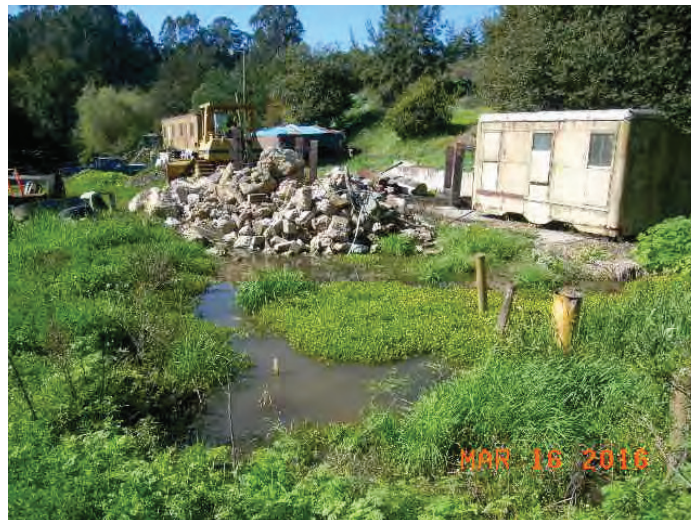
A man-made depression was located on APN 052-511-06, north of the existing Williams tree Service office (observed in March 2016). This low area collects rainwater and was found to support weedy wet-tolerant plant species, such as rabbitsfoot grass, brass buttons (*Cotula coronopifolia*), and willow lettuce (*Lactuca sp.*). Figure 8 shows the ruderal condition around the man-made depression in March. The depression was filled and condition of the area in October 2016 is depicted in Figure 9.

Figure 8. Wet-tolerant ruderal vegetation around man-made depression on APN 052-511-06, March 2016

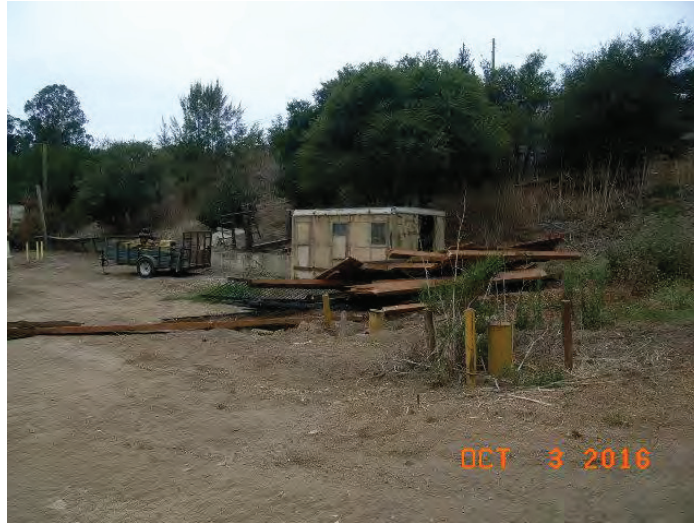
Figure 9. Area of former depression, October 2016

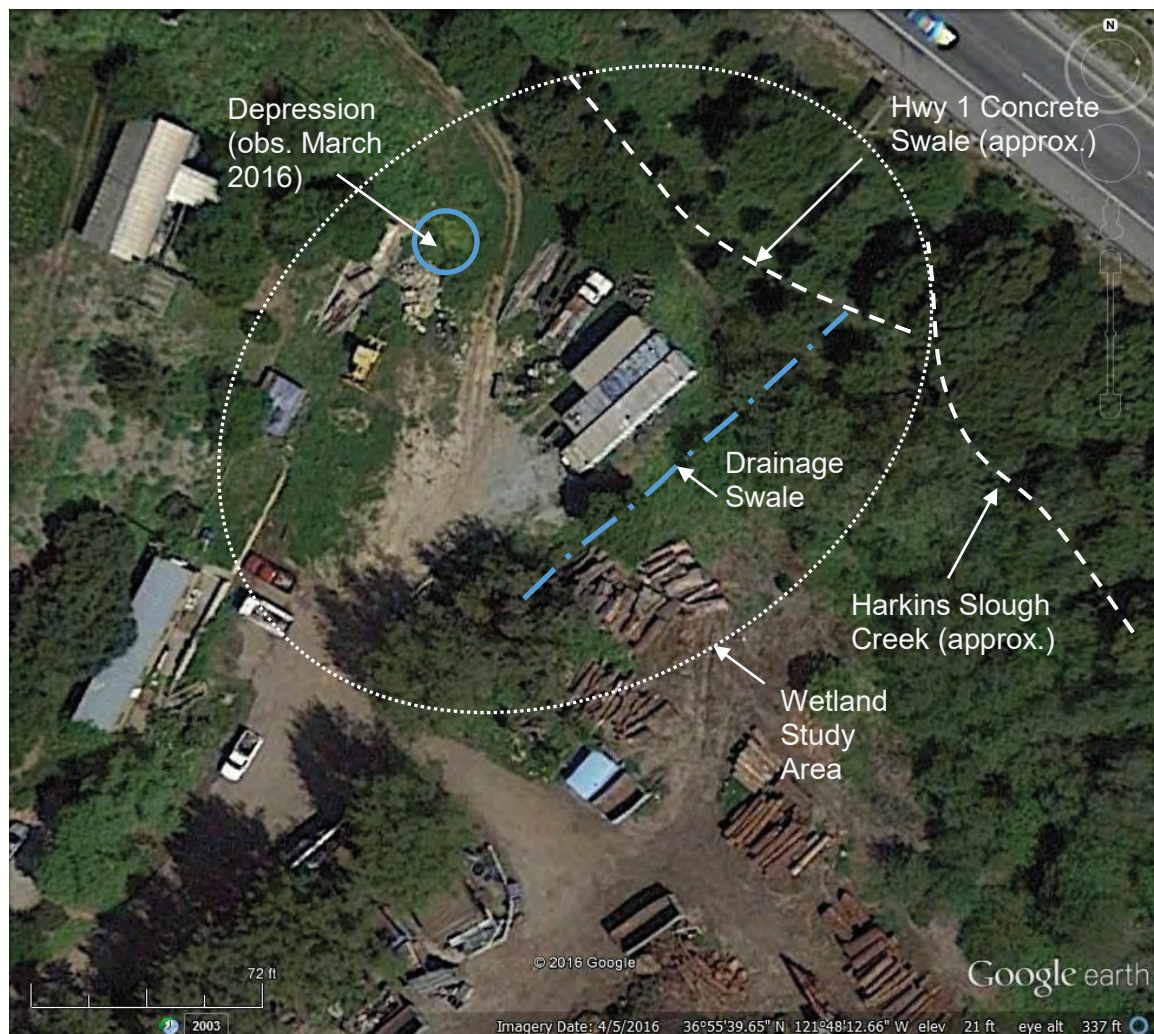
Figure 2 depicts the location of the wetland study area relative to surrounding property features. The wetland study area is located amid existing storage facilities, parking and equipment/materials storage areas. A drainage swale is located southeast of storage containers. During a survey of the property in March 2016 for a Biotic Report, a depression with open water was observed adjacent to a concrete pad and building at the base of the hillside (Pacific Coast Hardwoods Biotic Report, Biotic Resources Group, April 19, 2016). This feature was absent at the October 2016 site survey.

Figure 2. Wetland study area and existing site features

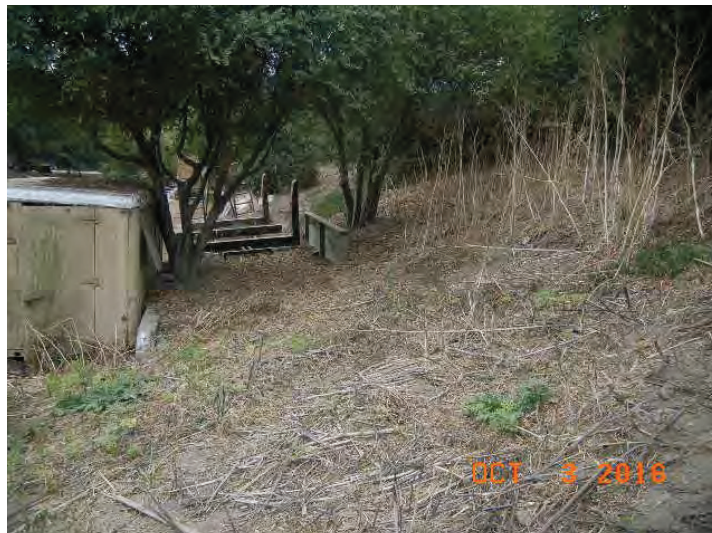
Ruderal (weedy) areas occur in the study area. The areas are dominated by non-native grasses and forbs typical of previously disturbed areas. The most commonly observed plant species is poison hemlock (*Conium maculatum*) (FAC) and Italian thistle (*Carduus pycnocephalus*) (NI). Other species include wild oat (*Avena fatua*) (UPL), ripgut brome (*Bromus diandrus*) (NI), rattail fescue (*Vulpia myuros*) (FACU), Bermuda grass (*Cynodon dactylon*) (FACU), wild radish (*Raphanus sativa*) (NI), narrow-leaved clover (*Trifolium angustifolium*) (NI), bur clover (*Medicago polymorpha*) (FACU), mallow (*Malva sp.*) (NI), wild mustard (*Brassica rapa*) (FACU), and ice plant (*Carpobrotus edulis*) (NI). Native plant species are limited; deerweed (*Acmispon glaber*) (NI), bracken fern (*Pteridium aquilinum*) (FACU), coyote brush (*Baccharis pilularis*) (NI), and young coast live oak (*Quercus agrifolia*) (NI) were observed. Figure 3 shows typical ruderal vegetation on the slope above the former depression. The ruderal areas are considered upland due to a lack of hydrophytic vegetation.

Figure 3. Ruderal vegetation upslope of former depression, October 2016

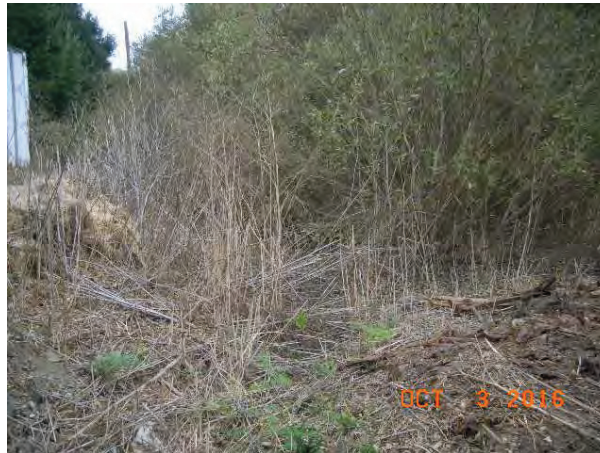
Figure 5. Woody (willow) riparian along lower (northeasterly) portion of swale, October 2016

riparian vegetation in the upper portion of the drainage swale, looking northeasterly. Figure 5 shows the dense willow at the downstream portion of the swale. The vegetation within the swale was examined as potential wetland due to a presence of hydrophytic vegetation.

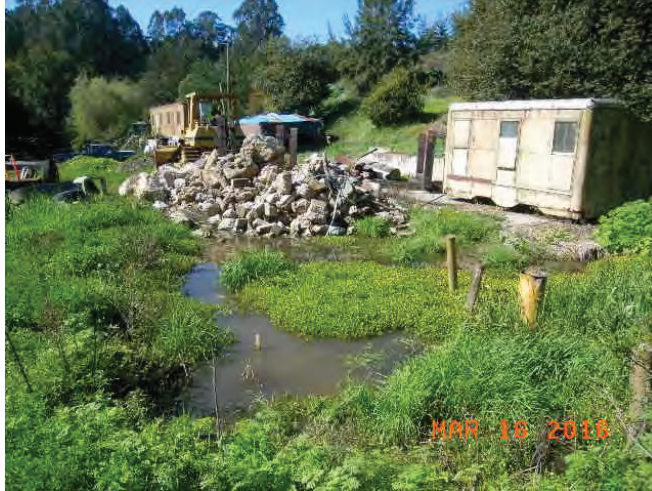
The depression was observed in March 2016. It was located northeast of the existing Williams Tree Service office, immediately adjacent to a concrete slab at the base of the hillside. At the March site visit, the depression measured approximately 20 feet by 20 feet and supported open water, edged with non-native wet-tolerant plant species. Rabbitsfoot grass (FACW), brass buttons (*Cotula coronopifolia*) (OBL), tall cyperus (FACW) and willow lettuce (*Lactuca serriola*) (FACU) were documented. The vegetation in and around the depression exhibited hydrophytic vegetation. Upland ruderal vegetation surrounded the depression. Figures 6 and 7 show the open water and vegetation in the depression in March 2016.

Figure 6. Vegetation around man-made pond on APN 052-511-06, March 2016

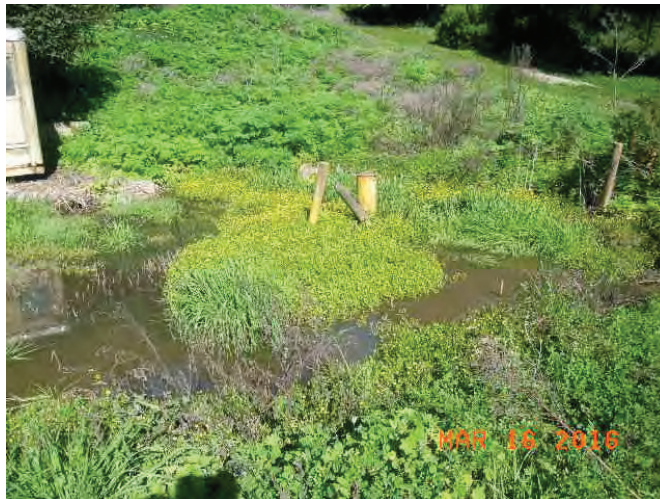
Figure 7. Vegetation around man-made pond on APN 052-511-06, March 2016

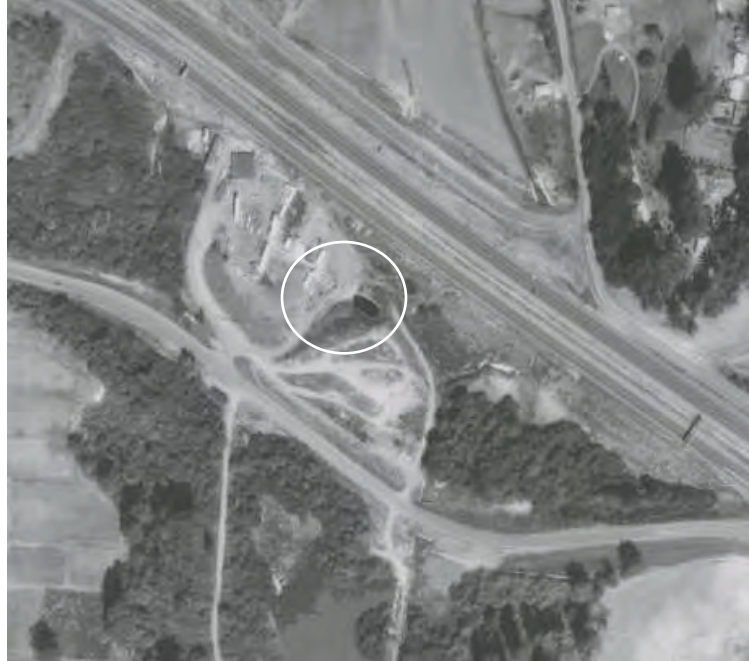
Figure 9 depicts an aerial image from 1975. A dirt road traverses the wetland study area, similar to the 1974 image. An open water feature is evident at the site; however, this feature appears to be within/adjacent to the existing drainage swale. It does not appear that the open water feature is located at the site of the 2015/16 former depression. The circle is the general location of the wetland study area.

Figure 9. Aerial photo dated 1975 (UCSC Digital Library, dated 10/14/1975)

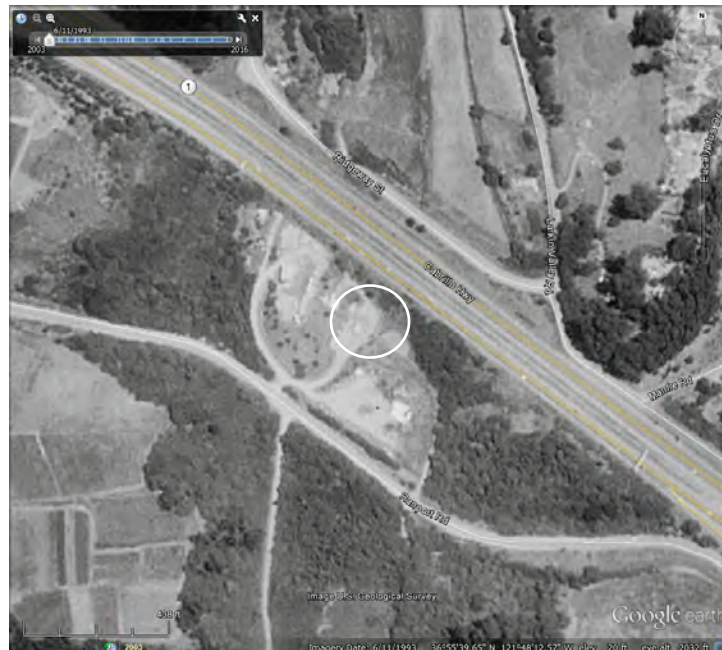
A photo from 1993 depicts vegetation in the vicinity of the drainage swale yet no evidence of an open water feature is present. The open water feature depicted in the 1975 photo is no longer evident, and a narrower drainage swale is present, as depicted in Figure 10. The circle is the general location of the wetland study area.

Figure 10. Aerial photo dated 1993 (Google Image, dated 6/11/1993)

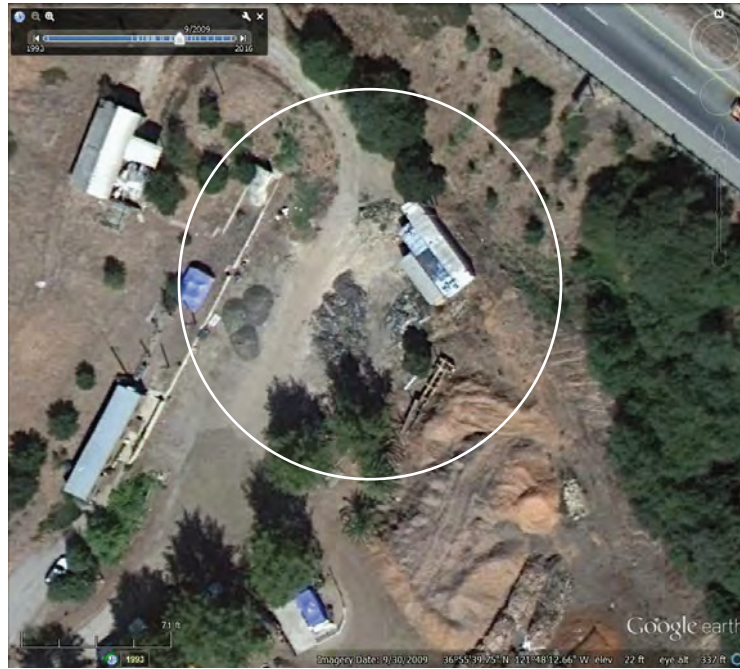
Figure 11. Aerial photo dated 1993 (Google Image, dated 9/30/2009)

Figure 11 depicts the 2009 aerial. The 2009 aerial shows the presence of the upper end of the drainage swale, yet the middle section supports a road, similar to that observed in 1974. There is no definitive image of an open water feature with the drainage feature or elsewhere.

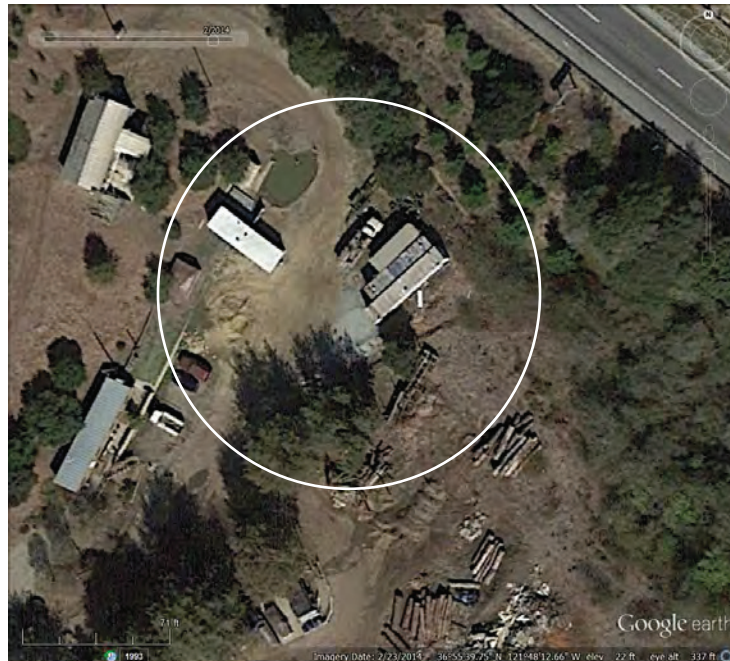
More recent photos from 2014 and 2015 show a more defined vegetated drainage swale. An open water feature is evident in the 2014 aerial, yet it is north of the feature observed in 1975 (Figures 12 and 13). The circle is the general location of the wetland study area.

Figure 12. Aerial photo dated 2014 (Google Image, dated 2/23/2014)

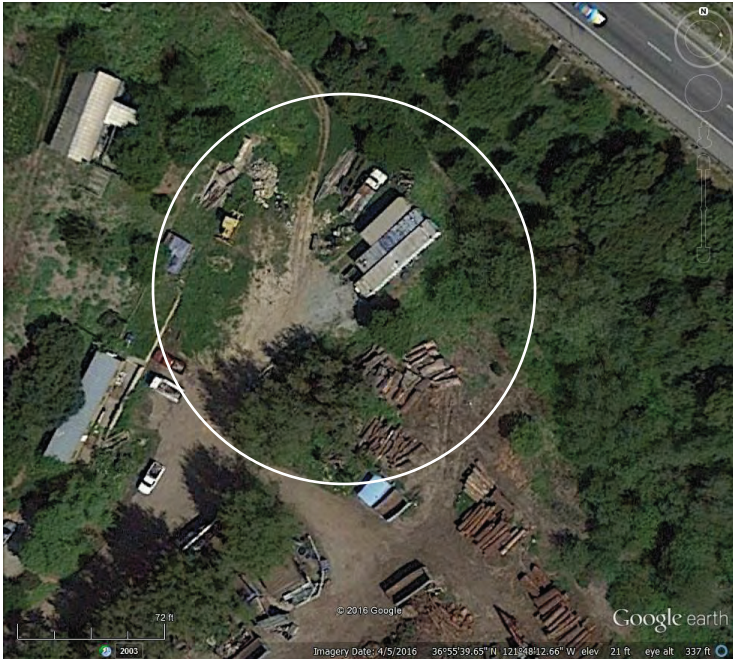
Figure 13. Aerial photo dated 2015 (Google Image, dated 3/28/2015)

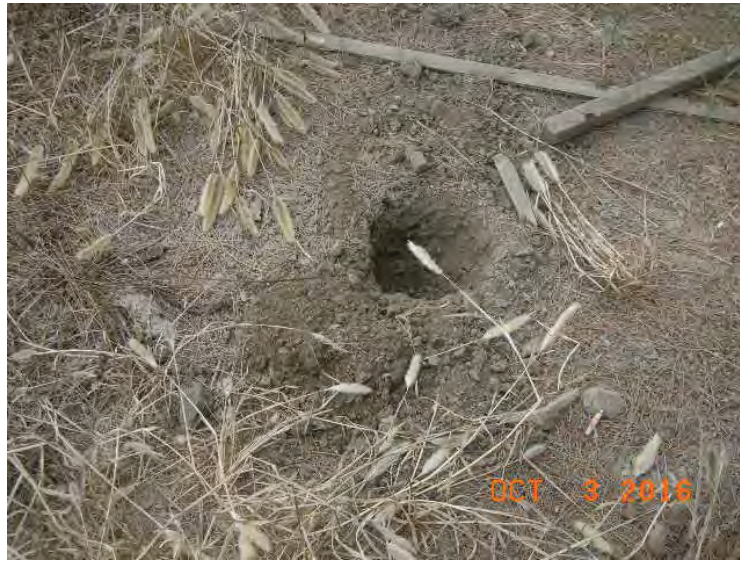
Figure 17. Sample point #1 in drainage swale

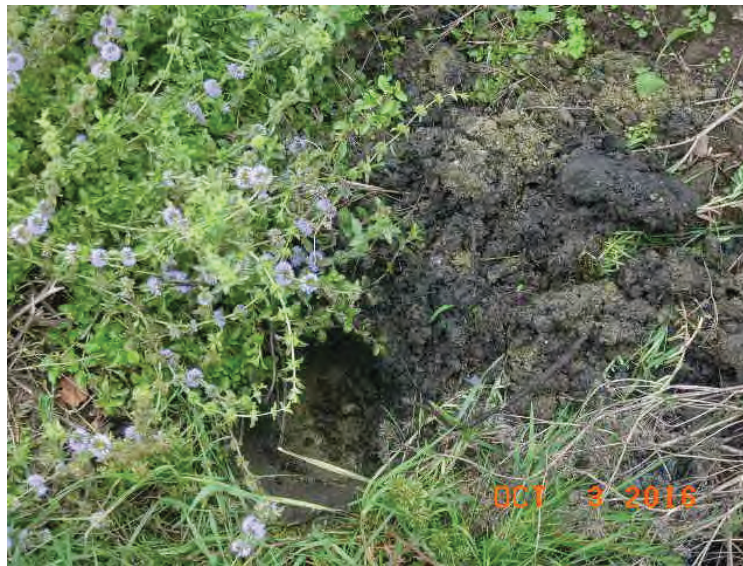
Figure 18. Sample point #2 in drainage swale

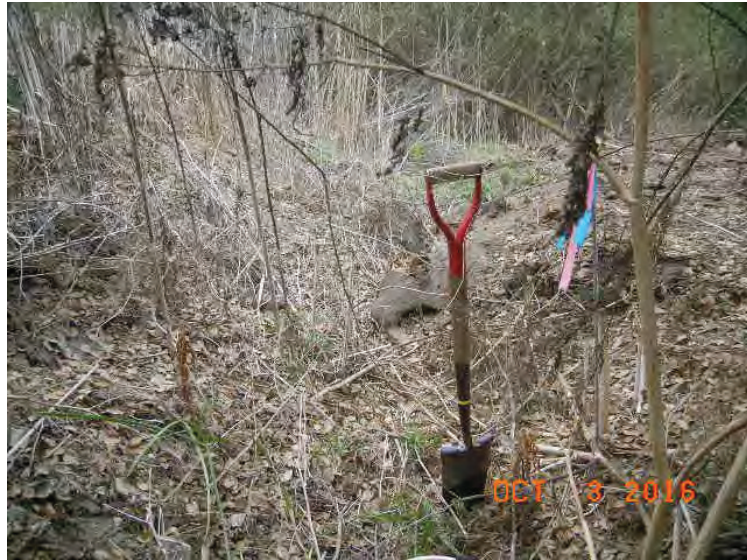
Figure 19. Sample point #3 in drainage swale

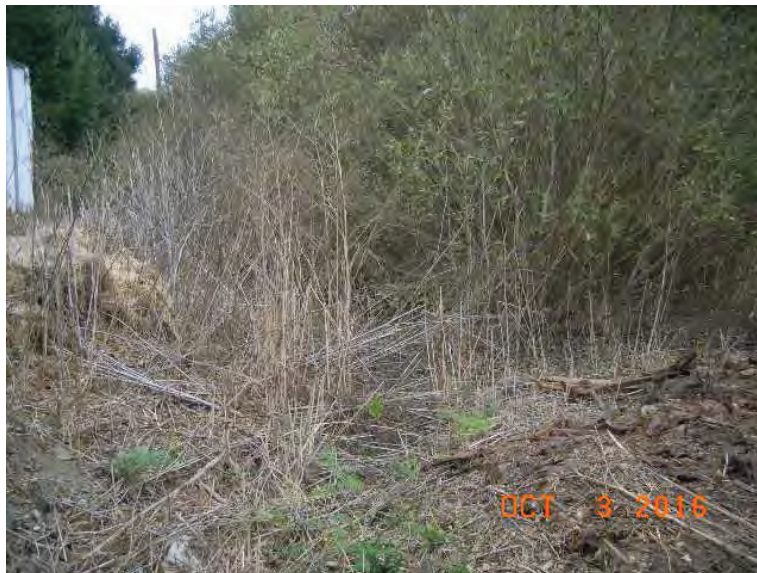
Figure 20. Sample point #4 in drainage swale

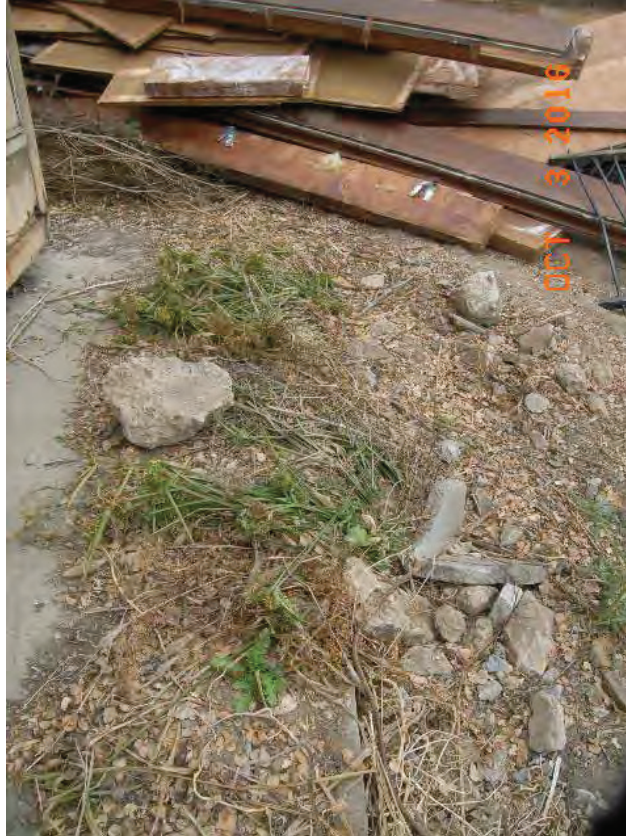
Figure 21. Sample point #5, edge of former depression

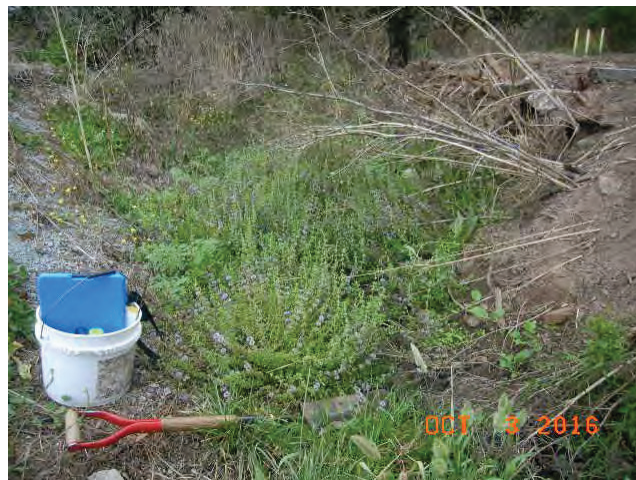
Figure 22. Character of area with perennial flow and wetland vegetation in drainage swale

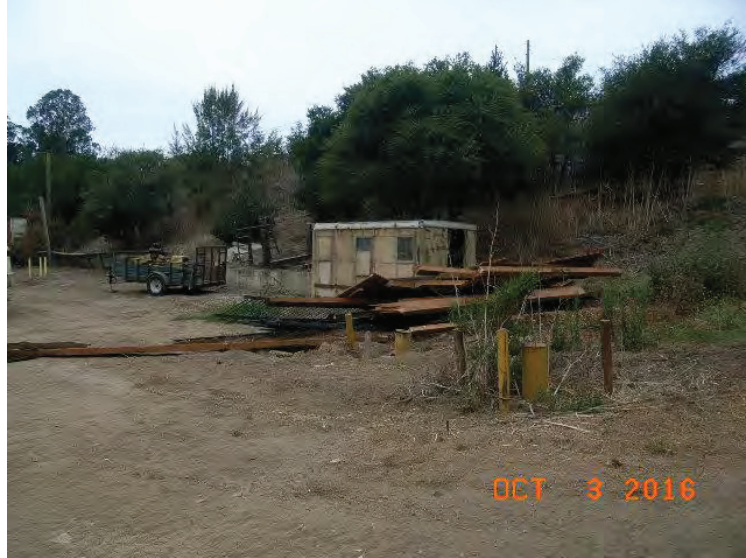
Figure 23. Character of former depression

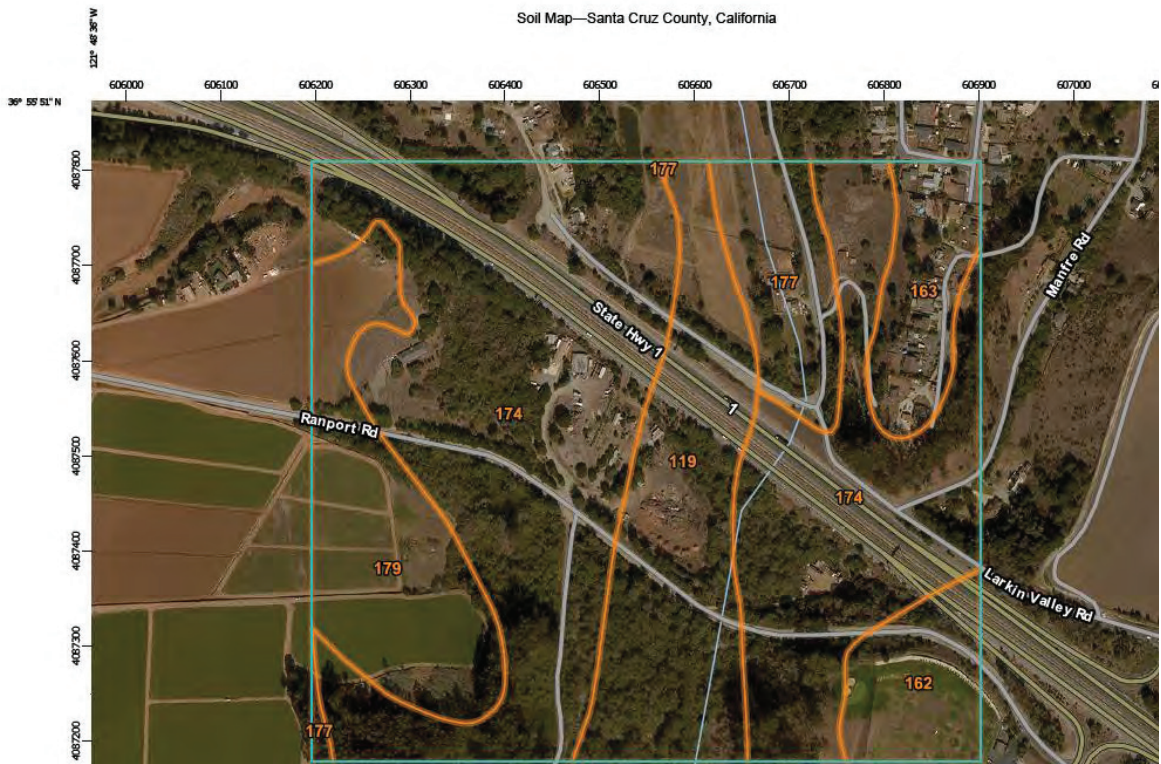
Appendix B Web Soil Survey Map

Soil Type

174	Tierra-Watsonville complex, 15 to 30 percent slopes
119	Clear Lake clay, drained, 0 to 1 percent slopes, MLRA 14

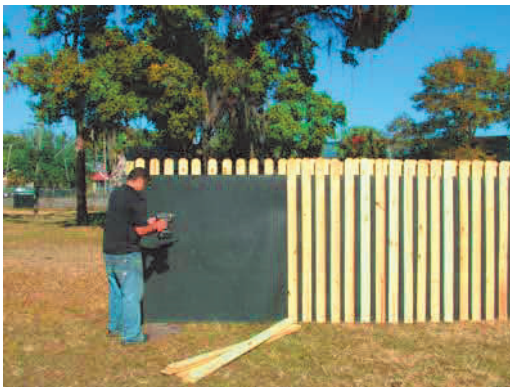
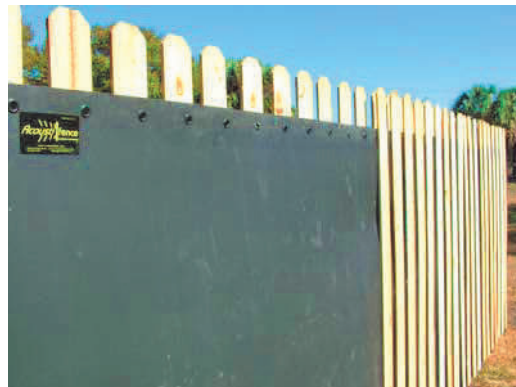
Acoustifence – Adding Acoustifence to a wooden fence will dramatically increase the sound transmission loss through the fence and create a reflective barrier.

Shadowbox fence with Acoustifence added – reflective barrier.

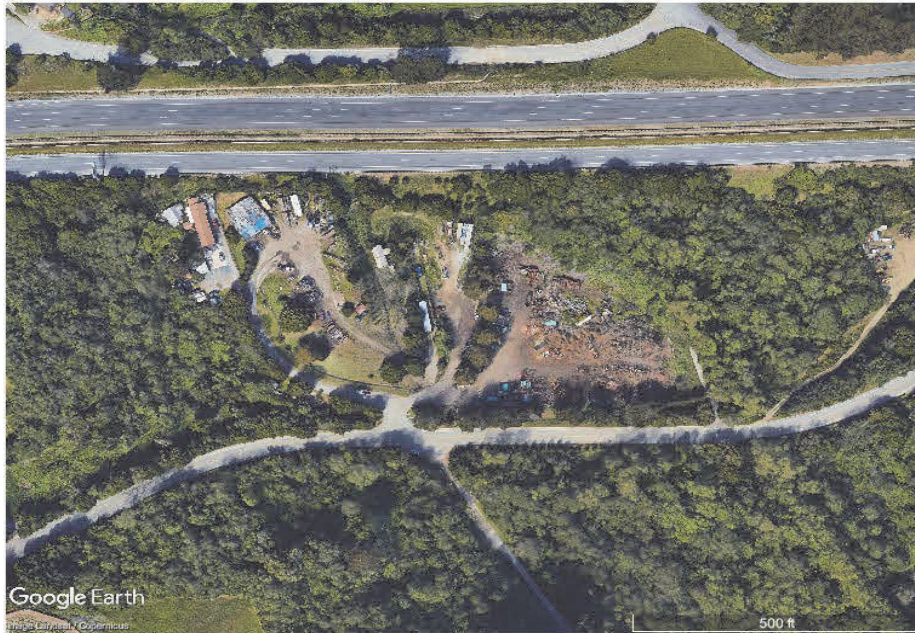
Picture 1 - Site of Central Coast Lumber Proposed Development

The 8.4-acre mill site is located directly adjacent Rampart Road, situated between Rampart Road and Highway 1 and slightly West of Airport Road (see picture 1 below). The current site is undergoing planned development; the various pieces of equipment were made operational for the noise testing. The proposed mill building, support and office buildings do not currently exist.
