### **PROJECT: San Vicente Creek Watershed Clematis Control Project**

**PROJECT DESCRIPTION:** The project proposes to treat and control the invasive plant *Clematis vitalba* (Clematis) on approximately 30 acres within Santa Cruz County's San Vicente Creek watershed. Clematis, a non-native invasive plant, has infested approximately 70 acres within the San Vicente Creek watershed (30 acres on the San Vicente Redwoods property owned by Peninsula Open Space Trust (POST) and Sempervirens Fund (SVF), and 40 acres on the Bureau of Land Management's (BLM) Coast Dairies property). The infestation poses a threat to anadromous fish and other wildlife habitat, water quality, and ecosystem health (including coast redwood habitat) throughout the lower watershed.

# San Vicente Creek Watershed

## Plan for Salmonid Recovery

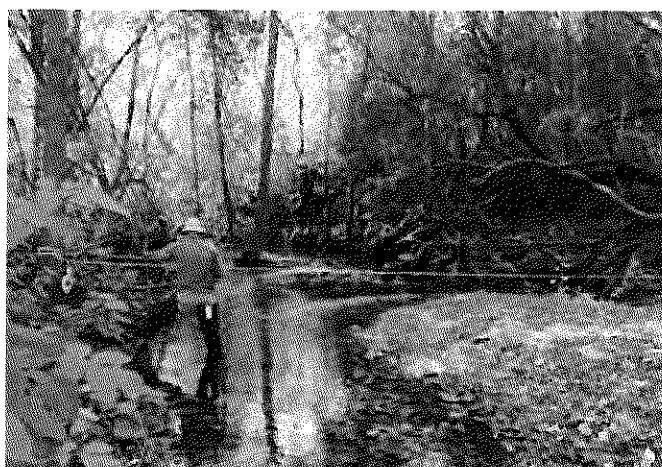
Figure 2-3: Synoptic low flow measurement made in July 2013 as a part of the watershed assessment project.

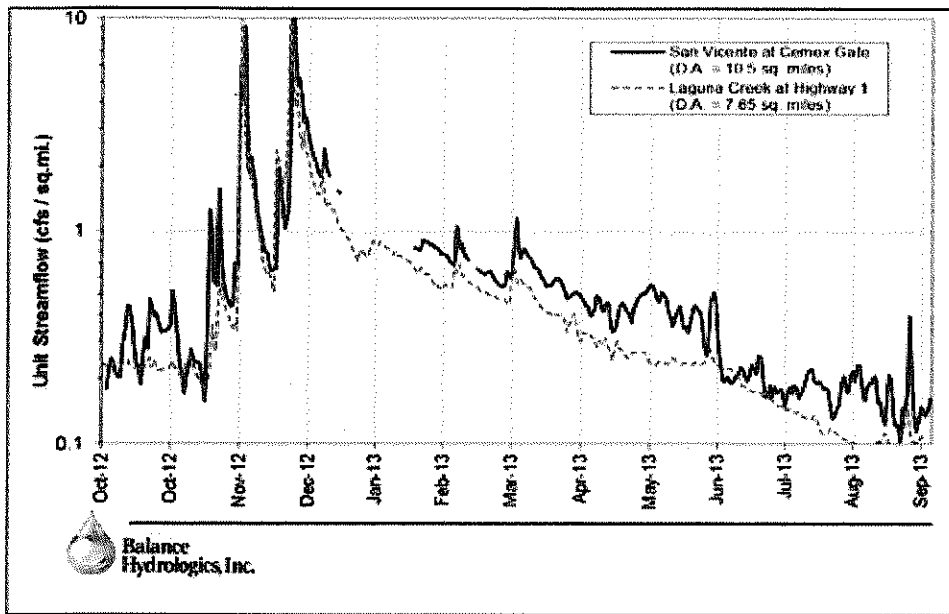
Figure 2-8. Unit streamflow for San Vicente at CEMEX Gate and Laguna Creek at Highway 1, WY2013. The flow record for Laguna Creek has been corrected for City of Santa Cruz water supply diversion. The San Vicente record however has not been corrected for upstream diversions, therefore in WY2013 San Vicente produced even more runoff per unit drainage area as measured at SVCG than what is depicted in Figure 2-8.

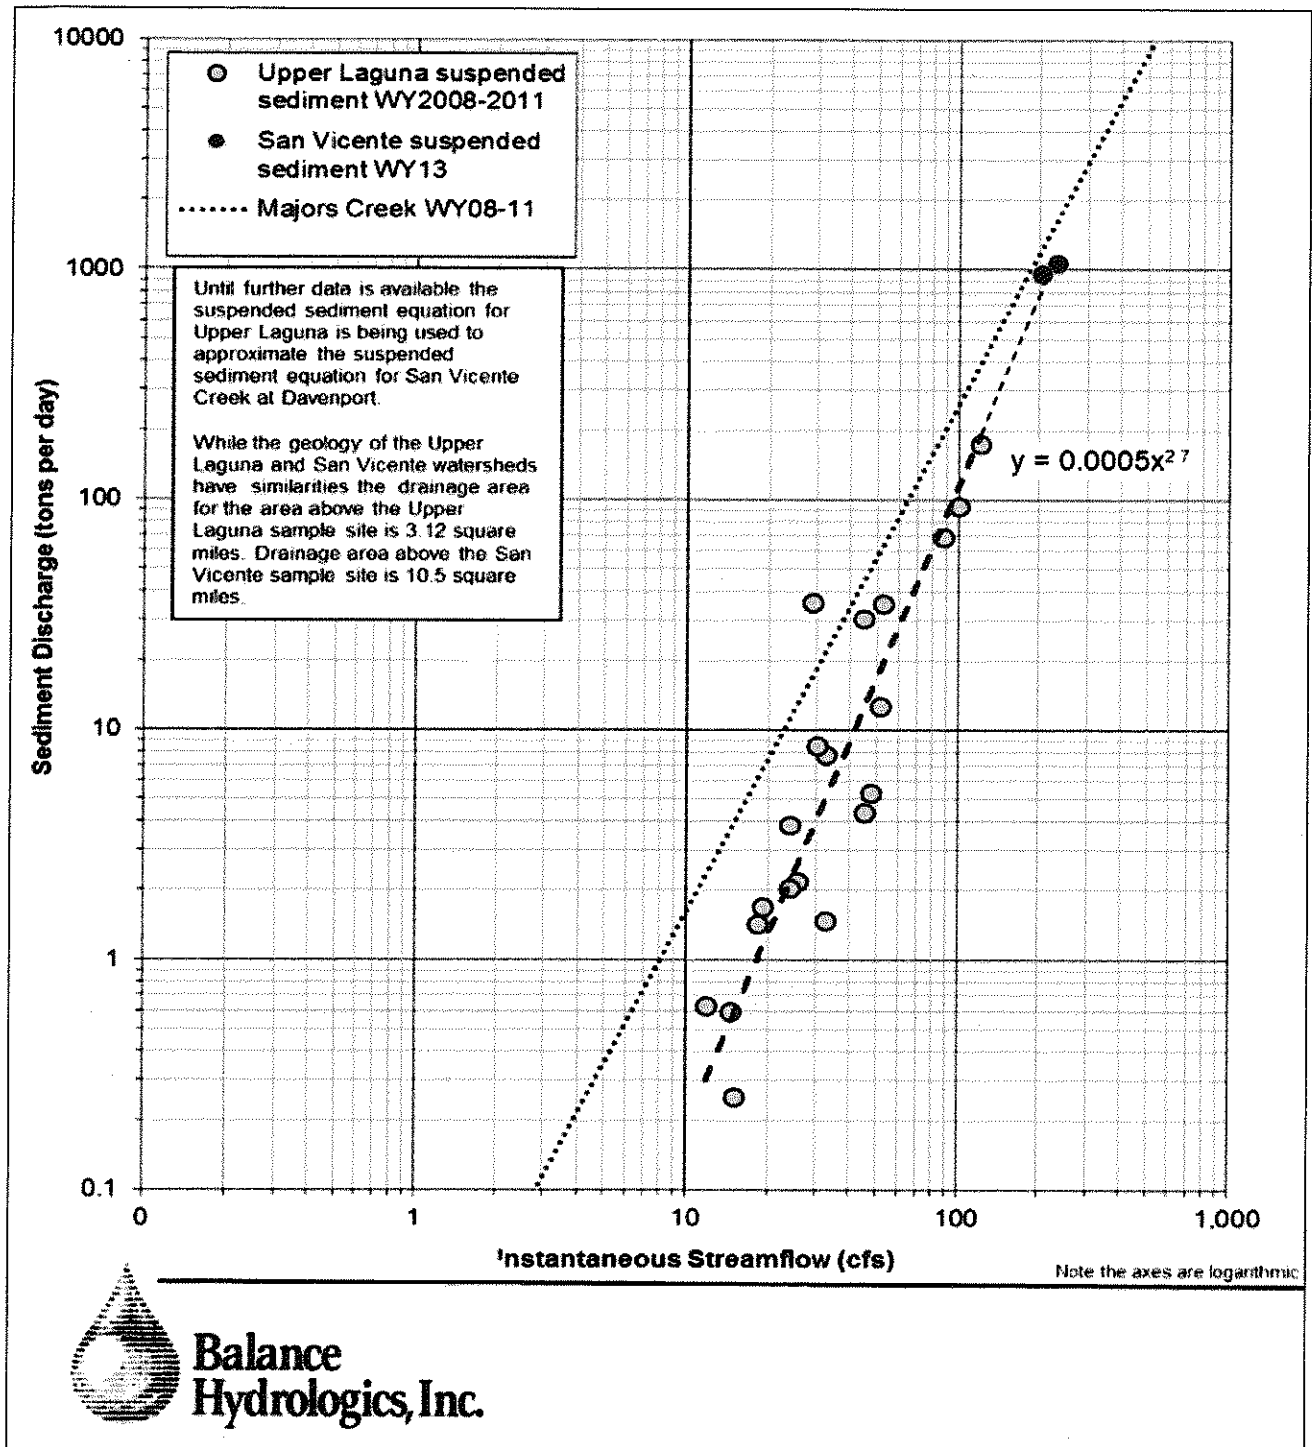
Figure 2-10. Suspended sediment data and rating curves for Santa Cruz County northcoast streams.

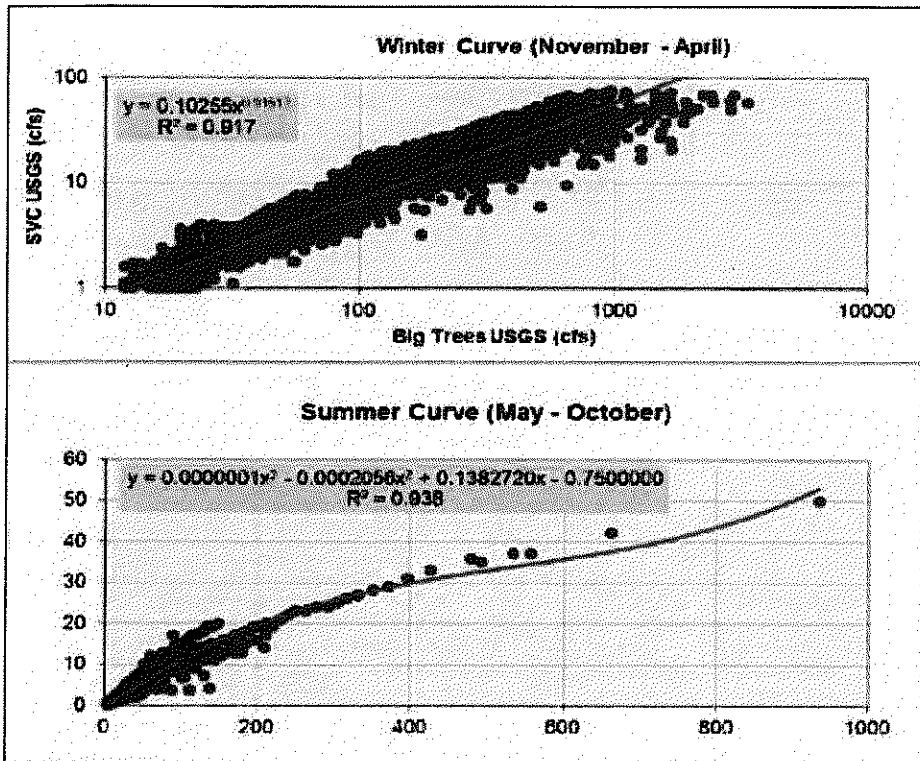
Figure 2-13. Regression models used to extend the USGS San Vicente record of streamflow using the USGS Big Trees gage on the San Lorenzo River.

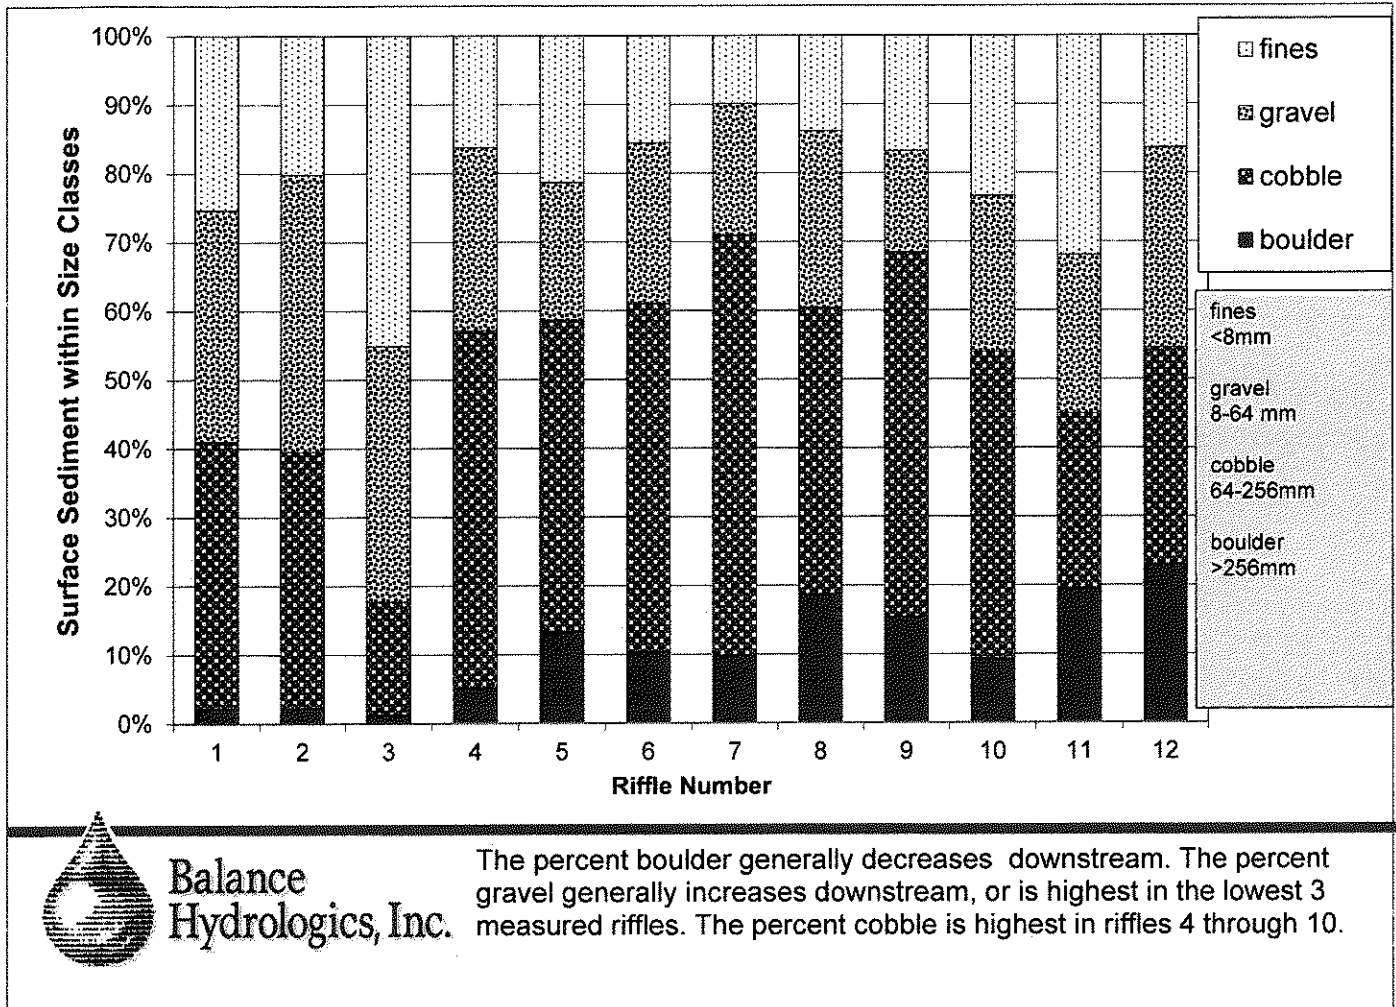
Figure 3-6. Riffle-surface texture measurements, San Vicente Creek July 2013.

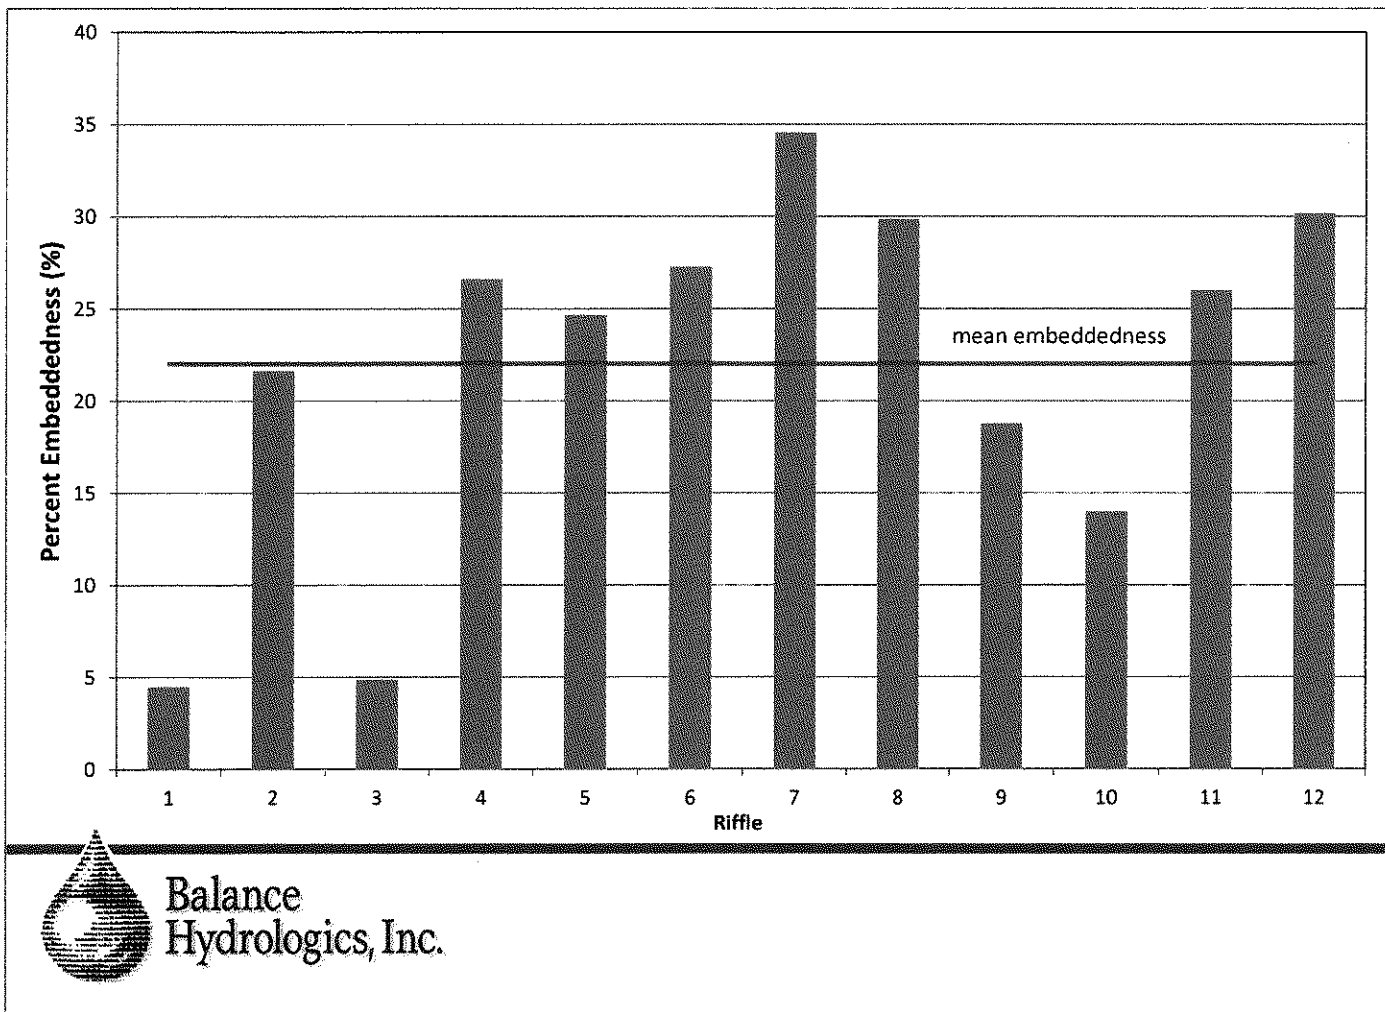
Figure 3-7. Percent of clasts in the measured riffles that were assessed to be embedded.
