Santa Cruz Countywide

# PARTNERS IN RESTORATION PERMIT COORDINATION PROGRAM

## 2020 ANNUAL REPORT

Prepared by the  
Resource Conservation District of Santa Cruz County

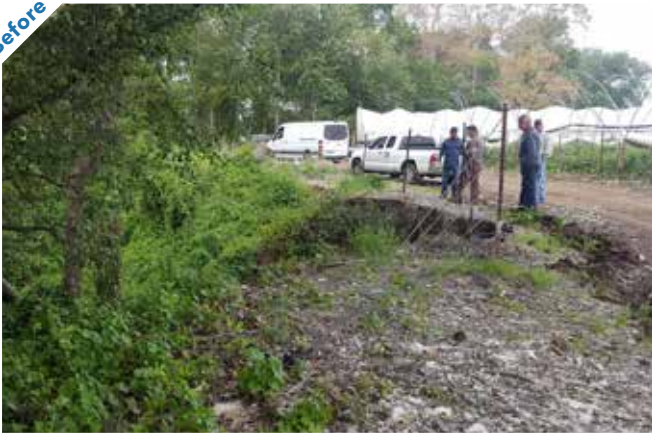
Before

Photo point 1: Looking west at the eroded streambank, which has a nearly vertical slope.

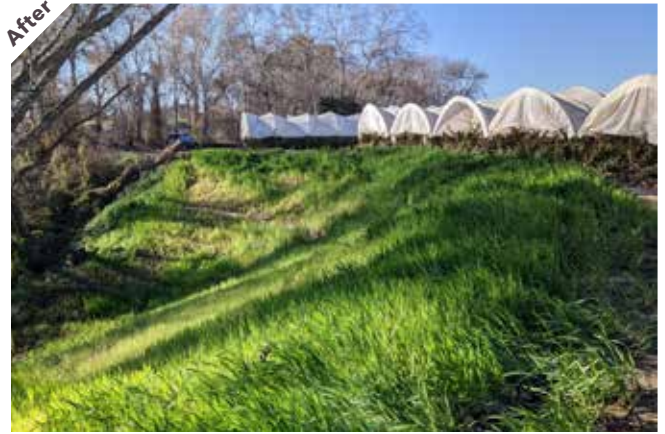
After

Photo point 1: Looking west, the bank has been excavated to a 2:1 slope. Fiber rolls have been installed along the contour and common barley is providing erosion control.

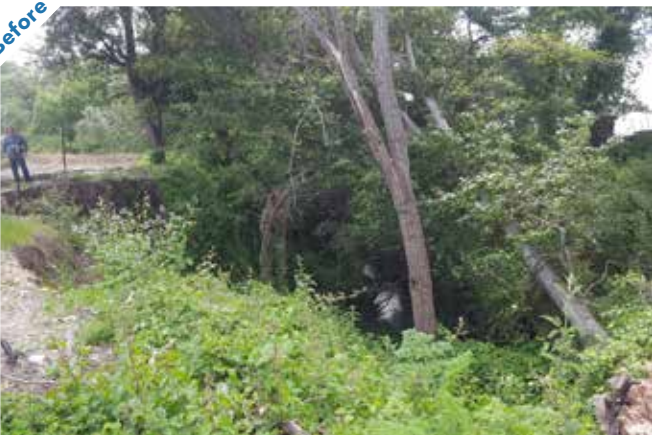
Before

Photo point 2: Looking east, the eroded, scalloped edge of the streambank can be seen on the left side of the photo.

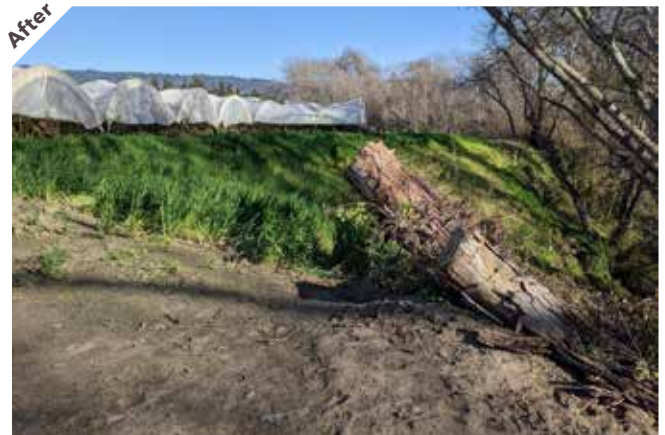
After

Photo point 2: Looking east, the bank has been sloped and well-seeded with common barley.

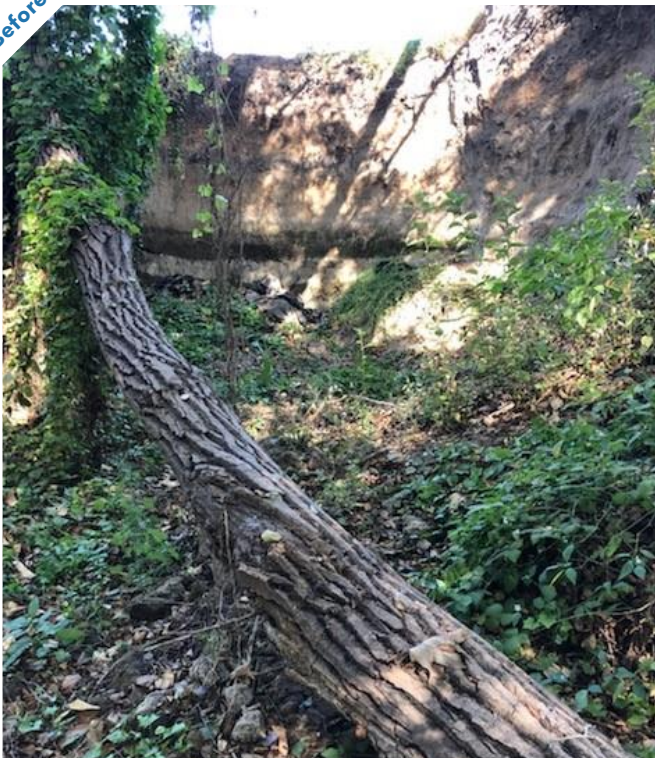
Before

Photo point 3: Looking north at the eroded streambank from Green Valley Creek.

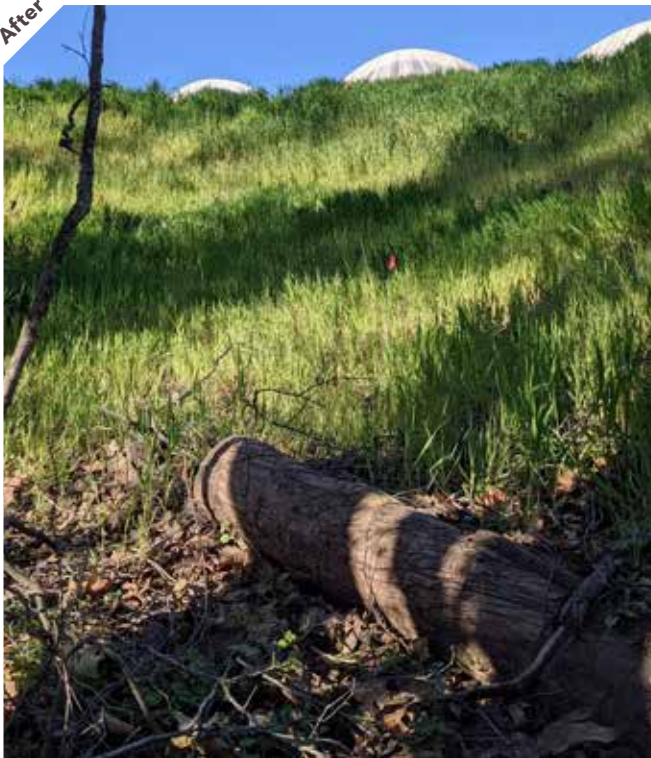
After

Photo point 3: Looking north, the streambank has been sloped to a 2:1. Cottonwood trees are marked with pink flags.

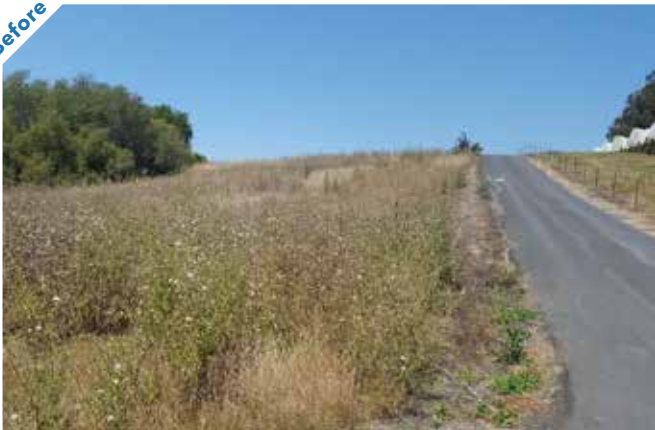
Before

Photo point 4: Looking north at the soil disposal site, which is predominantly covered by non-native weedy species, such as prickly ox-tongue.

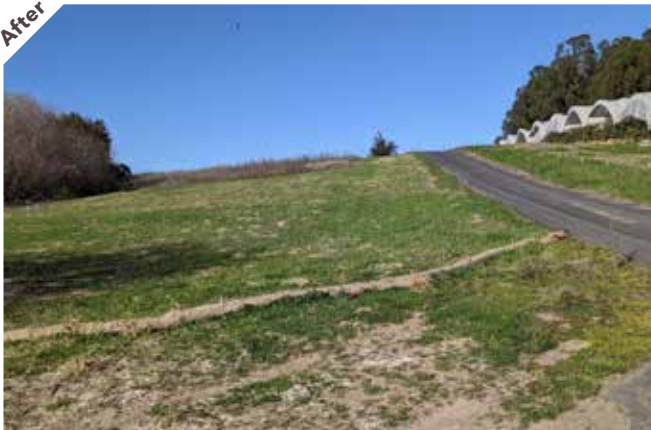
After

Photo point 4: Looking north, after spoils placement the site has been seeded with common barley and a fiber roll installed.

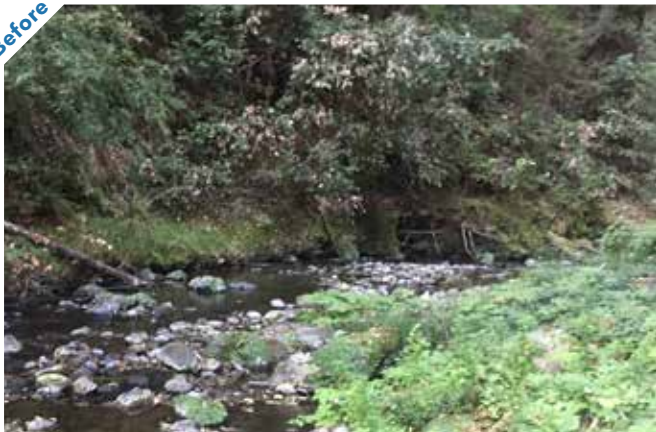
Before

Photo point 20: Looking downstream at future location of structure.

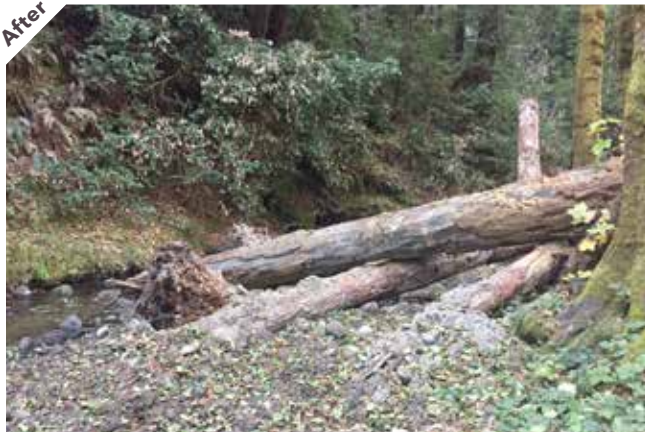
After

Photo point 20: Looking downstream at Type 1 structure. Rootwads visible.

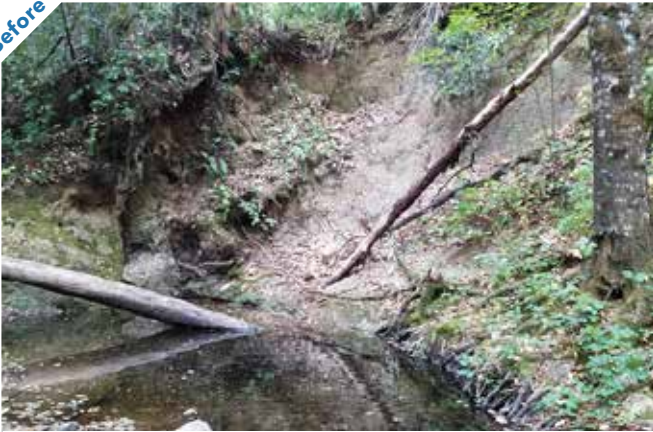
Before

Photo point 23: Looking upstream at future location of structure. Historic landslide visible as well as bedrock.

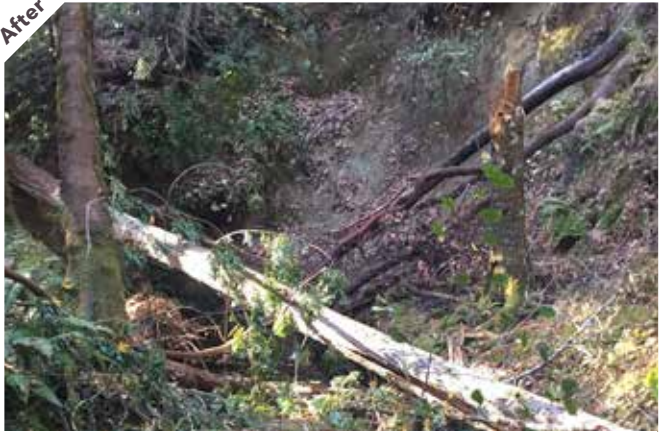
After

Photo point 23: Looking upstream at Type 3 structure. Historic landslide visible still slightly visible in background, bedrock hidden by branches

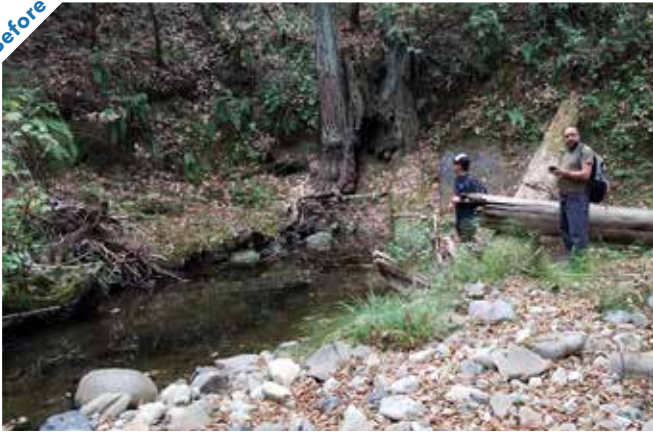
Before

Photo point 25 - Flow of water from right to left. Rocky bank visible in foreground. Some bank undercutting visible across the creek.

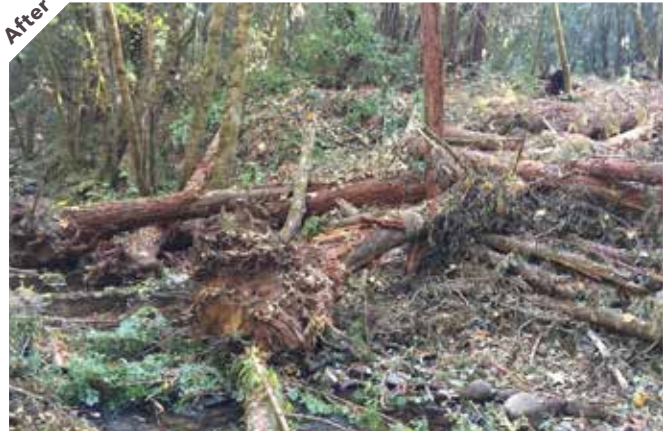
After

Photo point 25 - Type 2 structure. Looking upstream. Structure ultimately built slightly upstream of where pre-photo taken. Rocky bank visible in lower right of the photo. Rootwads visible.

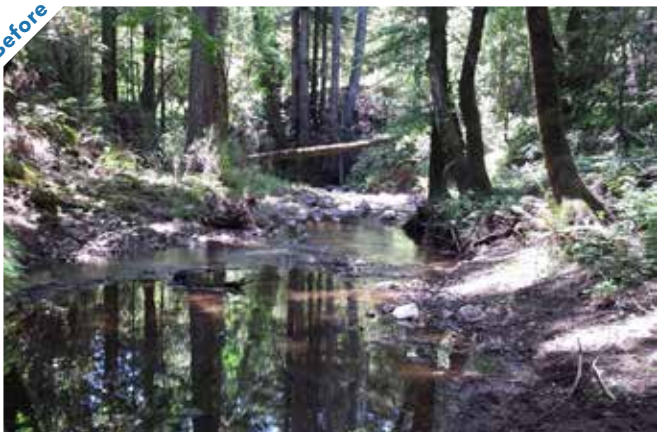
Before

Photo point 34 - Looking upstream. Rise of hill visible at top of photo.

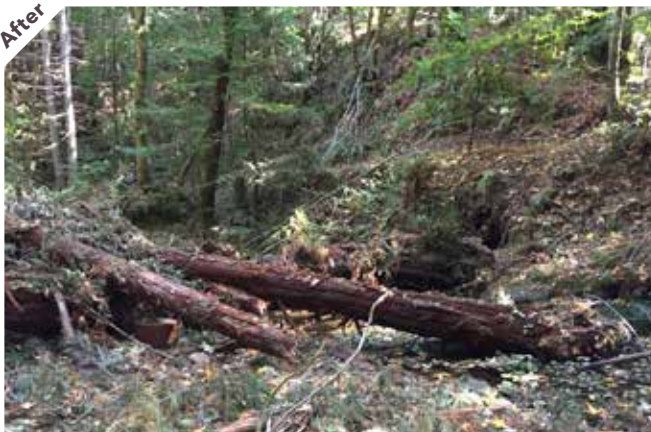
After

Photo point 34 - Type 4 Structure. Looking upstream. Rise of hill visible at top of photo.

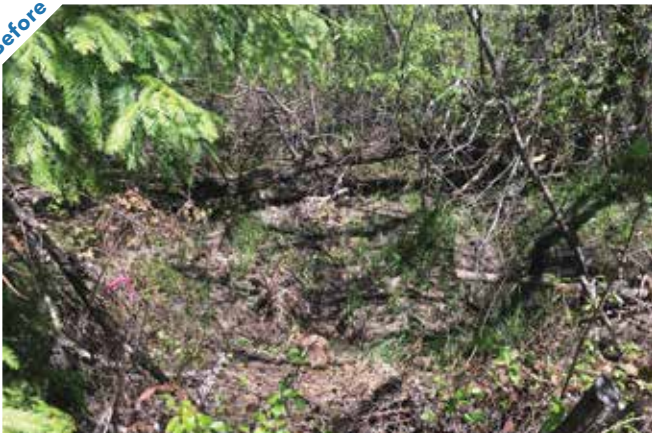
Before

Photo point 1: Looking upstream, the inlet to the undersized culvert to be removed is visible.

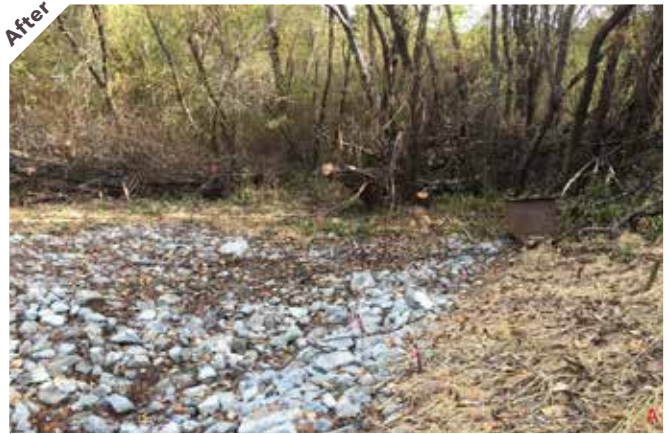
After

Photo point 1: Looking upstream, the culvert has been removed and replaced with a rock-lined open channel.

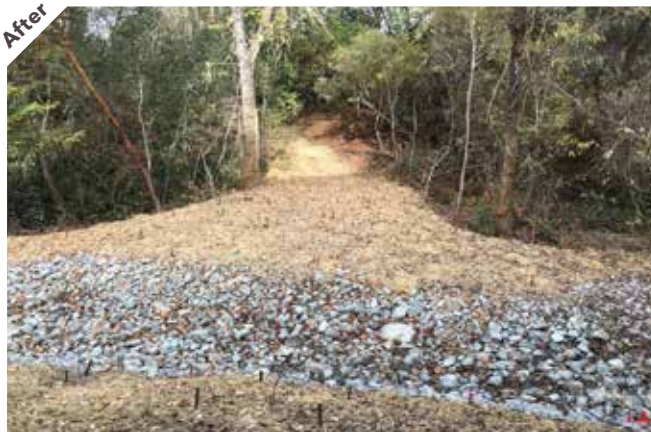
After

Photo point 3: Standing on the remaining embankment and looking north, the rock lined channel and willow stakes are visible.

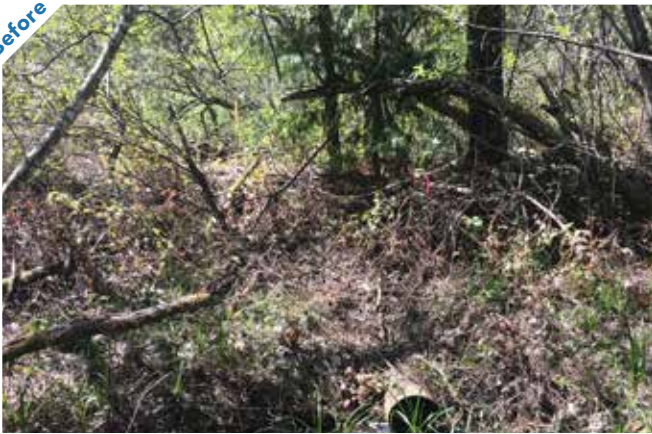
Before

Photo point 4: Looking downstream, the inlet to the undersized culvert to be removed is visible.

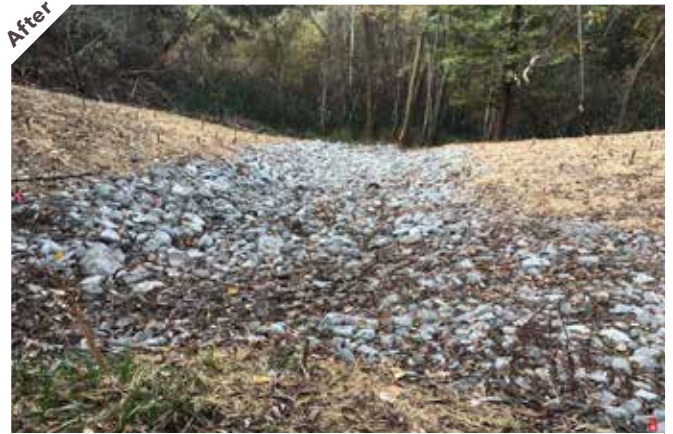
After

Photo point 4: Looking downstream, the culvert has been removed and replaced with a rock-lined open channel.

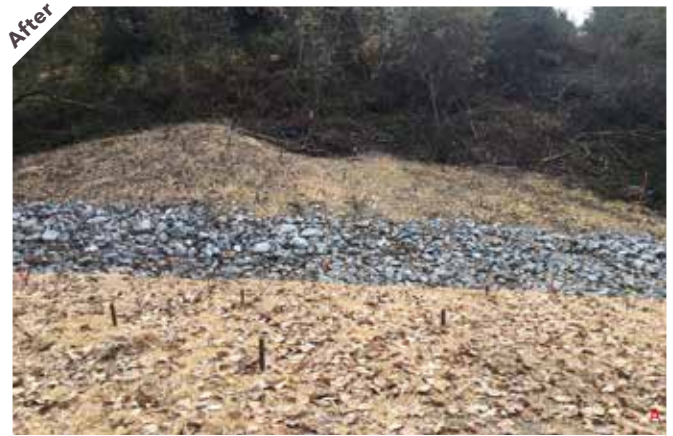
Photo point 5: Standing on the remaining embankment and looking south the culvert has been removed and replaced with a rock-lined open channel.

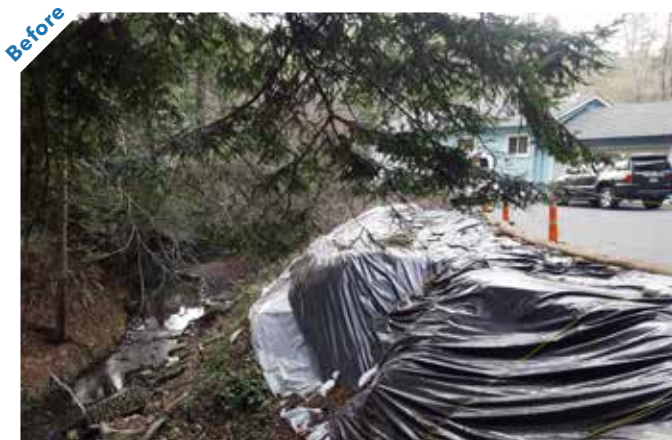
Photo point 2: The eroded streambank covered in plastic can be seen on the right. Branciforte Creek is visible on the left.

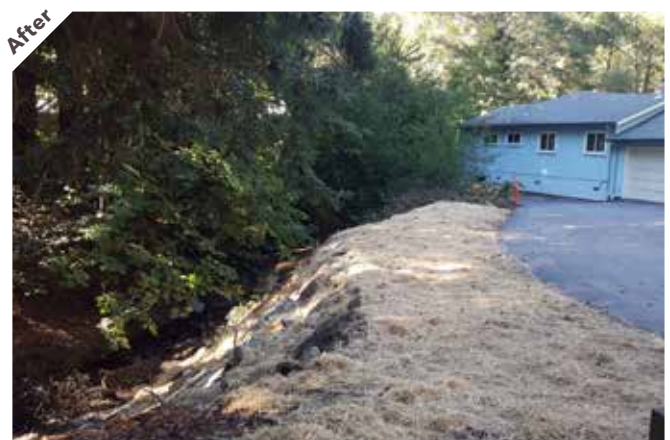
Photo point 2: Looking at the top of the bank failure. The site has been seeded and mulched.

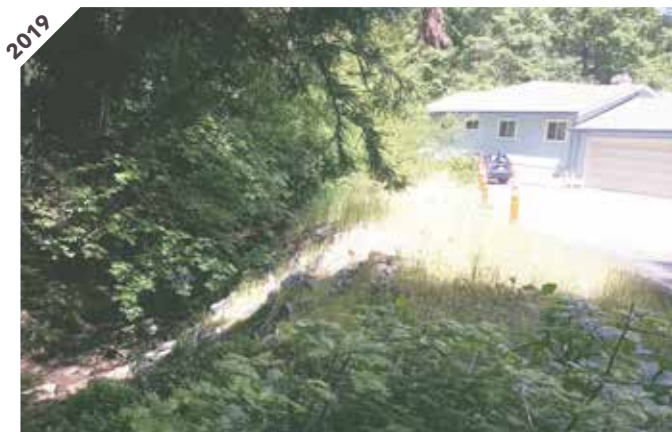
Photo point 2: Looking south at the top of the bank failure. The site is stabilized and revegetated.

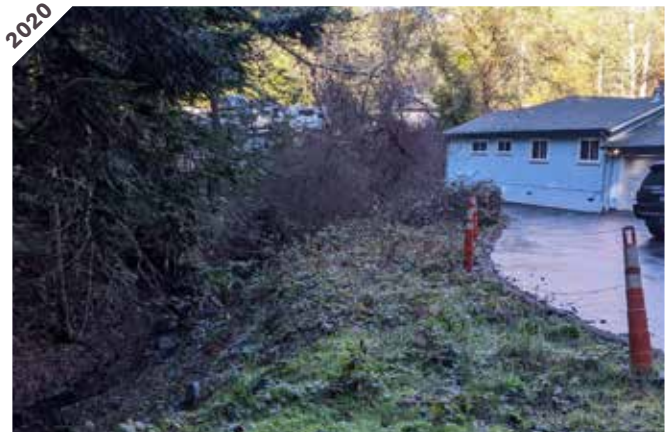
Photo point 2: The site is stabilized and revegetated with CA blackberry and miner's lettuce.

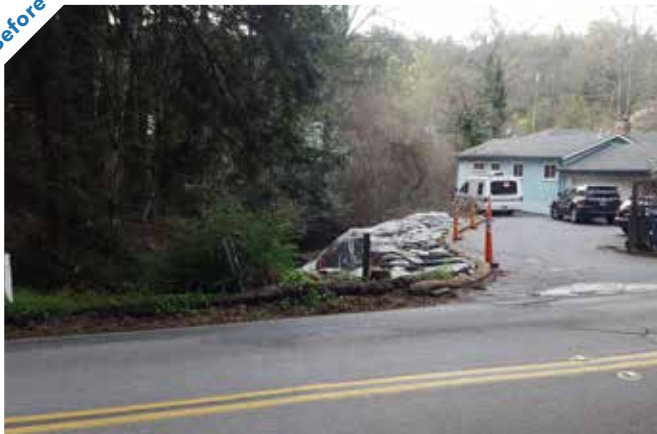
Before

Photo point 3: Looking at the project site from across Branciforte Drive before project completion.

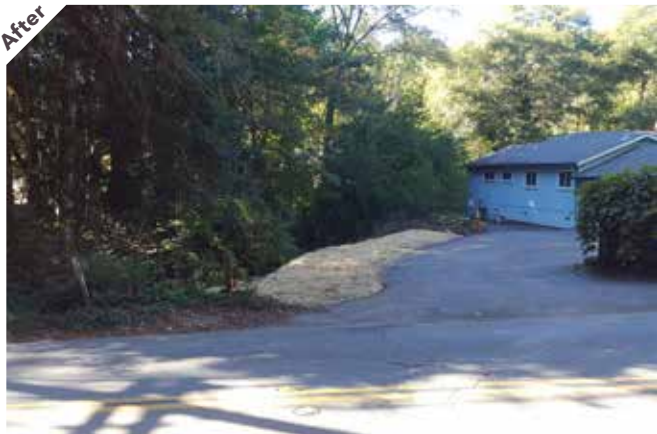
After

Photo point 3: Looking at the project site from across Branciforte Drive after project completion.

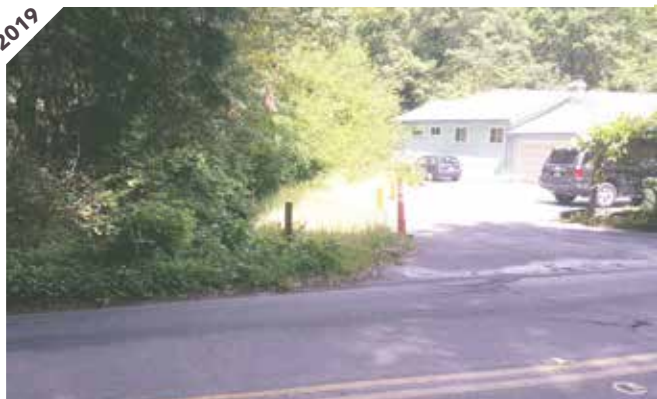
2019

Photo point 3: The site has become well established with grasses.

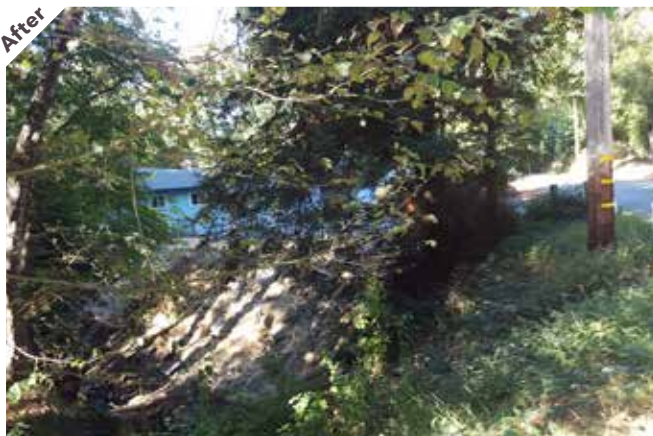
After

Photo point 5: Looking north. The plastic has been replaced and the bank repaired.

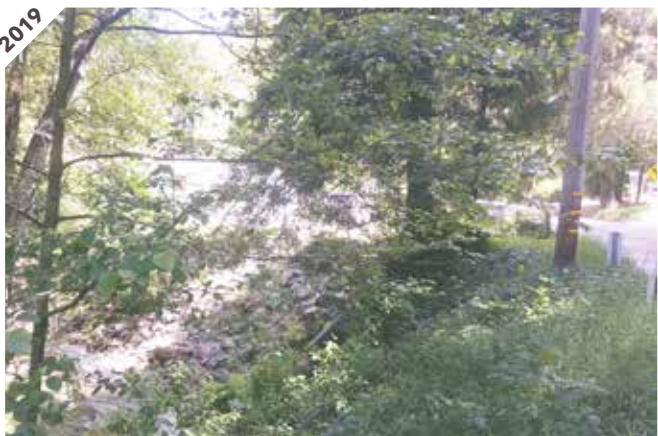
2019

Photo point 5: The plastic has been replaced and the bank repaired observed on the far bank of Branciforte Creek.

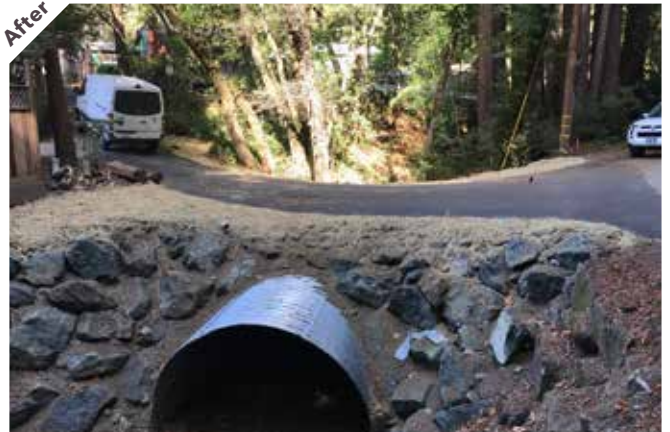
After

Photo point 1A: Looking upstream at the new, fish friendly crossing and repaved road.

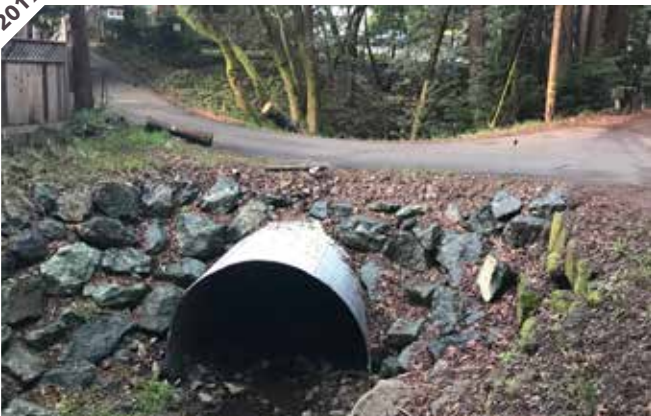
2019

Photo point 1A: The engineered stream materials in the culvert has stayed in place and there is no erosion present around the culvert.

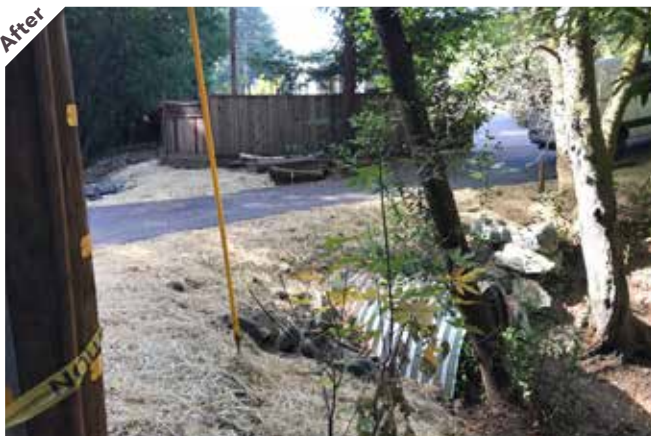
After

Photo point 3A: Looking downstream at the repaired crossing.

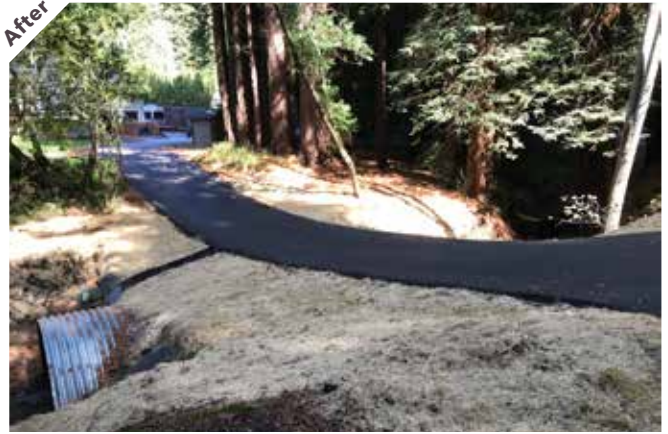
After

Photo point 1B: Looking upstream at the lower crossing with the new culvert and repaved road.

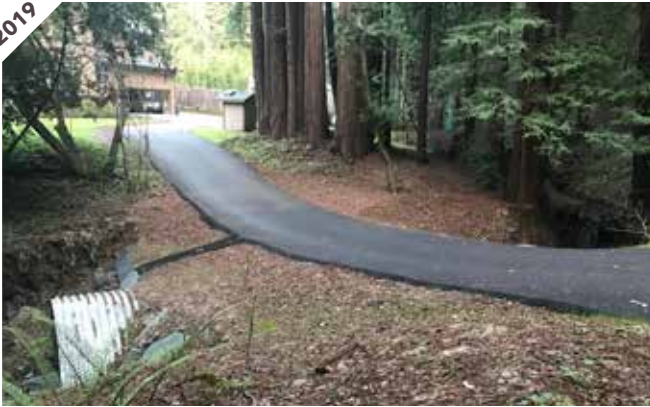
2019

Photo point 1B: Banks are stable and the culvert is functioning as intended.

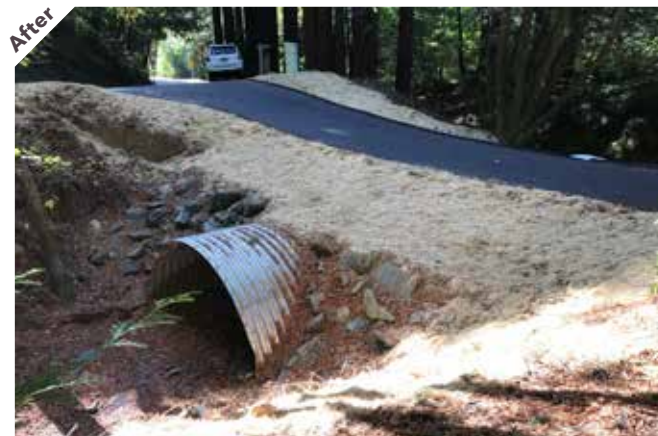
Photo point 3B: Looking downstream at the new crossing sized and placed for improved fish passage.

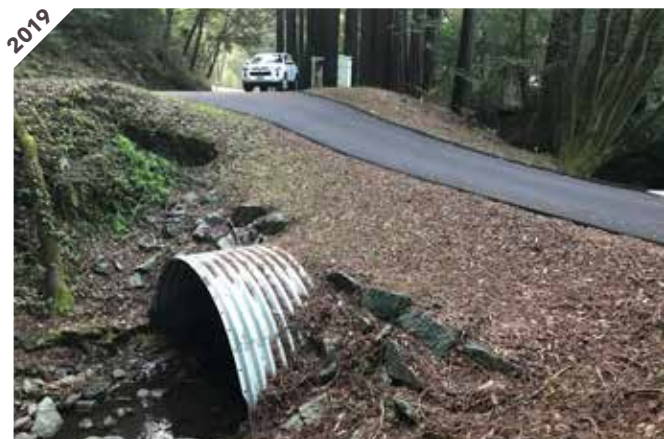
Photo point 3B: There is no erosion present at the culvert inlet. Banks are stable.

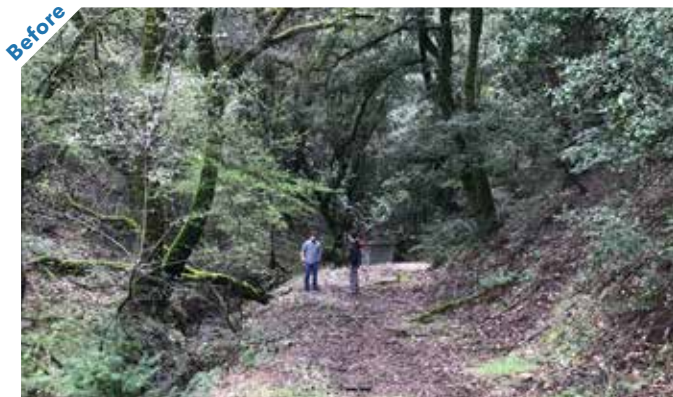
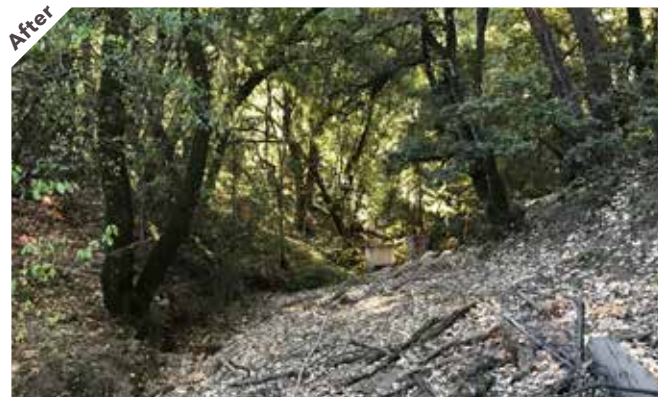
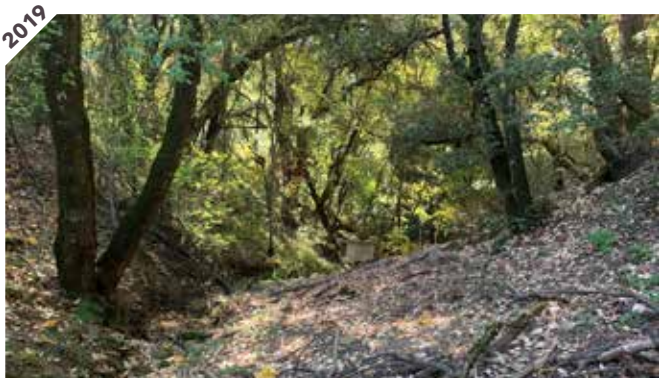
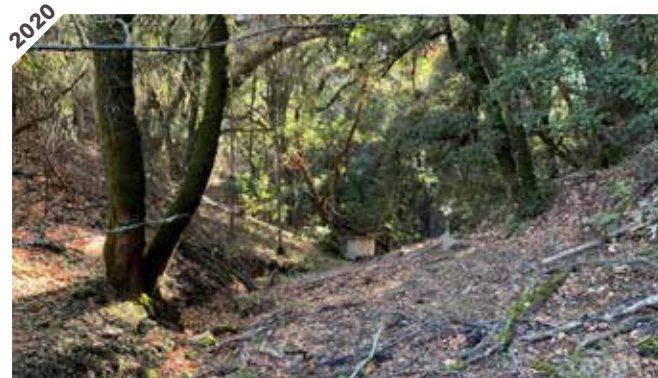
Photo point 2: Looking down the old access road that was decommissioned.

Photo point 2: The road was outslopped to closer mimic the natural slope of the land. Wood debris and understory duff removed during construction was spread back over the area.

Photo point 2: Looking south along the road that was removed. Decommission was effectively reducing runoff and natural recruitment of vegetation is occurring.

Photo point 2: Decommission is still effectively reducing runoff and natural recruitment of vegetation continues to occur at a high rate.

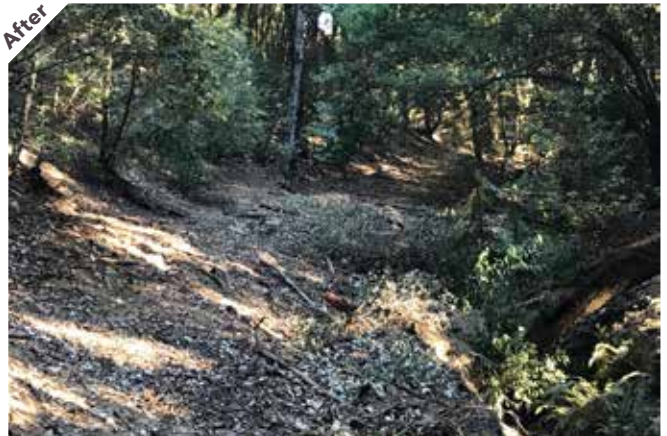
Photo point 5: Looking up the old access road that was decommissioned. Notice the road failure from concentrated runoff and a fallen tree.

Photo point 5: The road recontoured to more closely match the natural slope on the left and prevent ponding or concentrated runoff. Understory duff was stockpiled during construction and spread back over the area post-construction.

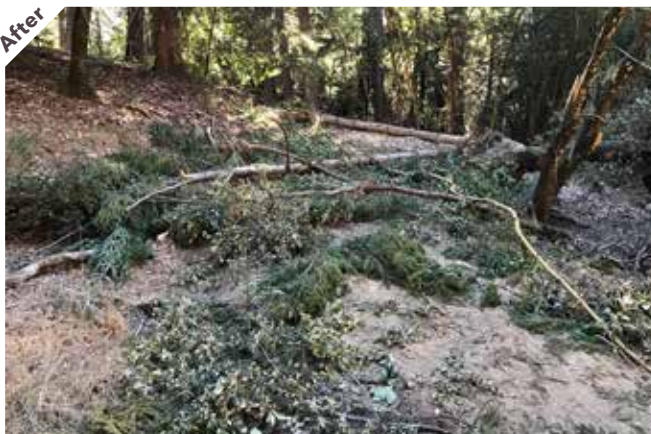
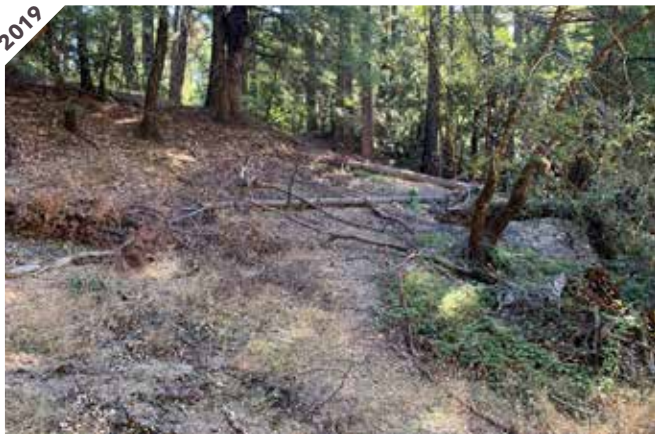
Photo point 9: Looking uphill long the upland portion of the road. The road is insloped the whole stretch above this point with no ditch relief thus contributing to runoff created erosion,

Photo point 9: The road was outsloped to reduce runoff and covered in duff and wood debris from onsite.

Photo point 9: Looking east uphill at former road junction. Decommission is effectively reducing runoff.

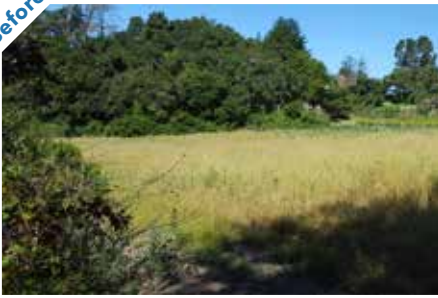
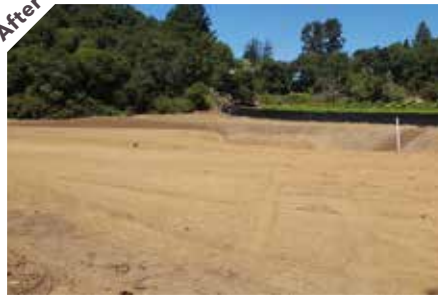
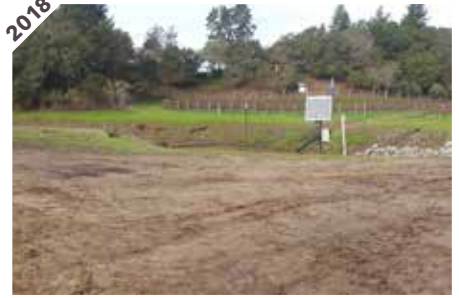
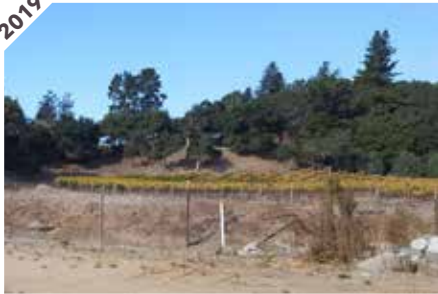
Photo point 5: From the culvert crossing, looking northwest at the basin location (left side of photo) and spoils disposal area (right side of photo). Vegetation has been slow to established on this access road. UCSC instrumentation used to monitor the basin can be seen on the right.

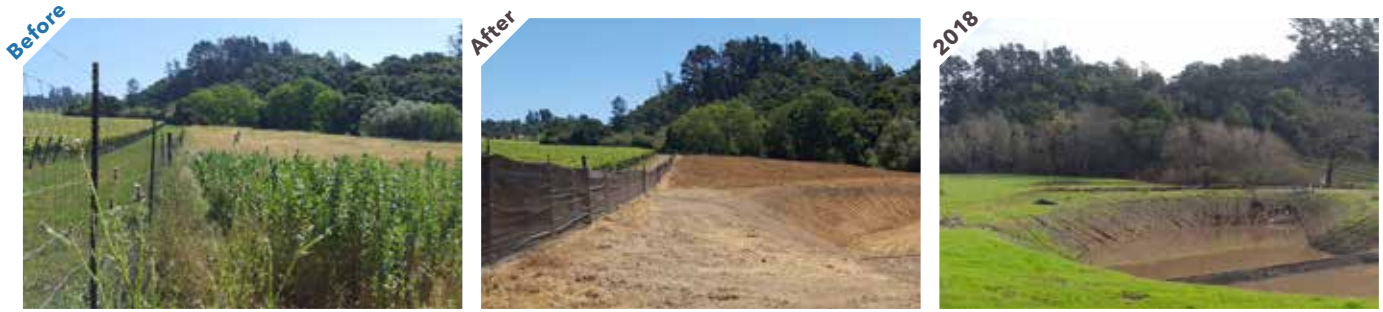
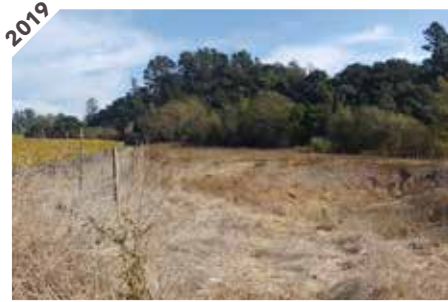
Photo point 7: Looking northeast at the basin. Revegetation occurred prior to the winter rains. In 2018 the basin was full of water after the initial winter rains. Vegetation is becoming established. In 2019 the basin was excavated to remove trap sediment prior to the winter rains.

Photo point 7: Looking northeast, accumulated sediment has been removed from the basin and the weir repaired. Vegetation has become well established on the slopes.

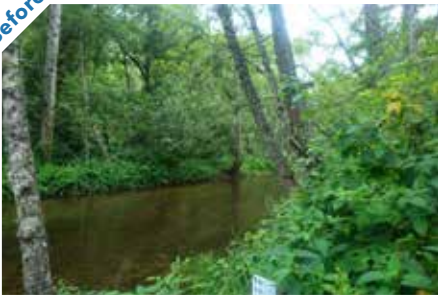
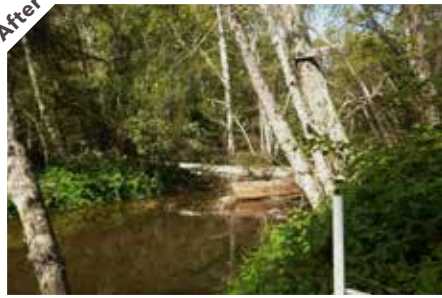
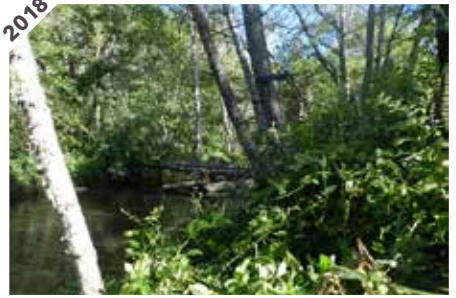
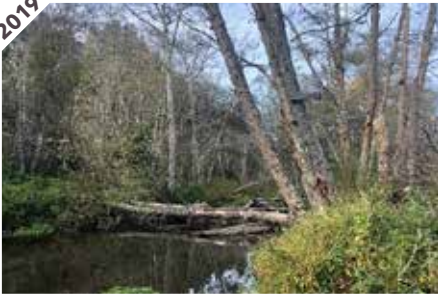
Photo point 2: Photo taken from the left bank of Scotts Creek looking towards a wood feature composed of red alder taken from the streambank, an redwood in the stream, and an imported eucalyptus log. The structure, comprised of alder, redwood and eucalyptus can be seen to the right of the photo and in 2018-19 was catching wood and creating nice scour habitat.

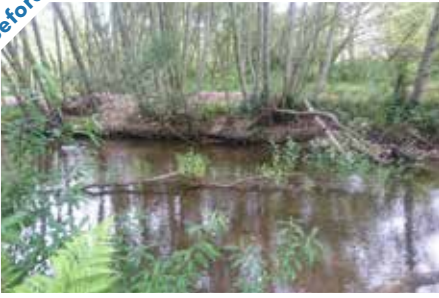
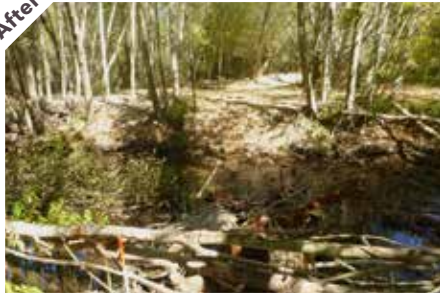
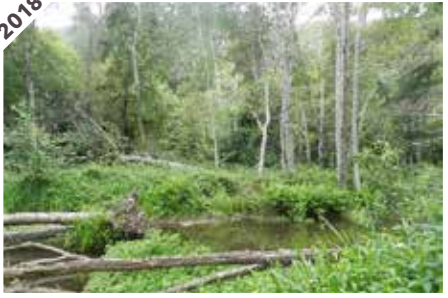
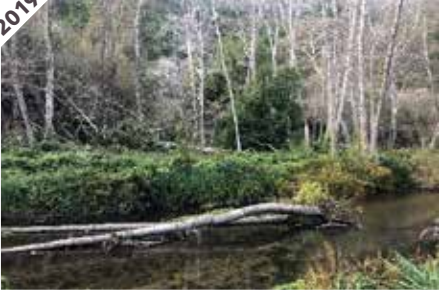
Photo point 4: Photo taken from the left bank of Scotts Creek looking toward a large wood feature of red alders. In 2018-19 the log wood structure was increasing in-stream habitat complexity.

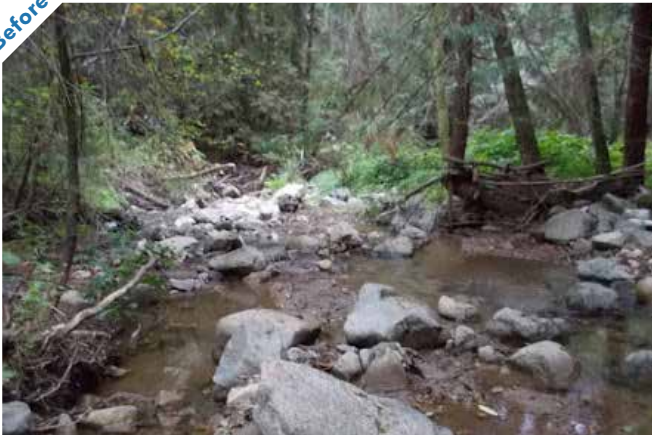
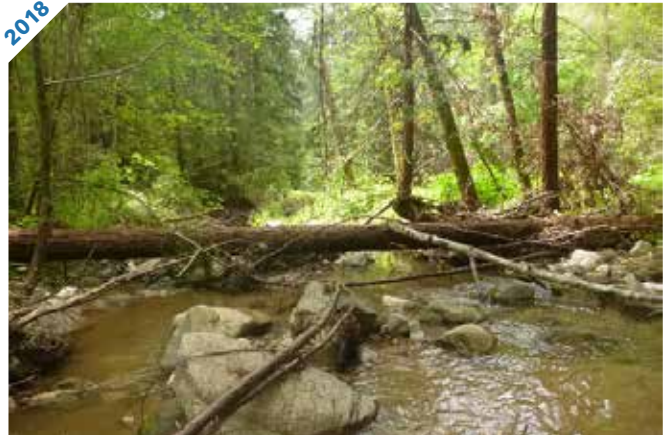
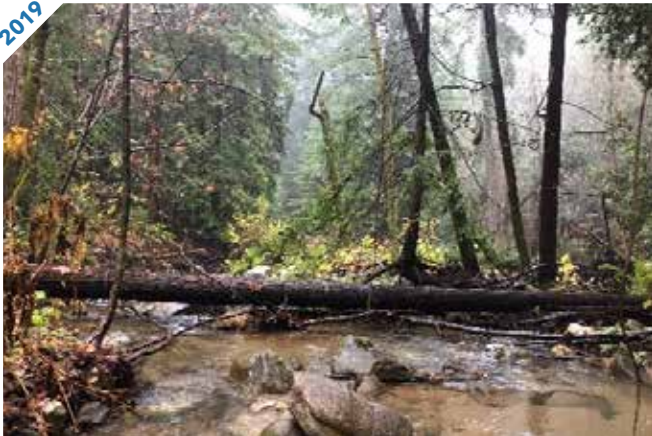
Photo point 2: Looking upstream, no large wood is in the channel.

Photo point 2: After project implementation, large wood can be seen spanning the channel.

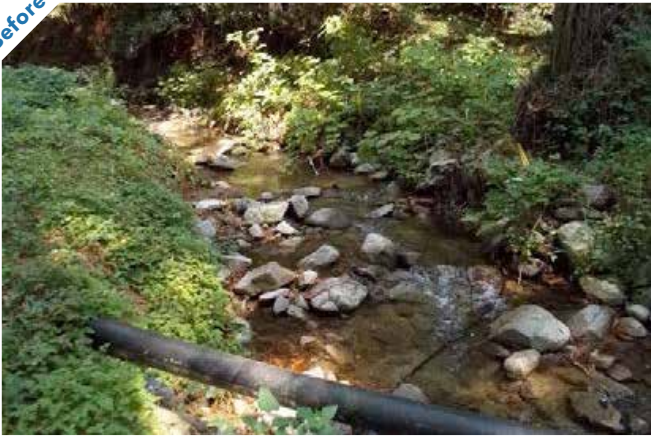
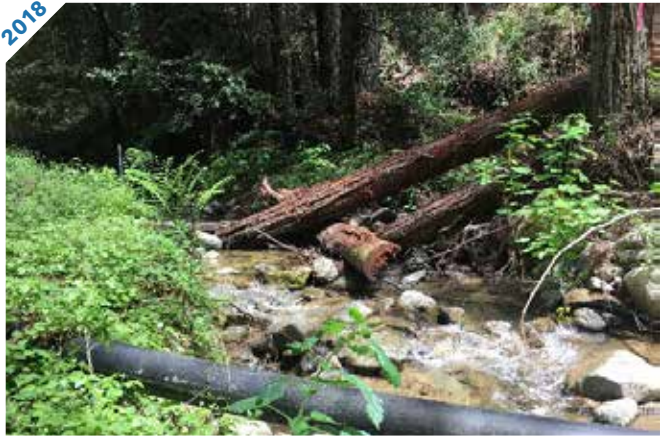
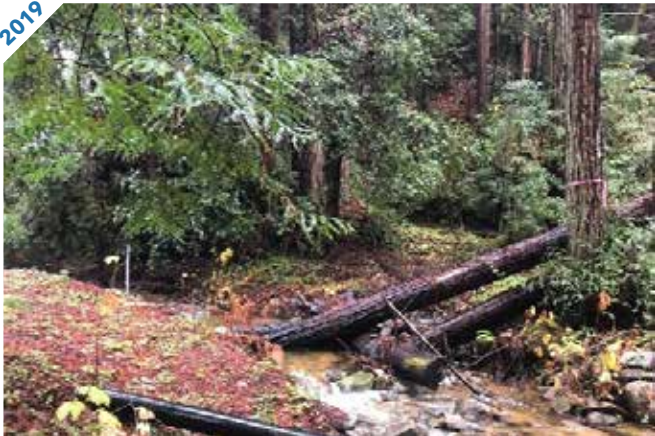
Photo point 5: A remnant side channel has not been active for over a decade at the confluence of San Vicente and Mill Creeks.

Photo point 5: Large wood was placed and a notch carved into the side channel to initiate floodplain re-activation.

Photo point 5: The large wood and notch in the side channel has increased floodplain activation.

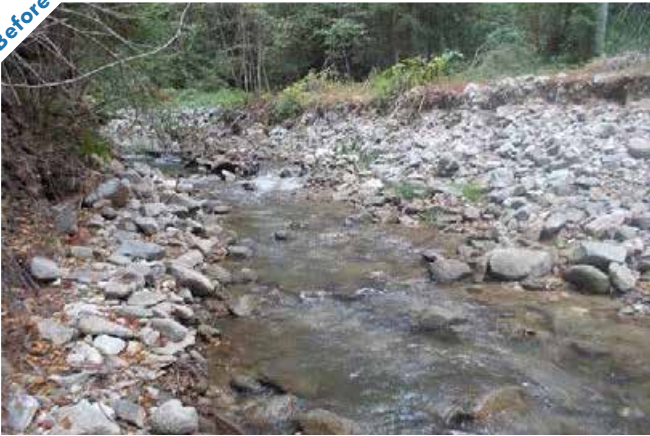
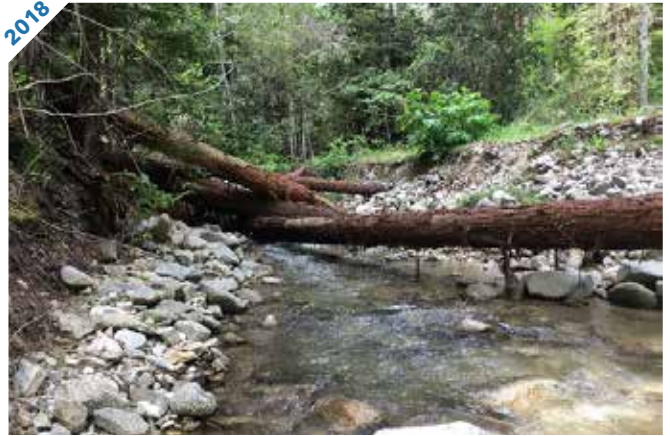
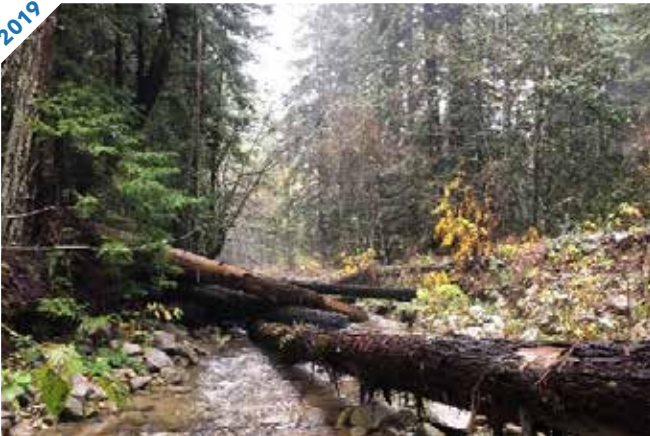
Photo point 5D: At the confluence of Mill and San Vicente Creeks, the channel became highly incised during the 2016/2017 storm event.

Photo point 5D: Large wood was placed just upstream of the confluence of San Vicente and Mill Creeks to assist in aggradation and pool development.

Photo point 5D: Large wood, placed just upstream of the confluence of San Vicente and Mill Creeks, is creating deposition.

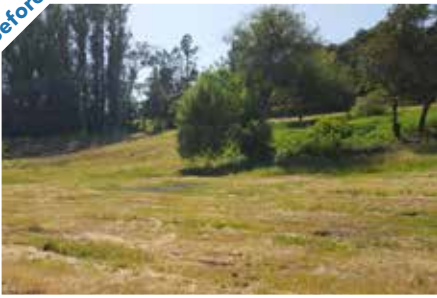
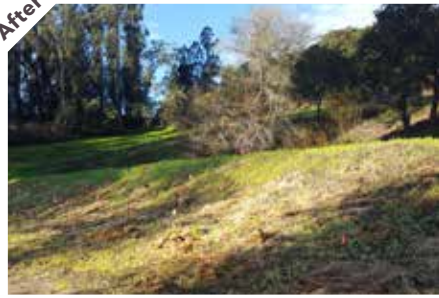
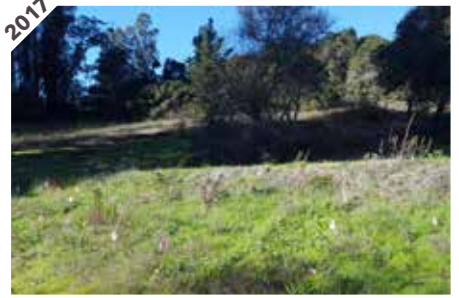
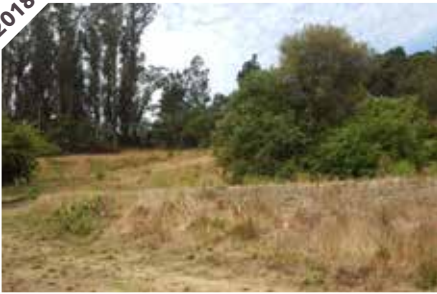
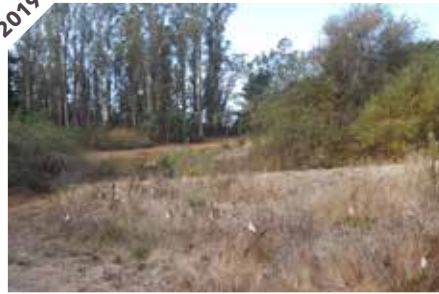
Photo point 4: The before photos shows the habitat prior to being enhanced. In the after photo, the wetland embankment, which can be seen in the right of the photo, will also double as a road to access other portions of the farm. All disturbed areas were seeding with common barley and mulch with weed-free wheat straw. In 2017-18, vegetation was becoming well established, particularly creeping wild rye, Santa Barbara, sedge, California bee plant, and spreading gooseberry. In 2019, the landowner continued irrigation throughout the summer months to increase survival. Vegetation is becoming well established, particularly creeping wildrye, mugwort, and juncus.

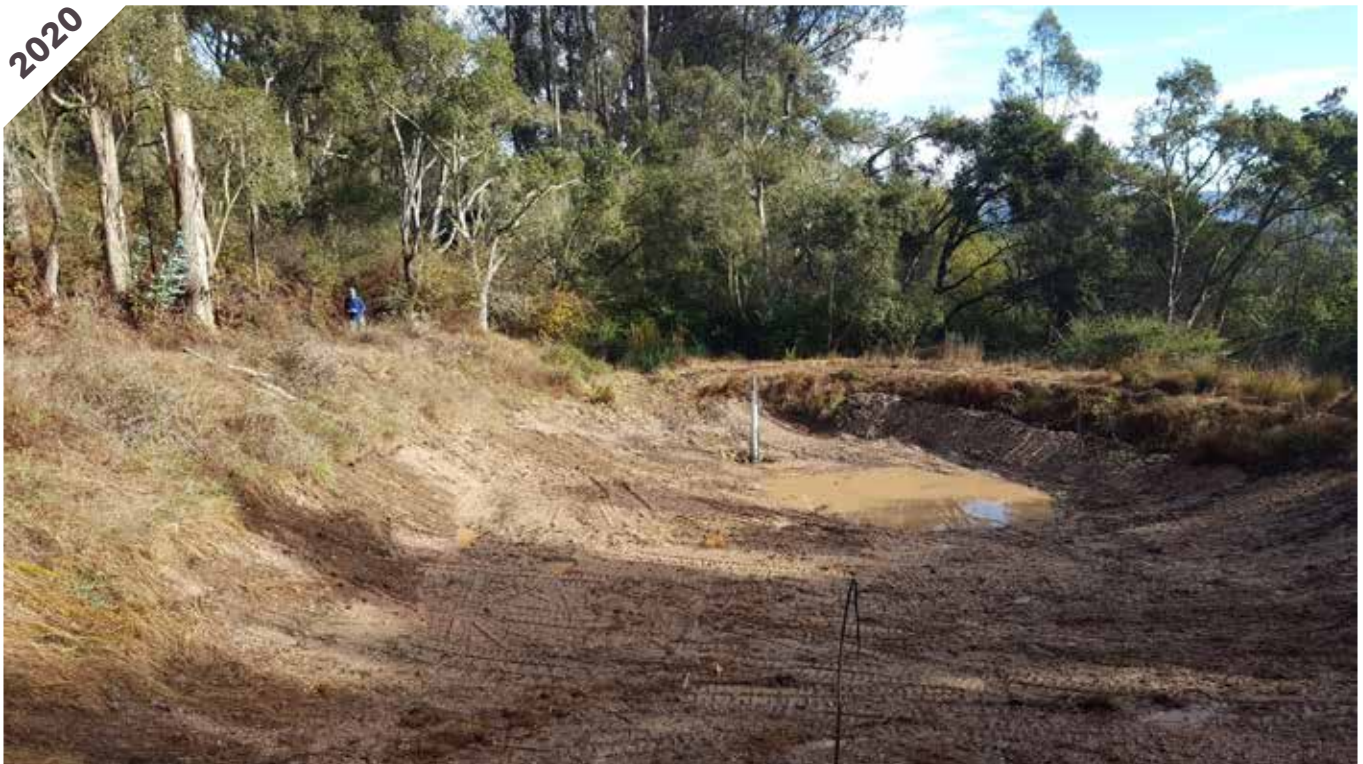
Photo point 3-2: The wetland was enhanced to increase the hydroperiod for amphibian breeding. A riser pipe to manage water levels can be seen. In 2016, the wetland did not hold water long enough to support amphibian breeding. Monitoring equipment was installed to monitor wetland hydroperiod and adaptive management measures are underway. In 2018-19 monitoring equipment was installed to monitor wetland hydroperiod and adaptive management measures were developed.

Photo point 3-2: Juncus and other wetland plants were undisturbed during pond lining. All topsoil was replaced.

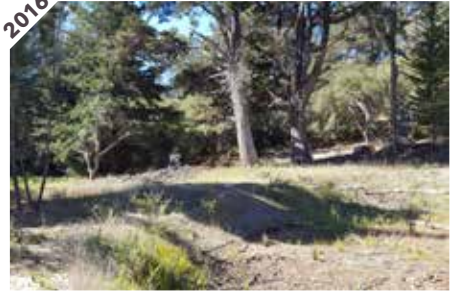
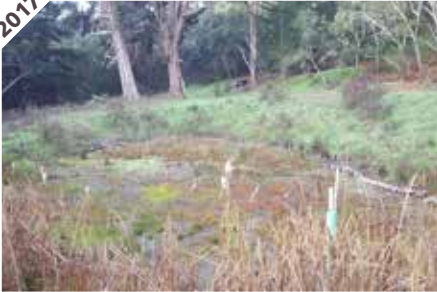
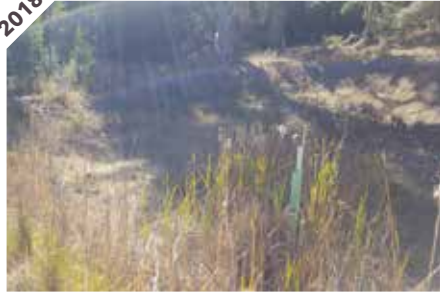
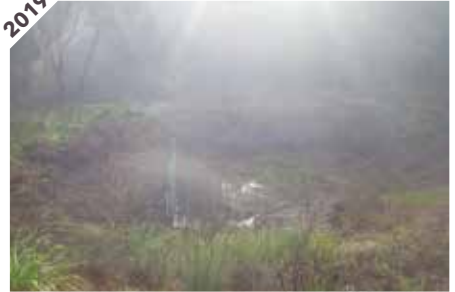
Photo point 4: The before photo is facing southwest from the pre-existing access road and breeding habitat. The wetland was enhanced to increase the hydroperiod for amphibian breeding. A riser pipe to manage water levels is visible in the center. In 2016-19, vegetation was becoming well established in the wetland/pond and was utilized by tree frogs and newts. Although french broom and jubata grass continued to present and needed to be removed.
