August 6, 2024

Mr. Steve Wiesner, PE
Mr. Tim Bailey, PE
Santa Cruz County
701 Ocean Street, 4th Floor,
Santa Cruz County, California 95060

SUBJECT: GEOTECHNICAL REPORT
Mountain Charlie Road Storm Damage PM 1.63
Santa Cruz County, California

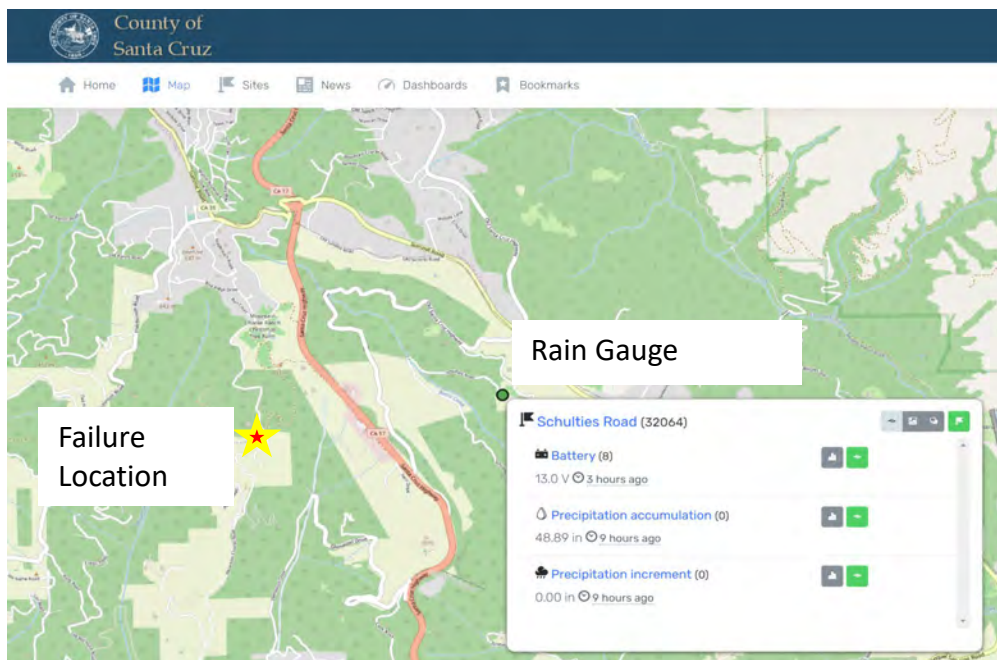
Exhibit 6 Rain Gauge Location

The presence of ponded water on May 2, 2024, weeks after a small 0.5-inch rainfall event on April 13, 2024, illustrates a delay of groundwater movement and interaction within the soil and geologic rock unit. This delay between rainfall event, soil saturation, and movement is seen in the storm events. The location of the rain gauge is shown on Exhibit 6.

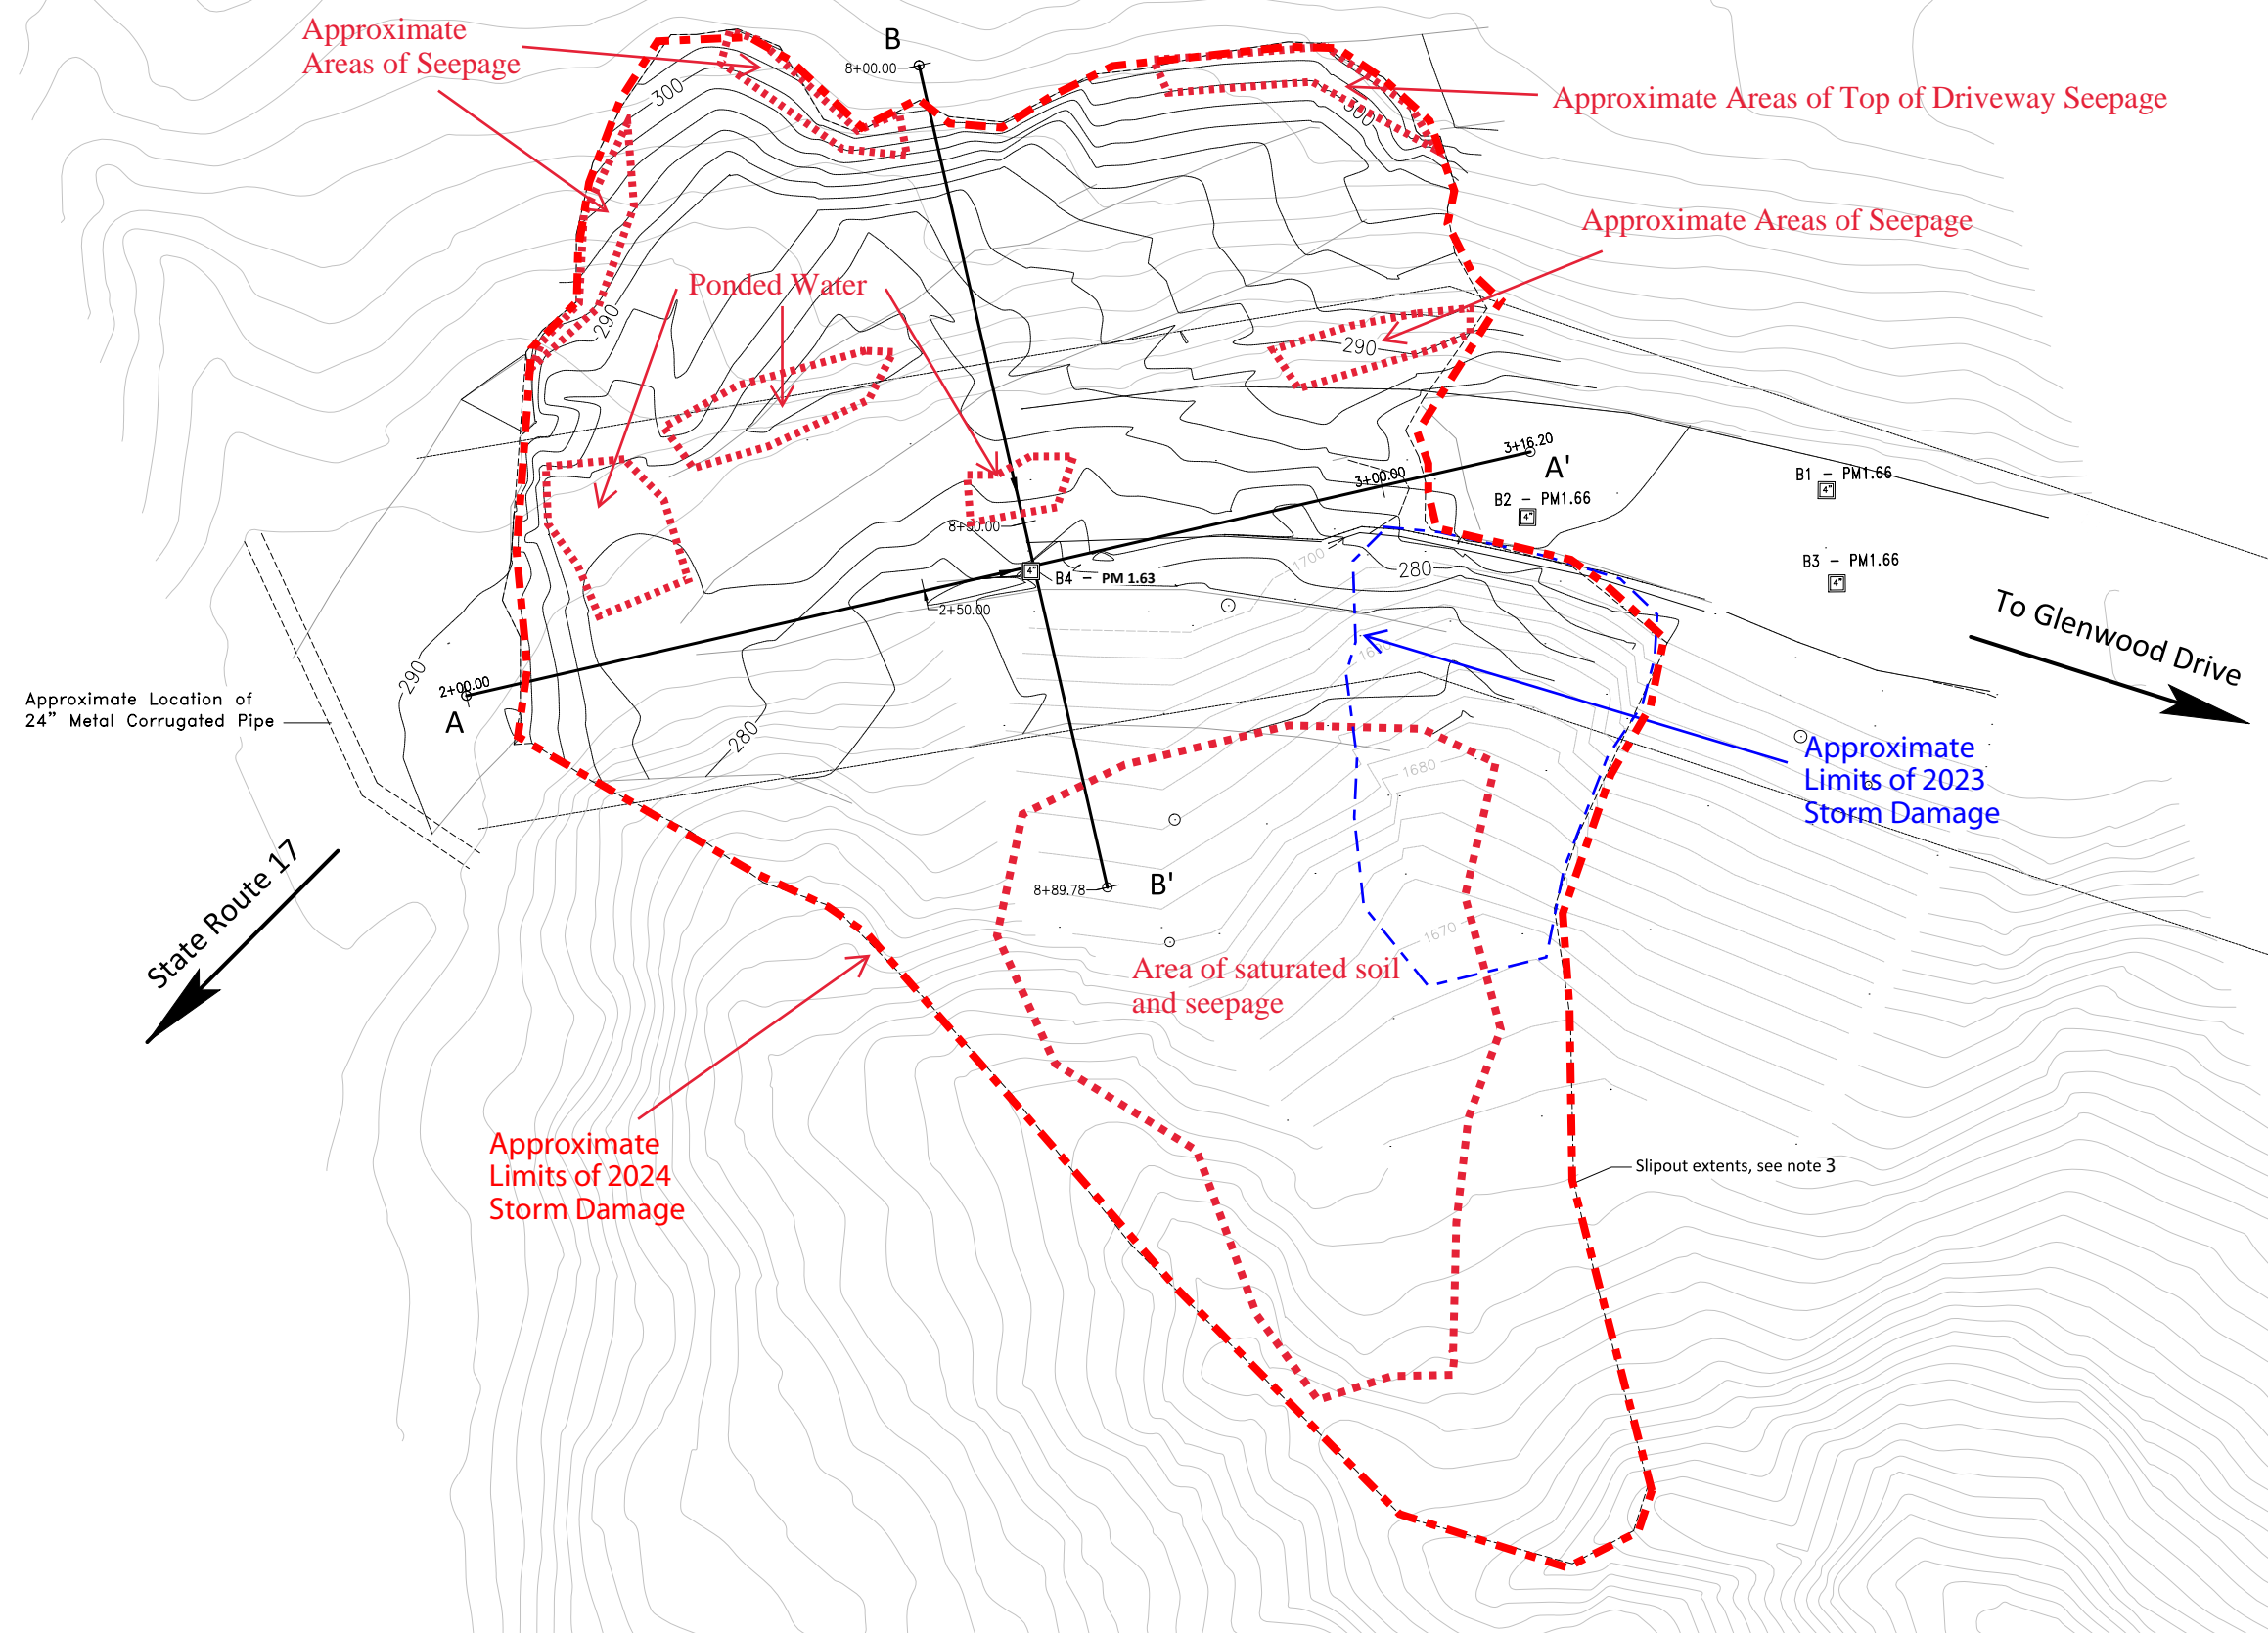
Cross Section Identification		PM 1.63 Site Map		
DIST. 5	COUNTY Santa Cruz	ROUTE	POSTMILE 1.63	PROJECT NUMBER 730
PROJECT OR BRIDGE NAME Santa Cruz Storm Damage				
FIGURE 3	PREPARED BY Edward Muro	DATE May 2024	SHEET 1 of 3

See Figure 2 Survey Monitoring for the locations, dates of readings, and measurements and the cumulative totals for each monitoring point. The survey team performed a topographic survey of the site on May 3, 2024. MGE used the topographic survey information and compared it with previous topographic survey information from 2023. MGE also performed site observations and geologic reconnaissance in the damaged area to evaluate the limits of the storm damage debris and slipout scarp extent. By combining the differences in topographic information along with site observations in the field, MGE was able to approximate and compare the lateral extents of the two slipouts which are shown in Figure 3 Site Map.

Observations of the driveway reveal that the top of the scarp is generally aligned with the inboard edge of the driveway and follows the edge of the driveway drainage path. See Exhibit 2. The scarp geometry encompasses a 100-foot segment of Mt Charlie Road and extends 80 feet east towards the driveway from the edge of pavement. The scarp extends about 100 feet from the Mt. Charlie Road pavement edge downslope to the west. The toe of the slipout was characterized as an area with saturated soils that exhibited seepage and showed moderate relief compared to the surroundings, see Figure 3 Site map.

Surface drainage along the private driveway is collected within a drainage ditch that flows to a culvert near the base of the wye intersection. Seepage was observed on the edge of driveway scarp. A corrugated metal pipe culvert is located beneath the roadway approximately 10 feet from a 24-inch north scarp face. The culvert diverts water from three locations: water from a creek uphill and east of the road, water from the drainage ditch north on Mt. Charlie Road, and the drainage ditch on the driveway. An approximate location of the culvert is shown on Figure 3 Site Map.

Near Monitoring Point No. 1 at the base of the driveway failure there are multiple locations where water is ponded in this area as shown on Figure 3 Site Map. The largest area of ponded water is located directly at the base of the driveway. The water depths of the ponding areas ranged from 5 inches to 1-foot of water. Water was still present at the locations during a site visit on May 2, 2024. At the top of the driveway at the southerly damage limits, the soil was generally firm and unyielding but near the bottom of the driveway the soil is saturated and soft when walked upon. Stepping on exposed portions of soil resulted in 3 to 4 inches of penetration.

Inclinometer Data in Boring B4 shows the depth of the failure plane at the B4 location is 28-feet deep. The scarp limits are defined by the obvious back scarp on the hillside and the toe of the storm damaged debris was observed and identified during walking traverse on the slope. These limits are shown on Figure 3 Site Map. In our opinion, the slipout failure plane is within the soil unit and not within the rock unit below 30-feet depth. MGE did not observe tension cracks upslope from the existing scarp limits. However, soft soil was observed above the scarp near the walking trail used by residents to access their property. This trail is within 20-feet of the upper scarp limits.

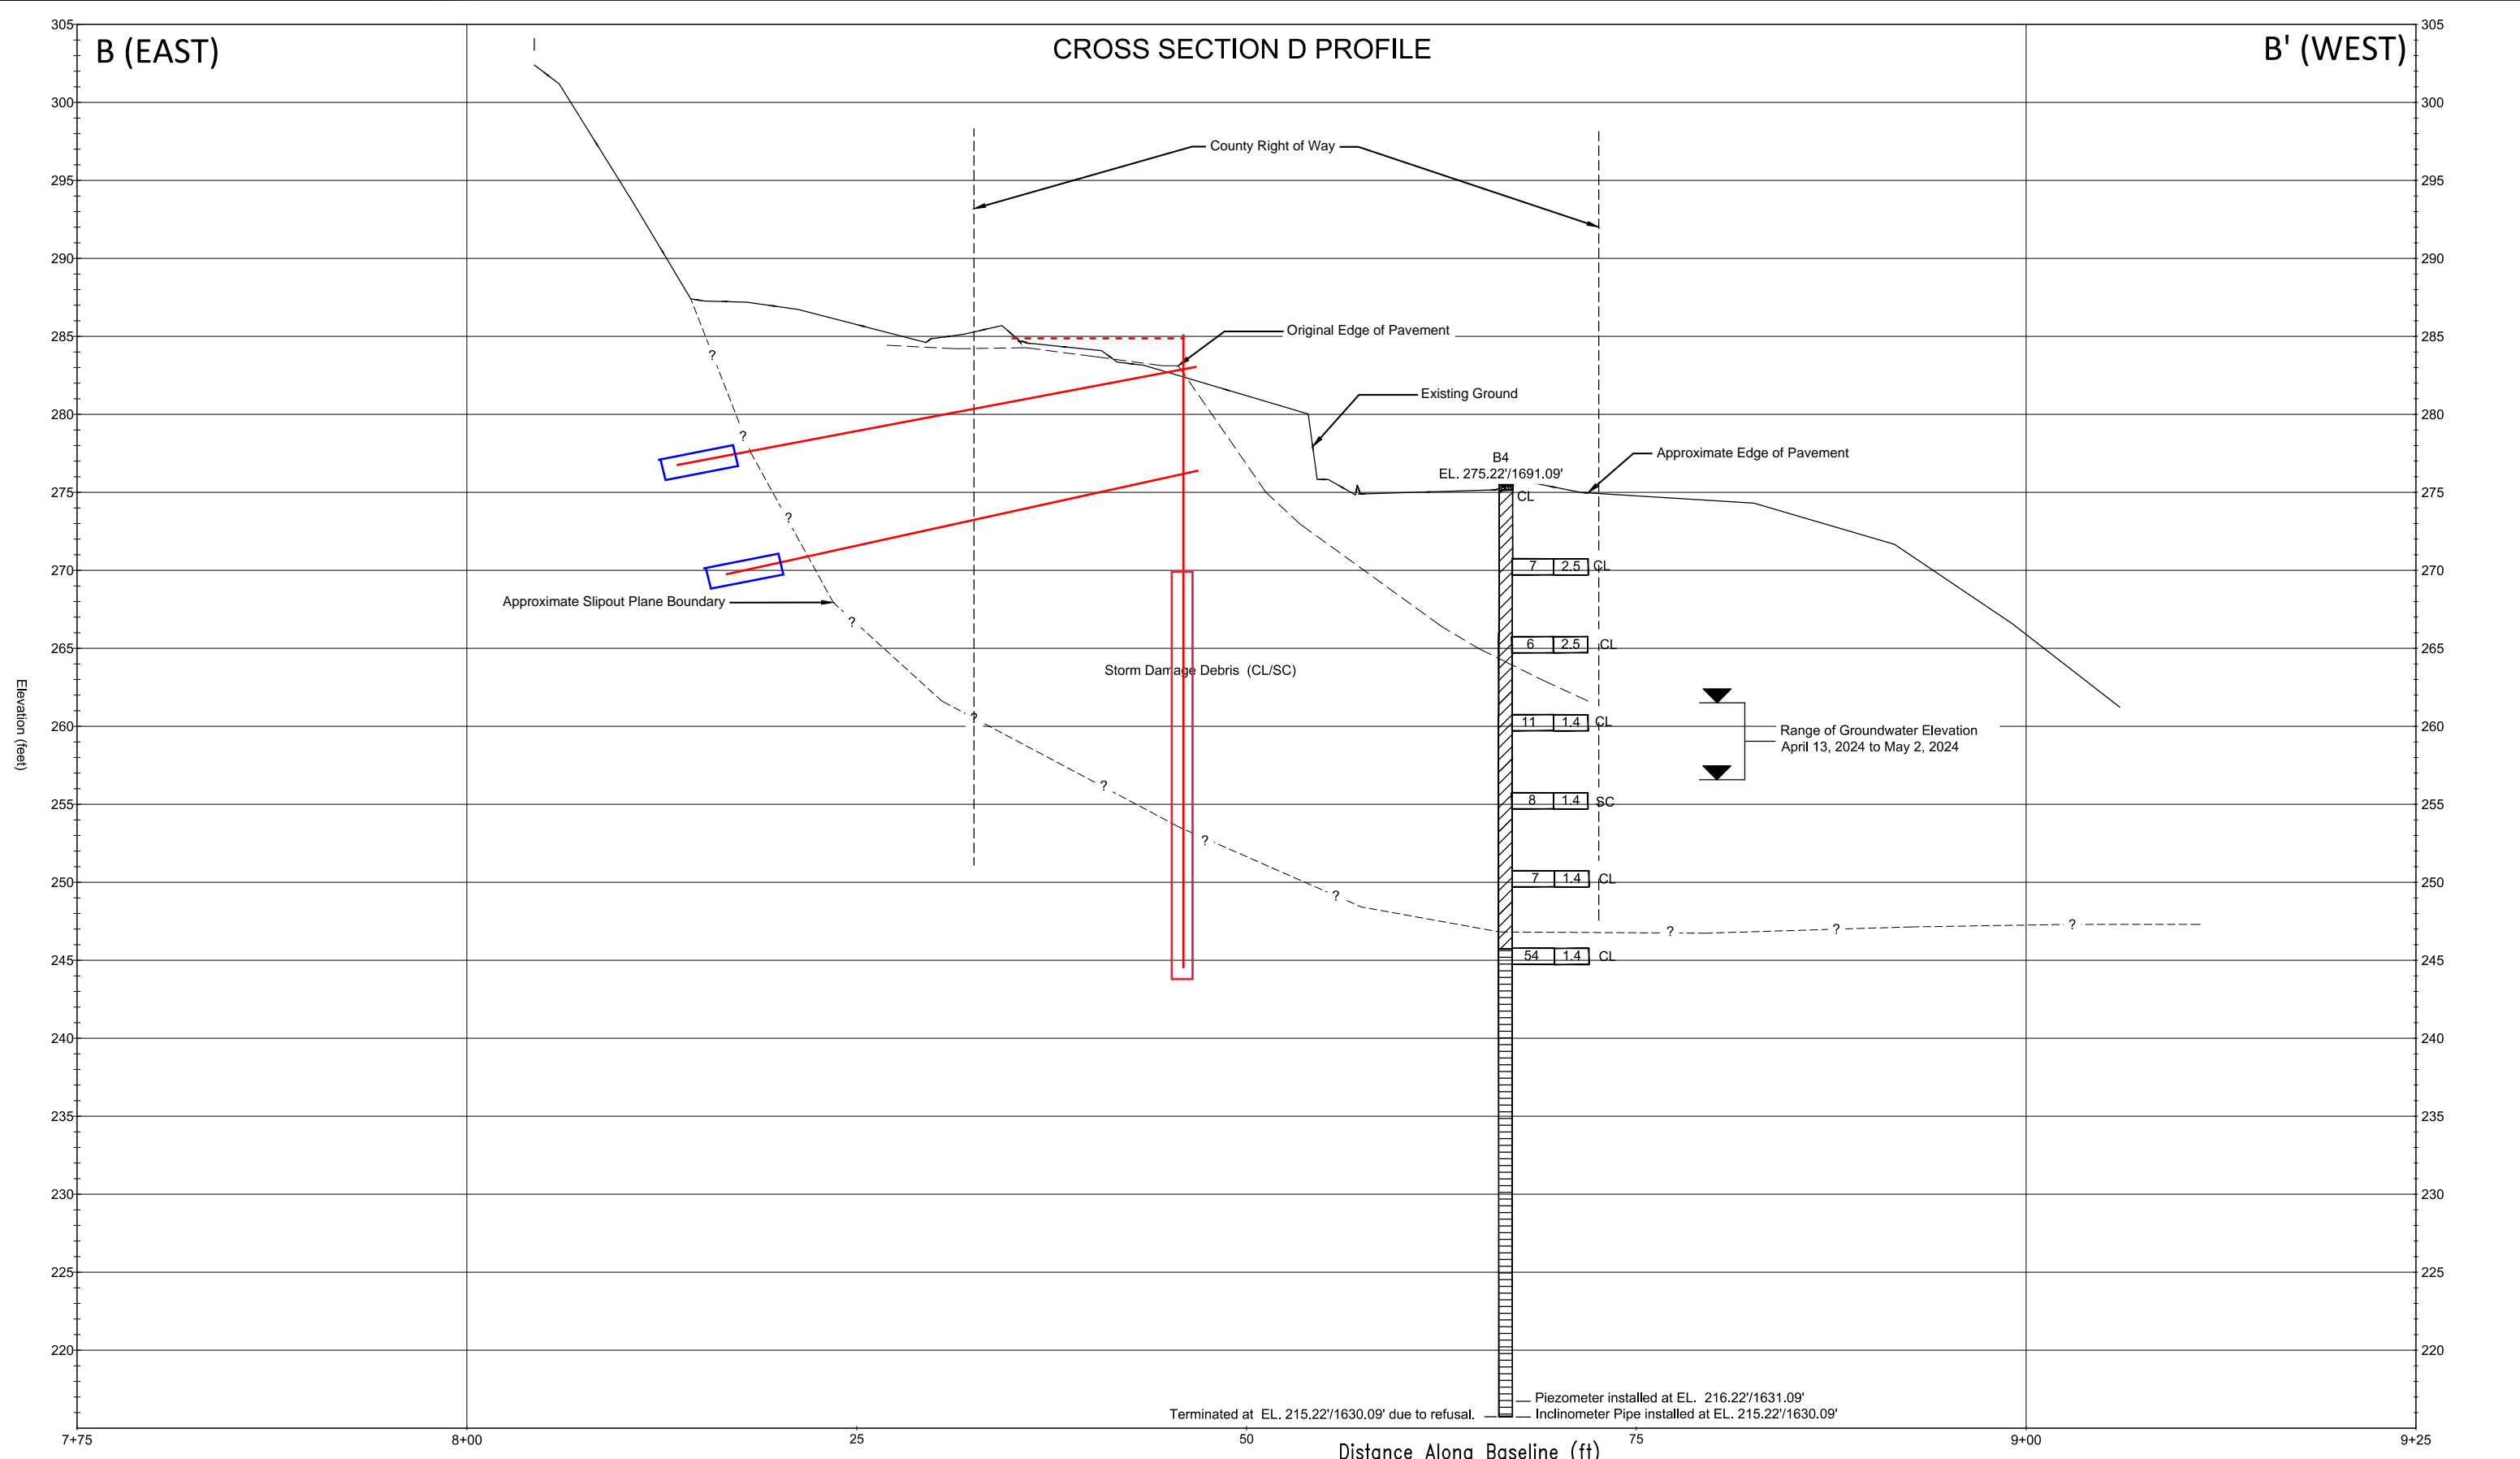
Cross Section Identification		Cross Section A		
DIST. 5	COUNTY Santa Cruz	ROUTE	POSTMILE 1.63	PROJECT NUMBER 730
PROJECT OR BRIDGE NAME Santa Cruz Storm Damage				
FIGURE 6		PREPARED BY Edward Muro	DATE May 2024	SHEET 2 of 3

Based on the borings and observations at the site, we interpreted the geology underlying the storm damage site. Interpreted geologic sections are appended as Figures 3, 6, and 7.
