**REVISED - GEOTECHNICAL DESIGN & DEBRIS FLOW HAZARD RISK ASSESSMENT
REPORT**

VETERANS VILLAGE HOUSING PROJECT

CE&G DOCUMENT: 220300.001

JUNE 24, 2022

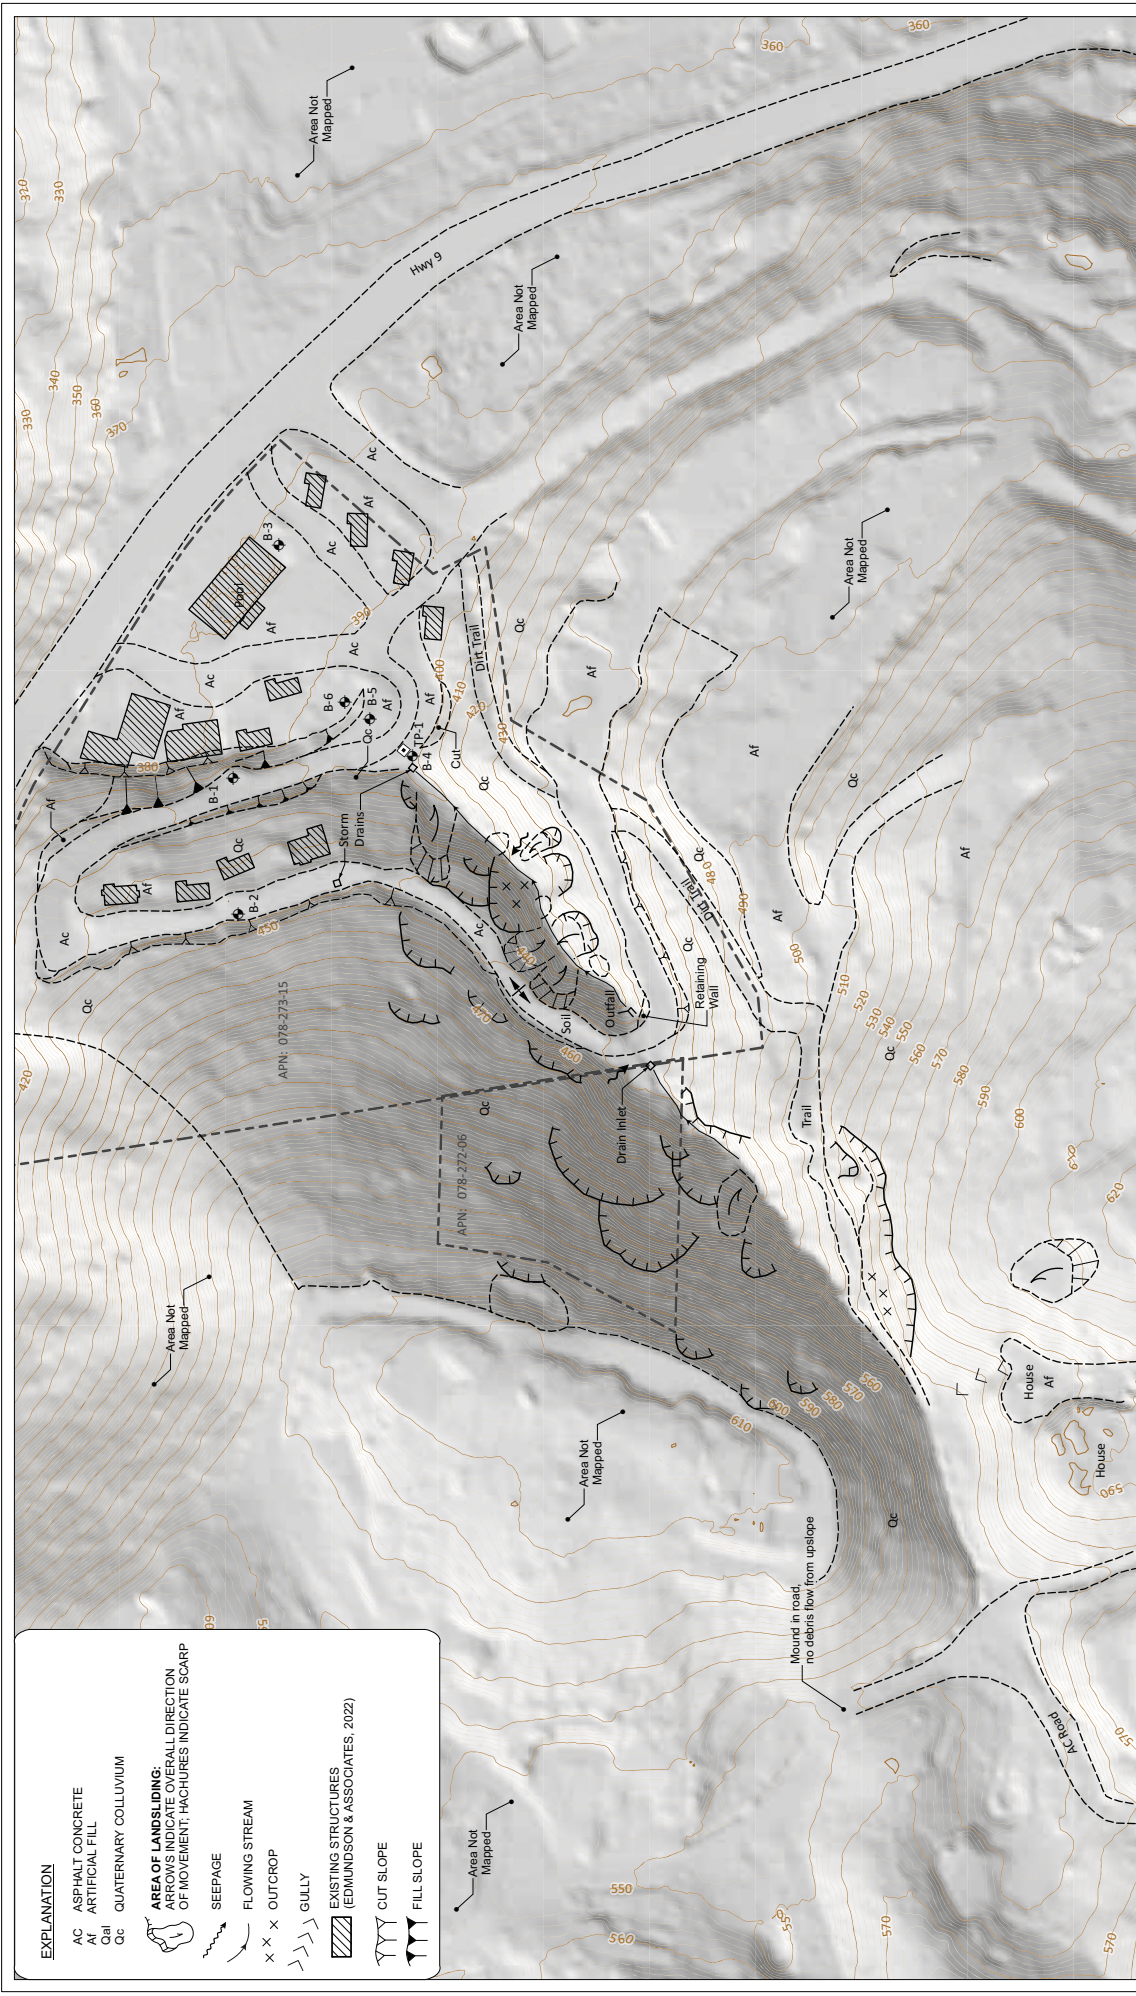
220300 June 2022 FIGURE 2

EXPLANATION

AC ASPHALT CONCRETE
 Af ARTIFICIAL FILL
 Qal QUATERNARY COLLUVIUM
 Qc QUATERNARY COLLUVIUM

BASEMAP REFERENCE
 1. GEOLOGIC MAPPING BY K. LOEB ON 4/6/2022.
 2. 2-FT CONTOURS DERIVED FROM 2018-2020 LIDAR DATA (3-FT DEM) FOR SANTA CRUZ COUNTY.

The project site is located in a moderately forested area of Ben Lomond, California, and is bounded by steep hilly terrain to the northwest, southwest, and southeast, and by Highway 9 to the northeast. The central and western portions of the site consist of steep hilly terrain with a northeast-trending stream channel, that actively flows to the northeast towards the gentle sloping portion of the site. The eastern portion of the project site gently slopes to the northeast towards Highway 9. The natural and fill slopes within the project area contain large redwood trees with a moderately brushy understory. On-site slopes that are not alongside the stream channel generally range from approximately 20° to 40°, whereas the slopes along the actively incising channel range from about 25° to 60°. These steeper slopes also contain small to large-sized trees, some of which have fallen due to slope instabilities along the channel. At the mouth of the channel is the apex of a gently sloping alluvial fan, which extends beyond highway 9 and makes up the gently sloping (0° to 10°) portions of the project site. The alluvial fan area has some large trees near the mouth of the channel and along the base of the slope but is mostly cleared of vegetation due to the existing development. The majority of the proposed development area sits within the gently sloping alluvial fan limits, except for four cabins (Keynotes 7 through 10), which are located on the adjacent hillside (Figure 2).

Key features of the project site are depicted on the attached Figure 2 and Appendix-A.

Six geotechnical borings were drilled in the vicinity of the planned improvements as part of our investigation. Before drilling, CE&G marked planned boring locations and coordinated utility clearance through USA and a private utility locator. The approximate boring locations are shown on the attached Figure 2.

The hillslopes along the on-site stream channel are lined with active landslides that occasionally add soil, rocks (e.g., gravel and cobbles), and organic debris (e.g., logs, tree stumps, branches, etc.) into the actively flowing channel (Figure 2). The toes of the landslides that have obstructed the stream channel have been incised by about 1 to 4 feet, leaving behind fill terraces along parts of the channel. Aside from oversteepening of the channel flanks, these landslides likely most often occur during higher flow events that erode the toes of the adjacent slopes, resulting in a loss of lateral support and eventually,

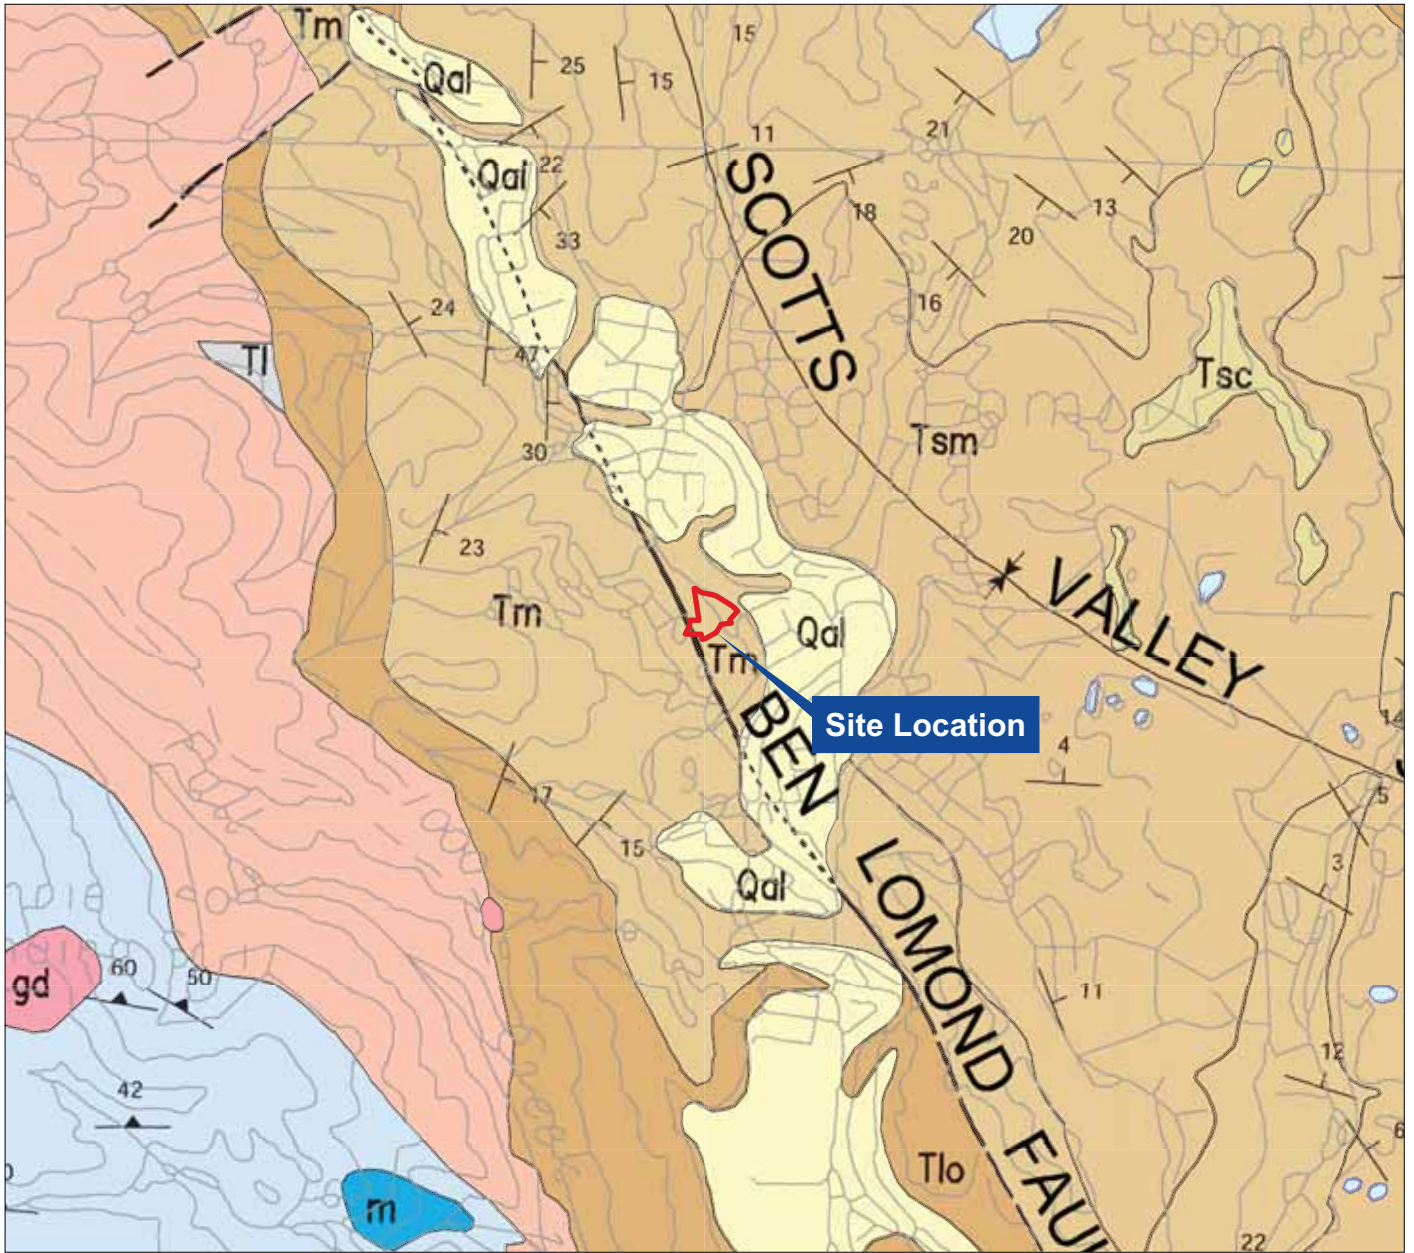
FIGURE 3

1. REGIONAL GEOLOGY FROM BRABB, 1997 (OPEN-FILE REPORT 97-489).

The geologic setting is shown on the Regional Geology Map, Figure 3.

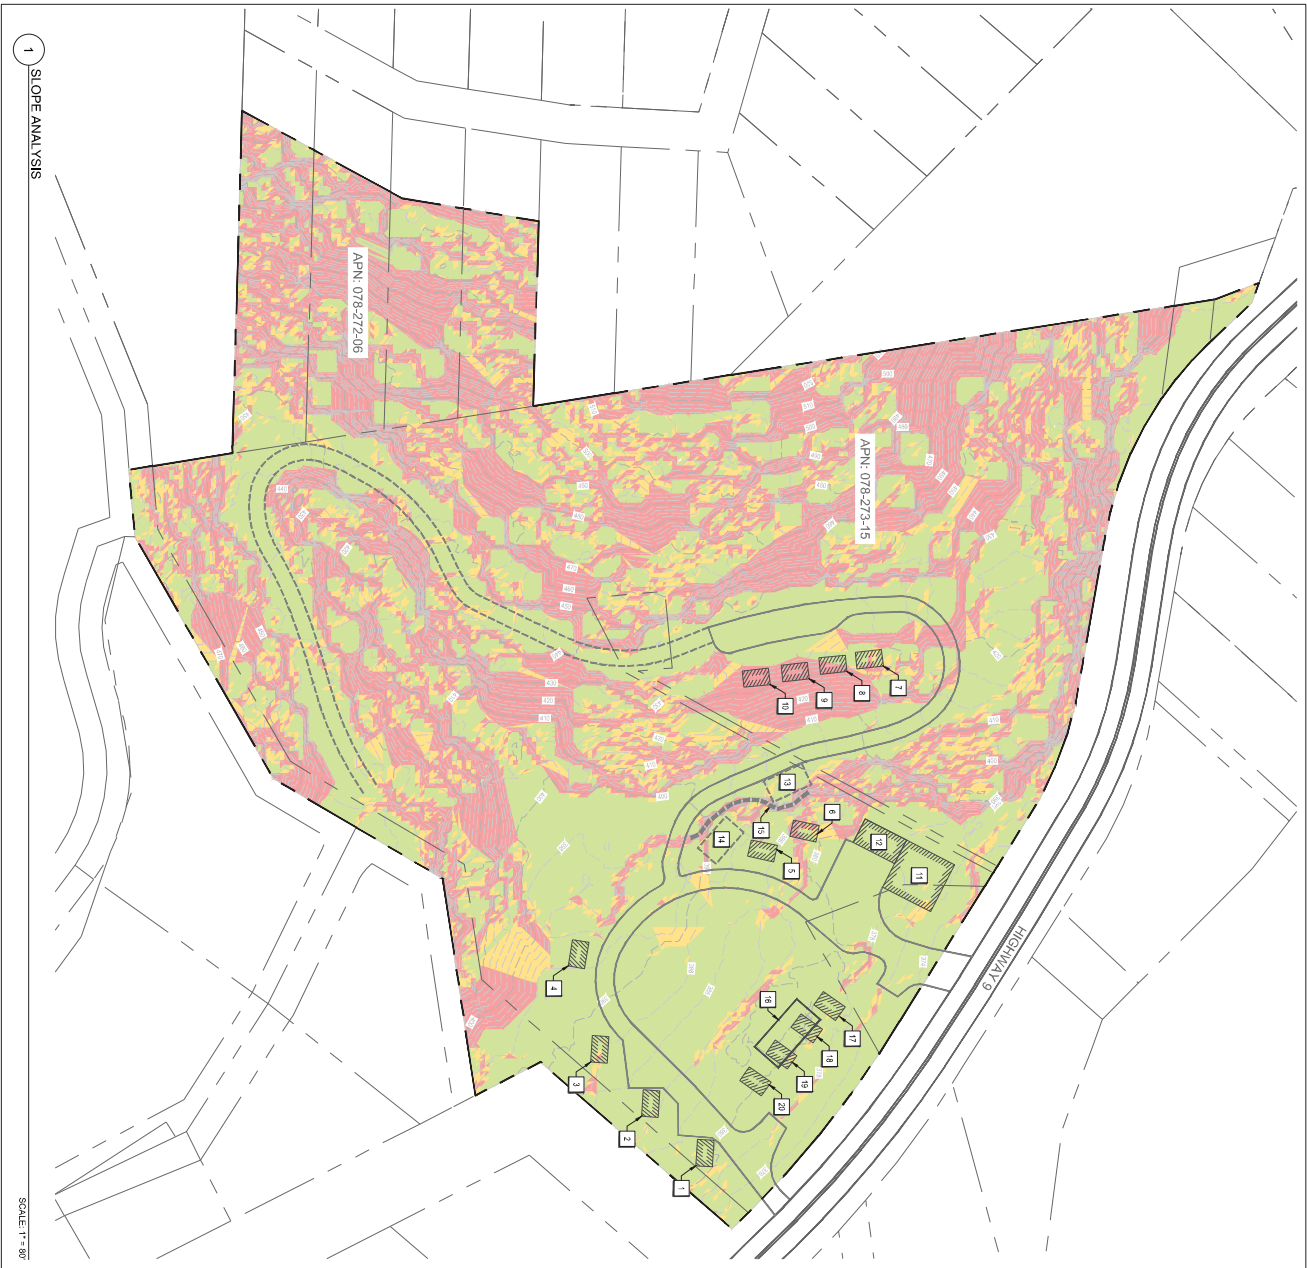
1 SLOPE ANALYSIS

SCALE 1" = 80'

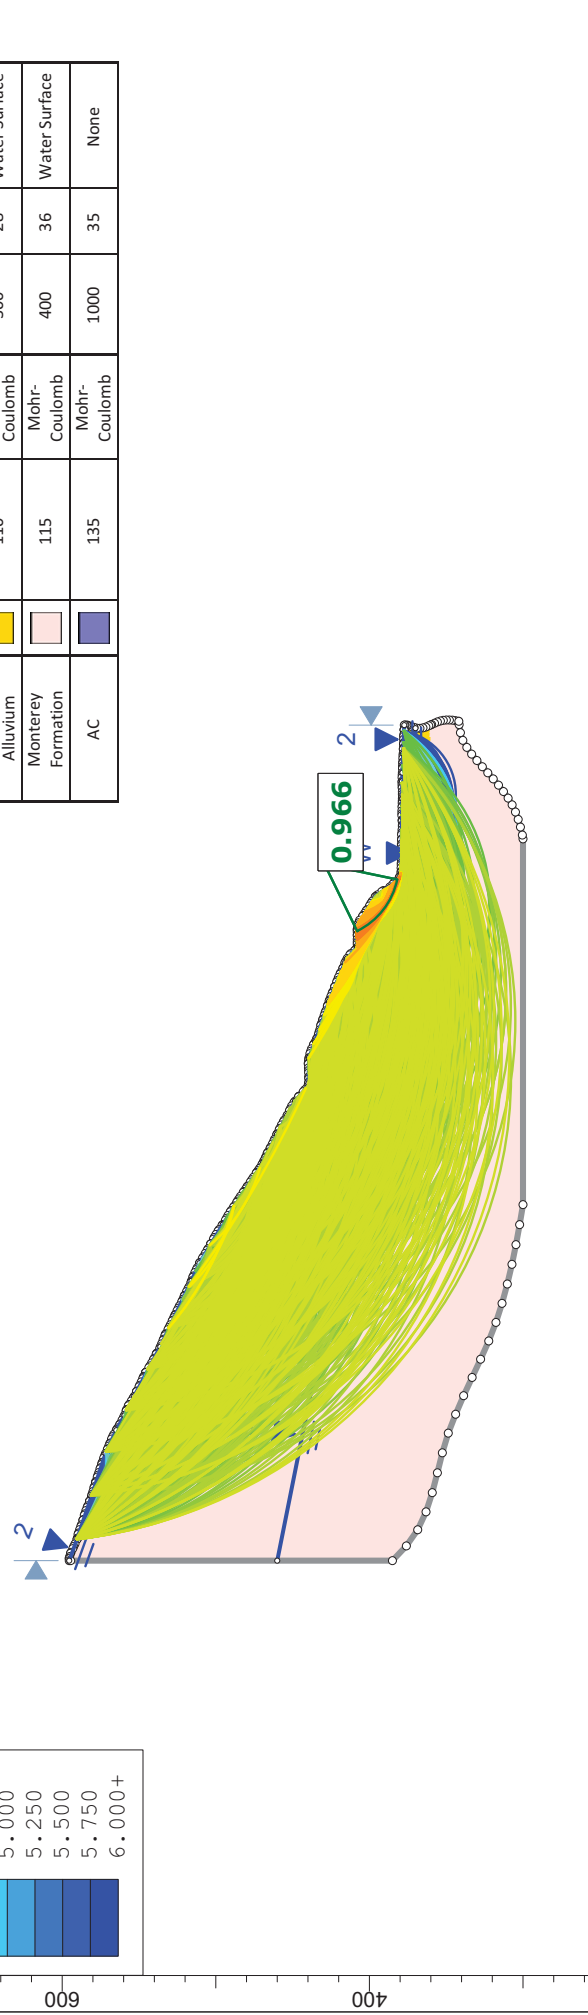
Wet Season - Static - All Failure Surfaces

Material Name	Color	Unit Weight (lbs/ft ³)	Strength Type	Cohesion (psf)	Phi (deg)	Water Surface
Artificial Fill		110	Mohr-Coulomb	400	28	Piezometric Line 2
Quaternary Colluvium		110	Mohr-Coulomb	300	28	Piezometric Line 2
Quaternary Alluvium		110	Mohr-Coulomb	300	28	Water Surface
Monterey Formation		115	Mohr-Coulomb	400	36	Water Surface
AC		135	Mohr-Coulomb	1000	35	None
