**Alternative 4  
Groins and Notch Filling**

Santa Cruz, California

**Figure 6-4**

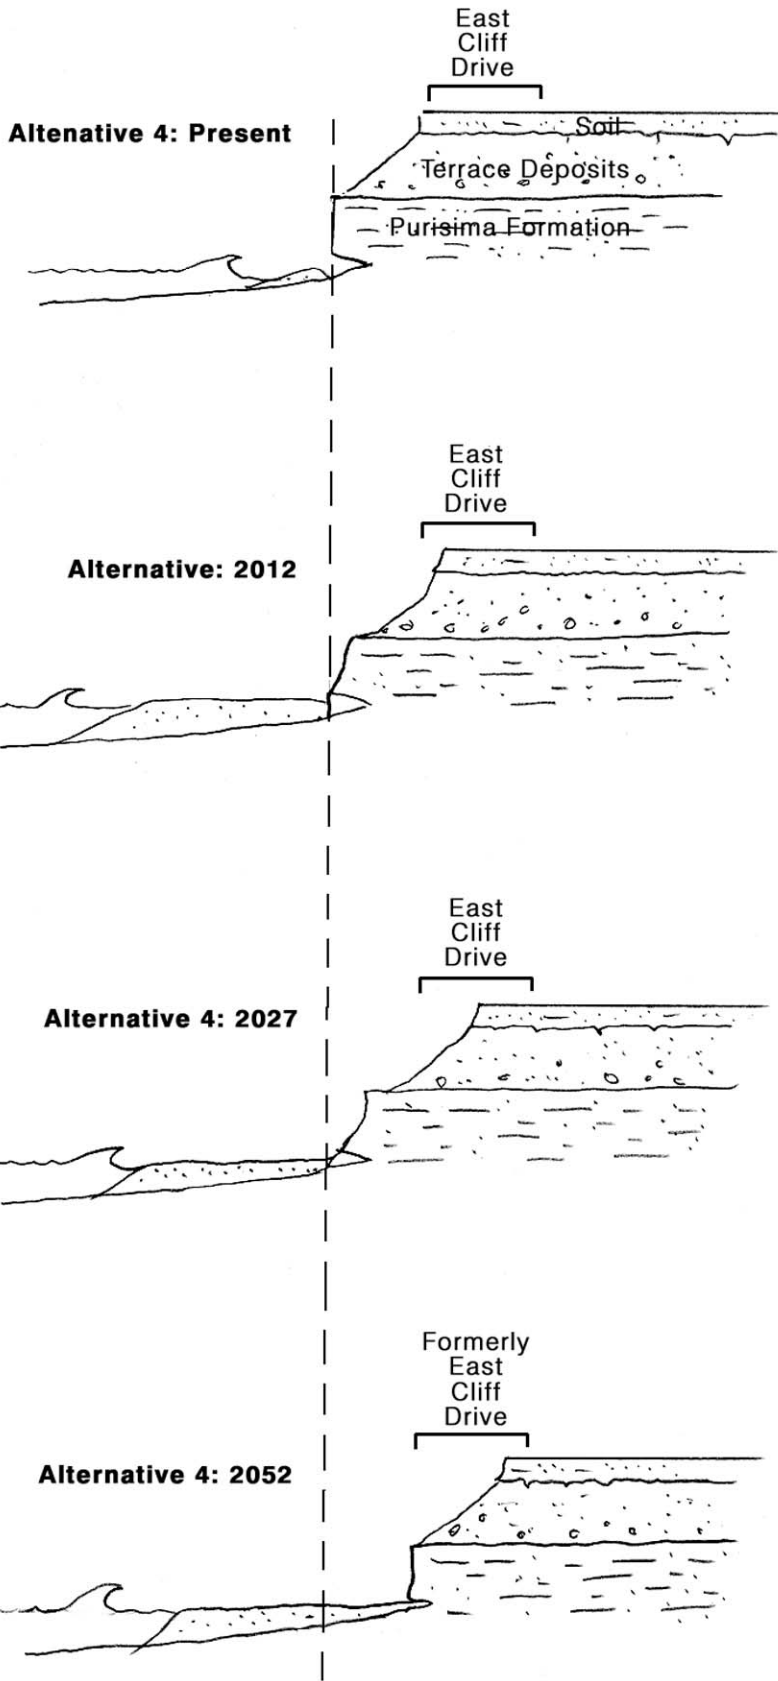
**Stage 1**

Same as No Project.

**Interlude A**

Same as No Project until construction is completed, then Purisima and Terrace deposits continue to retreat, but at a slower rate than for No Project.

**Stage 2**

Pocket beaches form, reducing wave erosion at base of Purisima. Terrace deposits have retreated to East Cliff Drive.

**Interlude B**

Terrace deposits continue to retreat but at a slower rate than Alternative 3. Purisima retreats slowly, but filling notches slow the rate of retreat.

**Stage 3**

Portions of East Cliff Drive have failed.

**Interlude C**

Purisima continues to fail and retreat, as do terrace deposits. New notches form in Purisima and, unless filled, eventually cause Purisima to fail.

**Stage 4**

Most of East Cliff Drive removed. Purisima unprotected and retreats, as for No Project.
